Technical Bulletin

94 15 01 March 27, 2015 2011521 Supersedes T. B. V941403 dated June 04, 2014 to include additional model applicability.

Exterior Lights, Moisture Accumulation

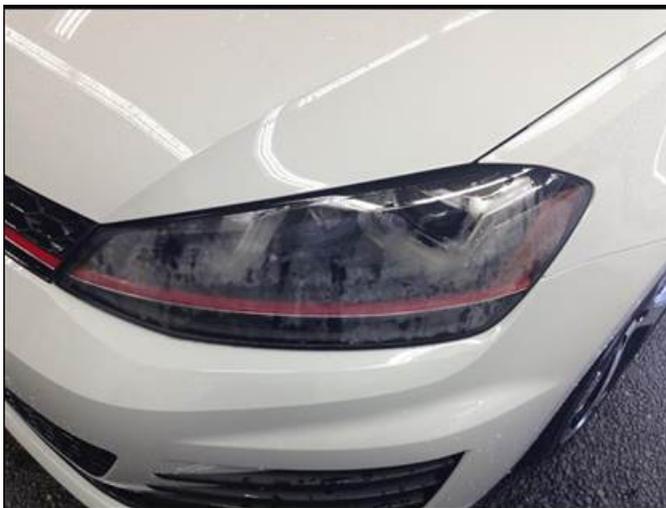
Figure 1

Condensation and or water droplets visible on inside of exterior light lenses.

Exterior light assemblies (headlights, taillights, fog lights, turn signals) are vented and may collect moisture on their inner surfaces, depending on humidity and climatic conditions. The unfavorable condensation built up (Figure 1) visible to the customer is more common with modern exterior lights because of clear glass optics, however this condition will not have an impact on the functionality or durability of the component.

For headlight condensation that is due to environmental conditions, the affected lens surface should be cleared after approx. 30 minutes of light operation.

If the condition is determined to be condensation due to environmental conditions and no damages are found, explain to the customer the information provided in the Technical Background section above.

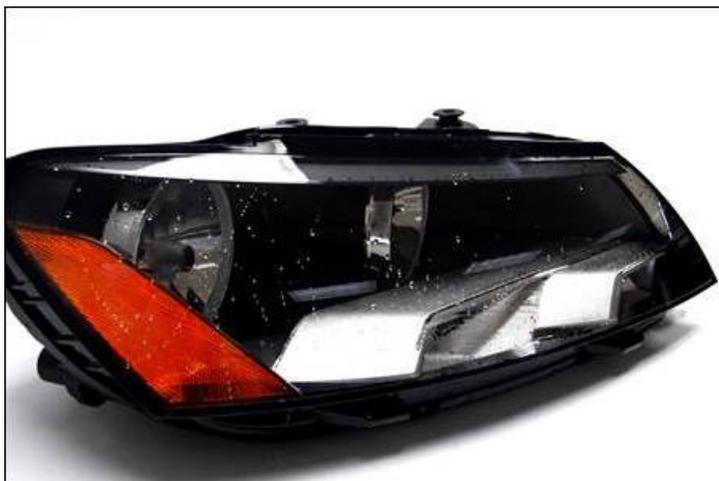
Figure 2

In cases where larger water droplets have formed on the inside of the lens or significant amount of water has collected at the bottom of a light assembly, Figure 2.

DO NOT replace light or lens assemblies unless damage is found.

If damage to seals or cracks to lenses or assemblies are found:

- Follow normal repair procedures for this type of failure (provide photograph(s) with repair documentation for verification).

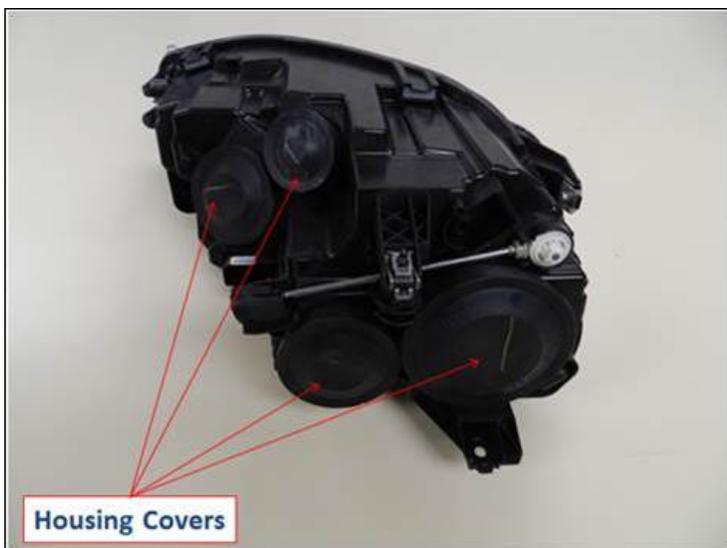
Figure 3

- Check that the housing covers (Figure 3) are properly installed. If the housing covers are not fully seated in place, use compressed air (less than 30 PSI) to blow out the lens and recheck for leaks.
- Check for leaking seals, cracks in lenses or assemblies.
