Tech Tips

TT 61-08-05

2007-2015 Eos – Convertible Top Repair Tip

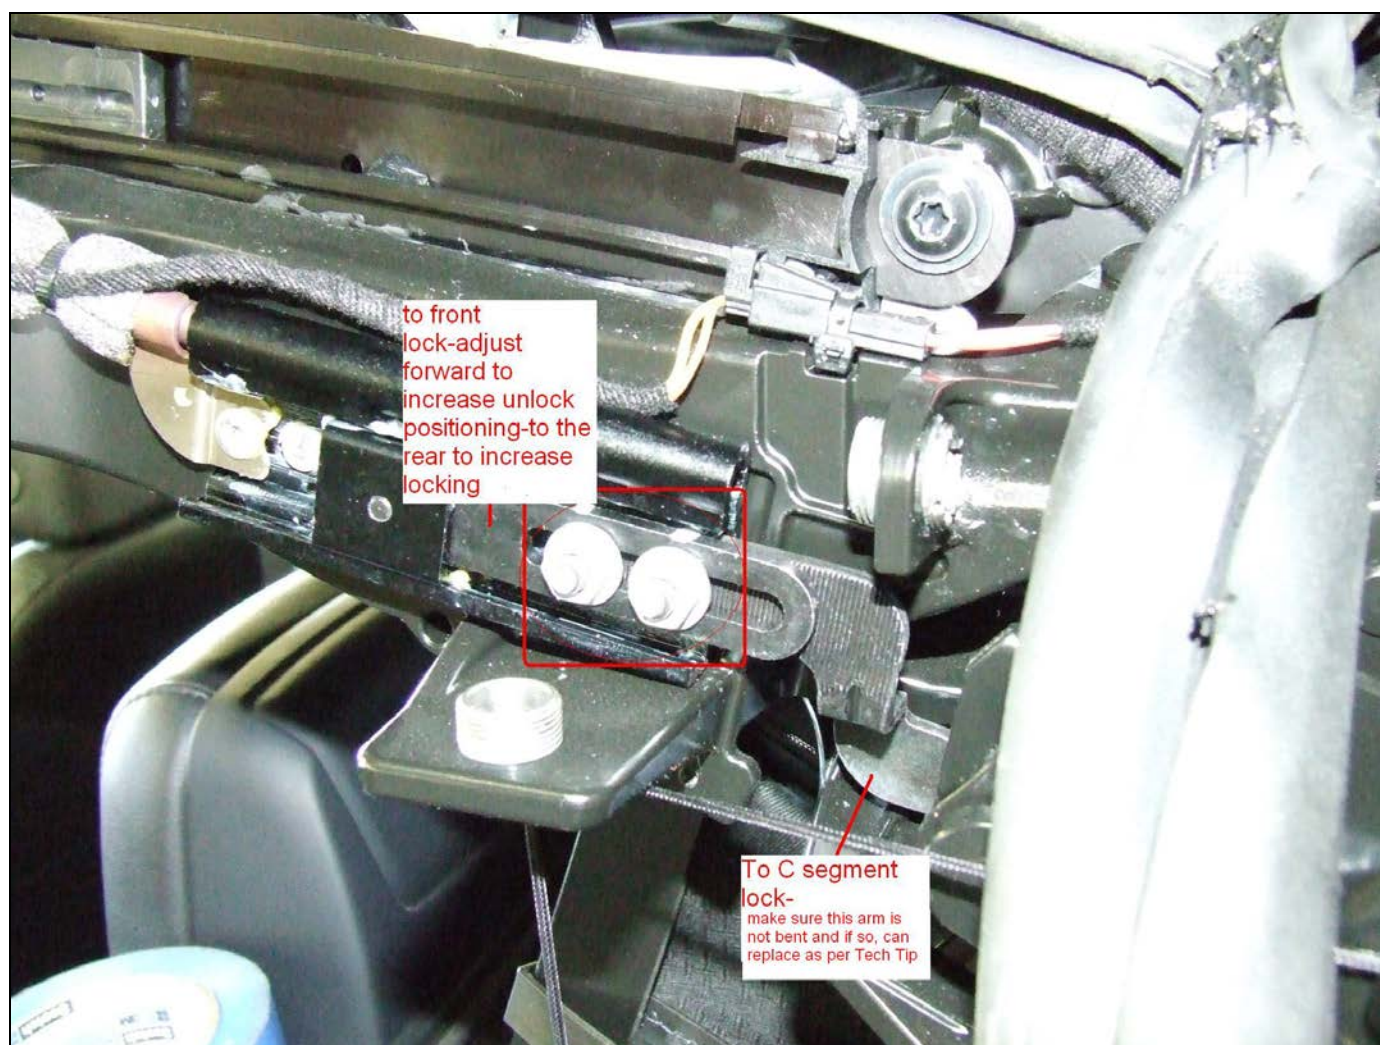
Figure 1

If, during diagnosis of the convertible top, the adjuster arm for the front lock is found damaged, order part number 1Q0898499 or latest supersession. This one part number will include both sides in the package. Adjuster arm location is shown below with painted roof pillar panel removed.
