# Service Information

Number: VSE-15-27

Subject: T10542/2 – Threaded Stud from High Voltage  
Adapter Set – **Special Notice**

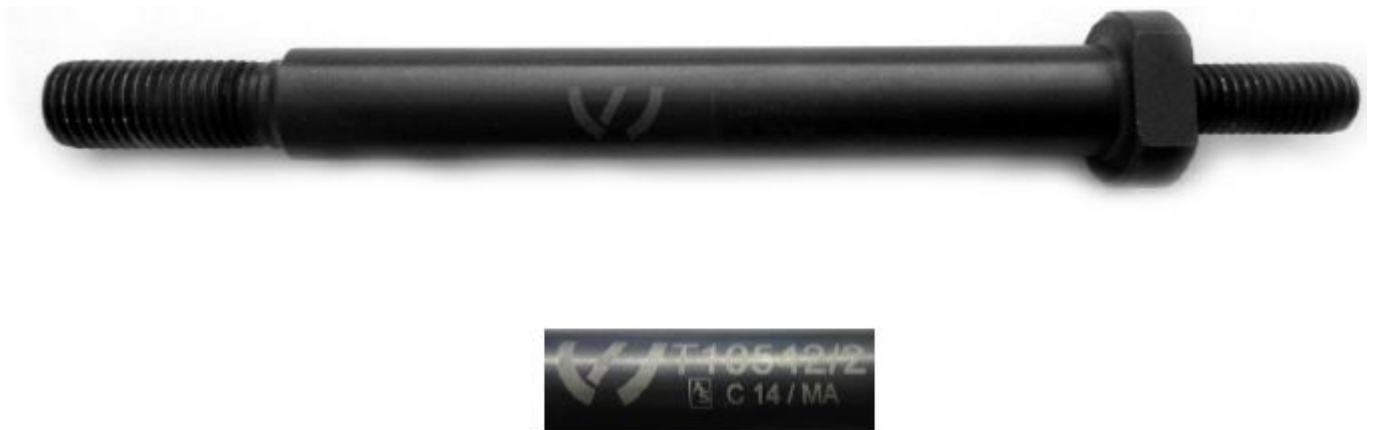
The T10542/2 Threaded Studs included in the T10542 adapter set sold by Matra between October 2014 and July 2015 do not meet the specified design. The affected T10542/2 studs are marked “**C 14 / MA**”, as shown in the picture above. There are two T10542/2 Threaded Studs in each T10542 Adapter set.

We would like to explicitly state that using the non-replaced version entails a risk of injury that may lead to bodily harm. For this reason, the affected T10542/2 Threaded Studs may not be used under any circumstances!

Until the affected T10542/2 Threaded Studs have been successfully replaced, the high-voltage battery may only be lifted with the T10542/1 adapter in combination with the vehicle's original screws. The bolted connection must be tightened to 40 Nm. Follow the Elsa Repair Manual!

Please do not dispose of these tools, store them in a safe location until further notice. We will inform you of the replacement procedure in a separate notification in the near future. Thank you very much for your support.
