57 15 06 December 16, 2015 2041749

Door Arrester (Door Check Rod/Door Check Strap) Noisy or Defective

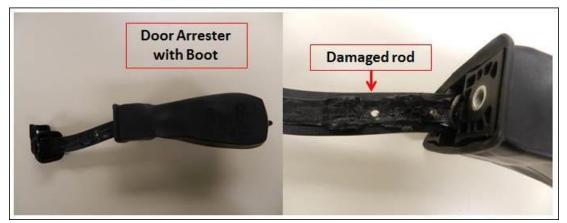
Figure 1.

The condition is caused by water ingress into the door arrester that accumulates in the arrester boot and freezes during cold weather conditions. The ice built up around the door arrester slider spring prevents it from compressing during door opening and closing operation and the spring will eventually wear through the plastic slider and damage the check rod.
