# Tech Tips

TT 63-15-01

## 2015 Passat- Rear Bumper Cover – Paint Peeling

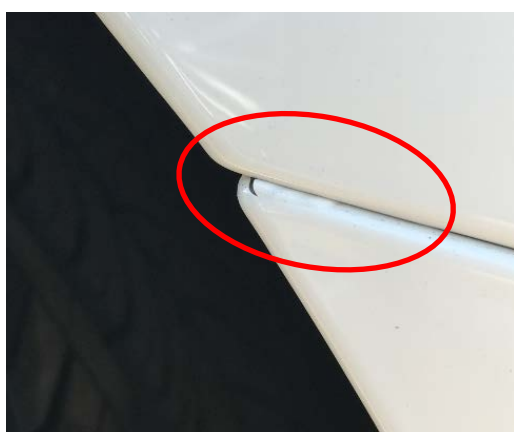
There have been cases identified where the paint is chipping/peeling on the rear bumper cover (see picture below). This issue was caused by process deviations at the supplier.

Passat rear bumper cover – affected area

In addition to the repair procedure in ELSA we recommend the use of **35887 3M EZ Sand Flexible Parts Repair**. The use of this product will assure the adhesion of the paint. Use **3M 05907 – Polyolefin adhesion promoter** to clean the area before applying the 3M 35887 EZ sand flexible parts repair.
