Technical Bulletin

00 15 03 June 5, 2015 2040590

PDI – Paint Defect - Water Migration Under the RAPGARD®

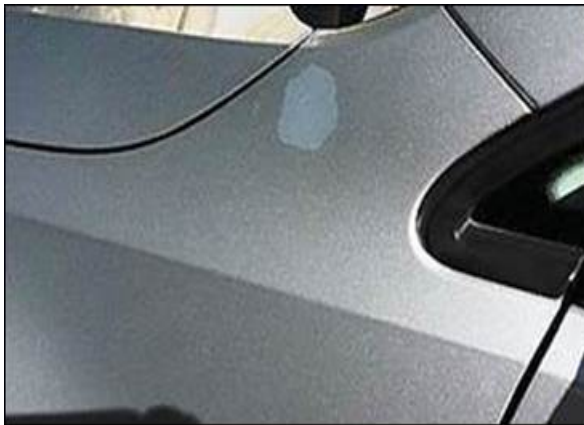
Example 1

Water migration under the RAPGARD® can be mistaken as a paint defect when in fact it is only moisture trapped in the clear coat of the paint. See Examples 1-10 to see how water migration may appear.

After removal of RAPGARD[®], some vehicles may exhibit temporary paint discoloration or paint swelling (caused by trapped moisture under the RAPGARD[®]).

- This temporary swelling is caused by the paint finish absorbing moisture trapped under the RAPGARD[®] film.
- This swelling will disappear with exposure to the sun or heat lamps within 2 -3 hours. Severe paint swelling may require 2 -3 days to recover.

DO NOT buff or refinish paint for this condition!

Paint discoloration (looks like shaded or dark magic marker lines) can be removed with a heat gun using the following procedure:

- Hold heat gun approximately 3 in. away from affected paint surfaces and apply heat using slow oscillating motions until discoloration is gone.
- If discoloration remains, wipe the heated area with Isopropyl alcohol and repeat procedure to increase surface drying.
