Technical Bulletin

87 15 08 July 7, 2015 **2005566** Supersedes Technical Bulletin V871402 dated April 18, 2014. Updated to add new models and new model year.

HVAC, Unpleasant Odor

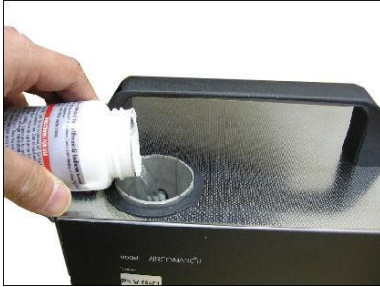
6. Remove the neck (long black pipe) of air conditioning cleaner VAS 6189A / VAS 6189B and fill with a bottle of cleaning fluid part number 30208 (observe instructions on bottle).

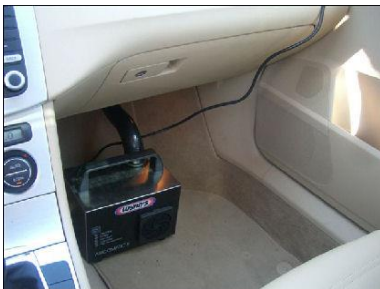
7. Place the air conditioning cleaner on the floor underneath the passenger glove box and point the neck towards the front of vehicle (see illustration).
