# Technical Bulletin

Model(s)	Year	Eng. Code	Trans. Code	VIN Range From	VIN Range To
Passat	2006 – 2010	All	All	All	All
Passat Wagon	2006 – 2010	All	All	All	All
CC	2009 – 2012	All	All	All	All

58 15 03 July 21, 2015 2039212 Supersedes Technical Bulletin 581405 dated December 19, 2014 to updated service number.

### Corrosion on Rear Door in Trim Strip Area

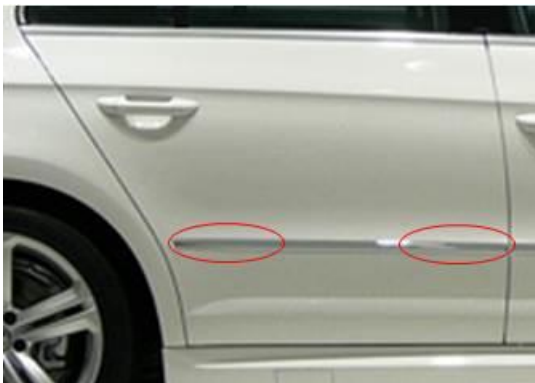
Figure 1 (the red ellipses show the area which can be affected by the corrosion)

Because of incomplete bonding of the trim strip (Figure 2, red circle) water can get between trim strip and door. Because of water ingress, corrosion is possible in the area of the guide holes (Figure 1, red circles).

- Disassemble the door according to the repair manual. See Repair Group 58 in Elsa
- Remove the corrosion on the inner and outer door in the area of the guide holes using a pneumatic brush grinder.

- Apply a VOC compliant epoxy primer as an anti-corrosion treatment and primer to both sides of the door (locally sourced).
- Repaint the rear door according to Volkswagen guidelines.

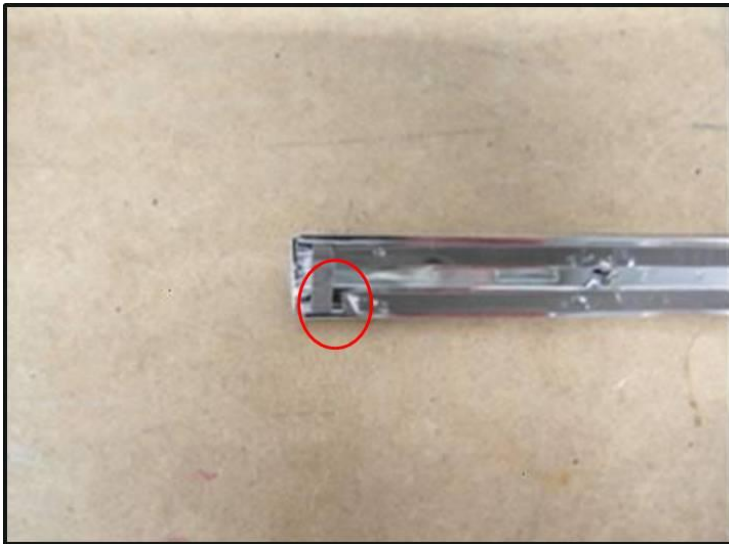
Figure 2 (the red circle shows the opening of the incomplete bonding)

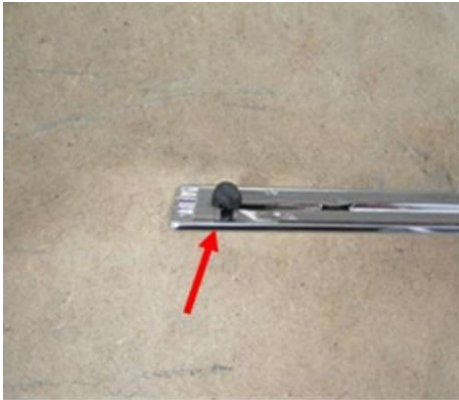
**Figure 6 (rear trim strip area)**

- Form two balls of butyl sealing cord (part number: AKL 450 005 05) per trim strip with a diameter of 4-5 mm. Attach the butyl balls centrally in the end areas of the trim strip from the inside (Figures 5 and 6).

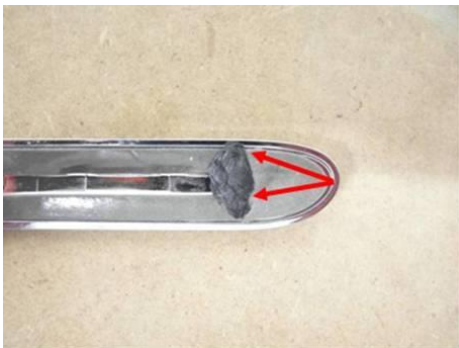
**Figure 7 (front trim strip area)**

- The open areas of the adhesive tape must be closed by pressing the butyl balls into the gaps of the tape (Figure 7).
