Technical Bulletin

Model(s)	Year	Eng. Code	Trans. Code	VIN Range From	VIN Range To
Passat	2006 – 2010	All	All	All	All
Passat Wagon	2006 – 2010	All	All	All	All
CC	2009 – 2012	All	All	All	All

57 15 04 July 20, 2015 2038995 Supersedes Technical Bulletin V571409 dated December 19, 2014 to update the service number.

Corrosion on the Front Door in Trim Strip Area

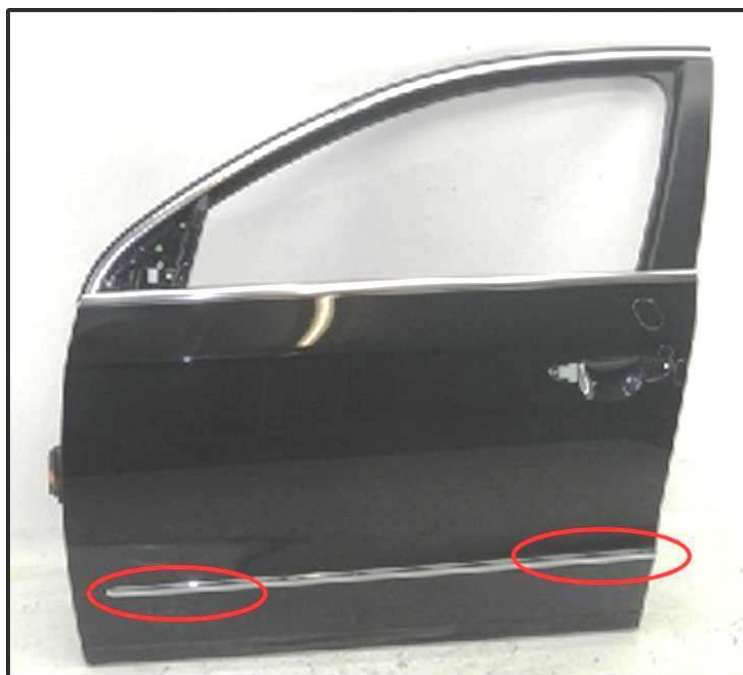
Figure 1 (the red ellipses show the area which can be affected by the corrosion)

Because of incomplete bonding of the trim strip (Figure 2, red circle) water can get between trim strip and door. Because of water ingress, corrosion is possible in the area of the guide holes (Figure 1, red circles).

- Disassemble the door according to the repair manual. See Repair Group 57 in Elsa
- Remove the corrosion on the inner and outer door in the area of the guide holes.
- Apply a VOC compliant epoxy primer as an anti-corrosion treatment and primer to both sides of the door (locally sourced).
- Repaint the front door according to Volkswagen guidelines.

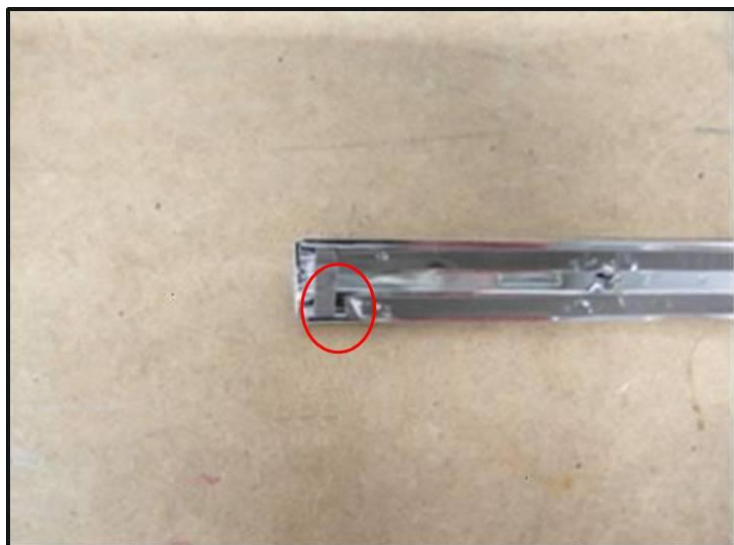
Figure 2 (the red circle shows the opening of the incomplete bonding)

- To avoid repeated water ingress, close the open areas on the trim strips in the end points of the adhesive tape with butyl sealing cord (part number AKL 450 005 05 - Figure 3 and 4, red arrows).

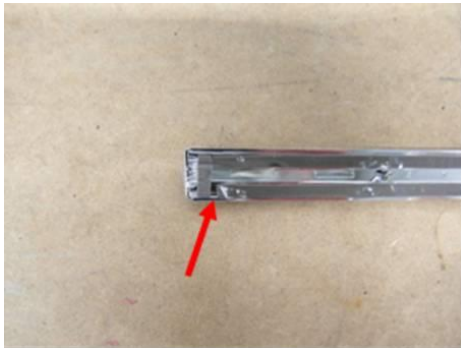
Figure 3 (rear end of a trim strip)

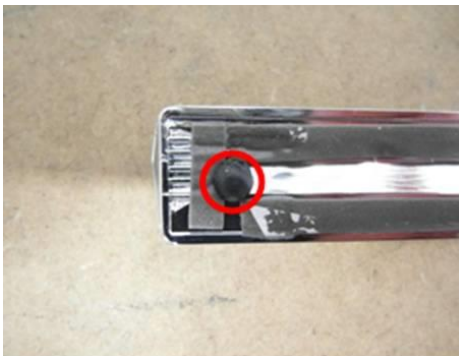
Figure 5 (rear trim strip area)

- Form two balls of butyl sealing cord (part number: AKL 450 005 05) per trim strip with a diameter of 4-5 mm. Attach the butyl balls centrally in the end areas of the trim strip from the inside (Figures 5 and 6).

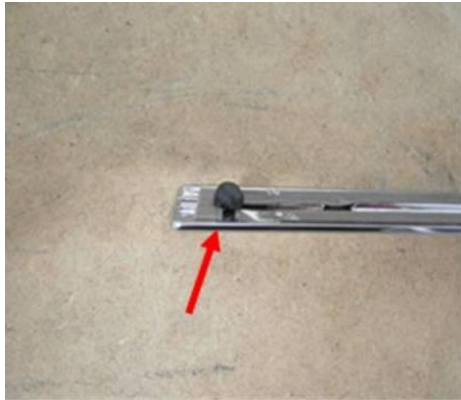
Figure 6 (rear trim strip area)

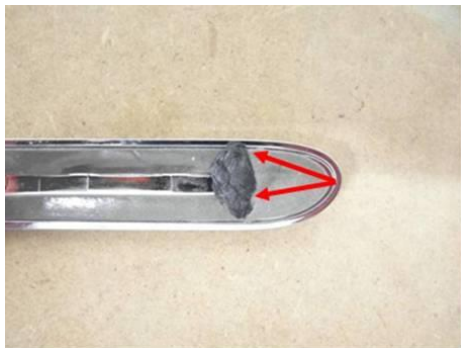
Figure 7 (front trim strip area)

- The open areas of the adhesive tape must be closed by pressing the butyl balls into the gaps of the tape (Figure 7).
