Technical Bulletin

26 15 06 July 14, 2015 **2039436** Supersedes Technical Bulletin V261504 dated April 30, 2015 to include applicable model VIN ranges.

Ad Blue Warning and or MIL ON - Ad Blue Leakage at Reductant Injector

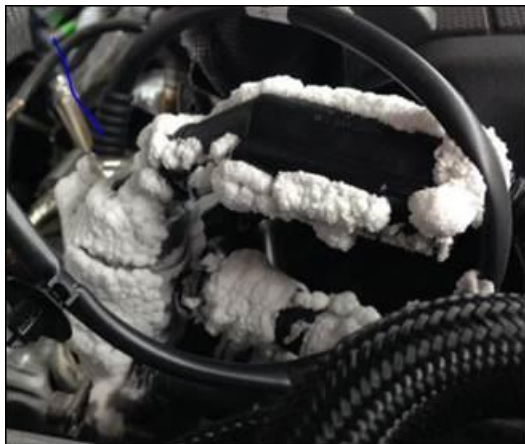
Welding process issues of the reductant line connector to the supply line may cause Ad Blue leakage at the reductant injector.

Inspect the connection of the reductant supply line connector at the reductant injector in the engine compartment. If white crystalized (dried) Ad Blue is found at the reductant injector (see Figure 1 & 2), it will be necessary to replace the reductant supply line.

Thoroughly clean the area of the reductant supply line connection with water to remove the crystalized Ad Blue.

Replace the reductant supply line.

It is not necessary to replace the reductant injector.
