Tech Tips

TT 55-15-01

2015 Golf/GTI-Hood will not open (release cable has come apart at the coupling)

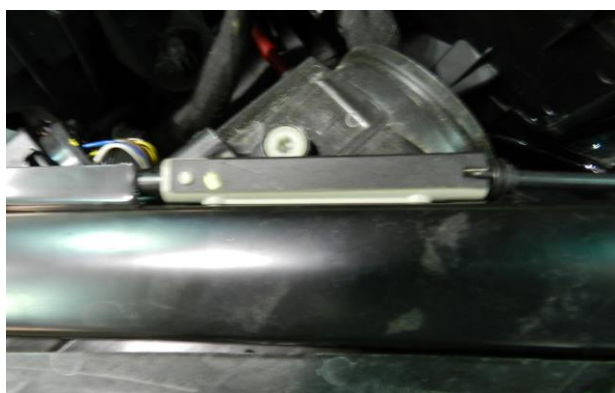
Figure 1

Hood latch release cable coupling located on the cross support bracket, above the driver's side headlight (Figure 1.)

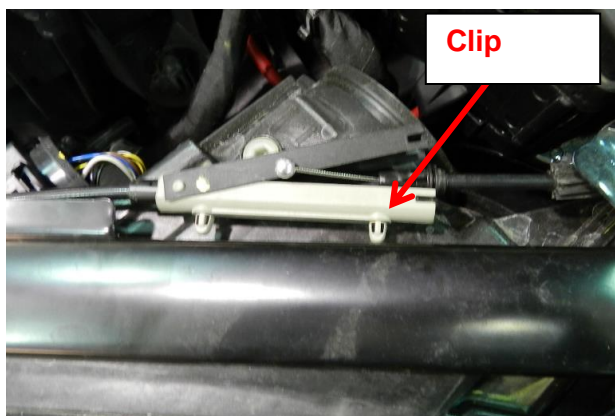
Figure 2

For concerns of the hood will not open and it is found that the hood release cable came apart at the coupling (Figure 2), check the following:

Hood latch release cable coupling that came apart at the coupling

- Check if the coupling clips that install into the cross support bracket have broken (figure 2).

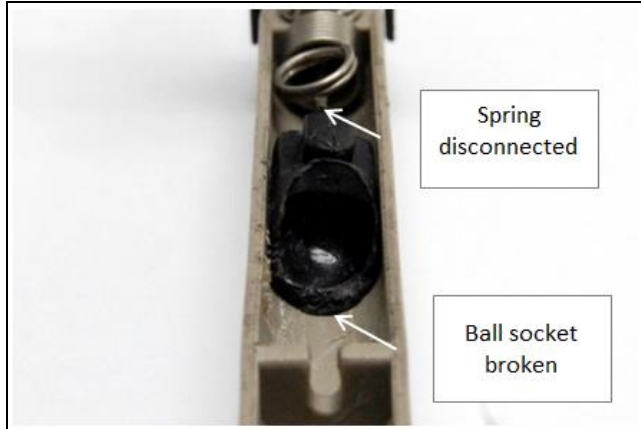
Figure 3.

- Check if the ball socket is broken or the spring is disconnected.

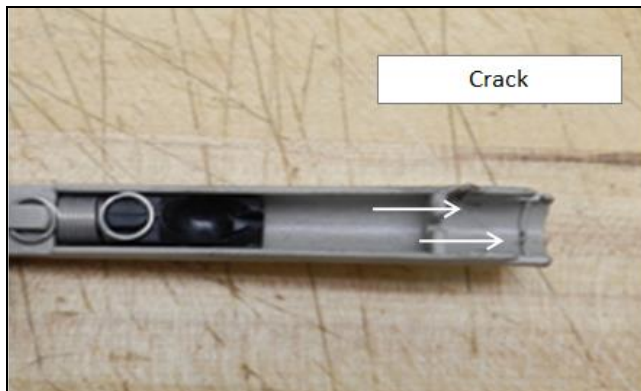
Figure 4.

- Check for cracks.

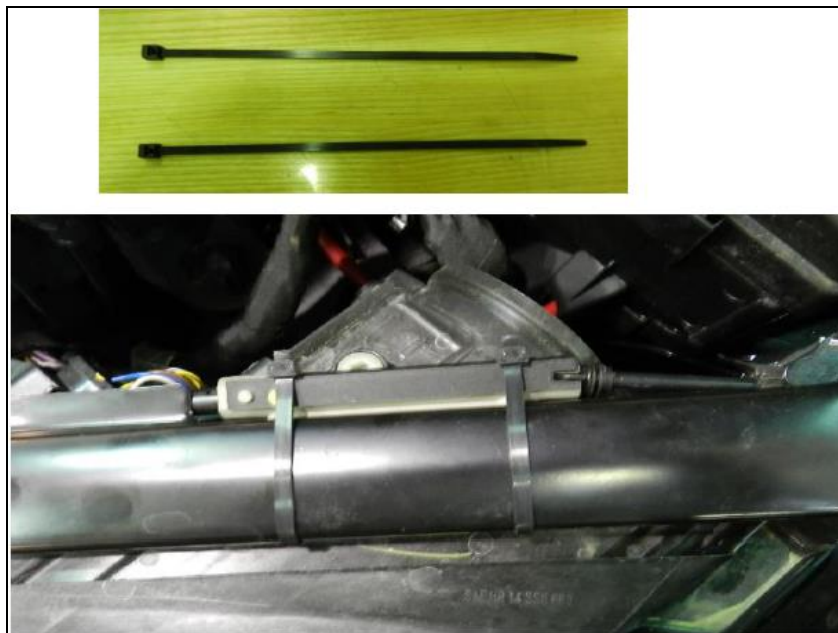
Figure 6.

If the coupling is not damaged, reassemble the coupling and install it to the cross support bracket using zip ties to secure it to the bracket (Figure 6).

If the coupling is damaged, replace the part and use zip ties to secure the new part to the support bracket.
