VW Elsa Newsletter

Edition 149: August 17, 2015

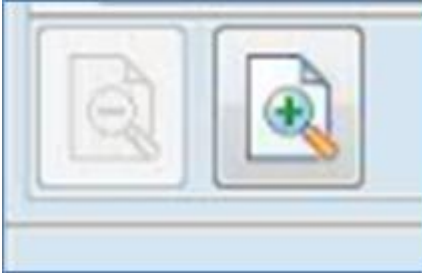
Note: The main ODIS screen may not refresh due to an anti-virus or anti-malware application locking a file or files, resulting in a blank window. To refresh the screen manually, use the zoom in / zoom out buttons at the bottom left corner of the main screen. (see below)

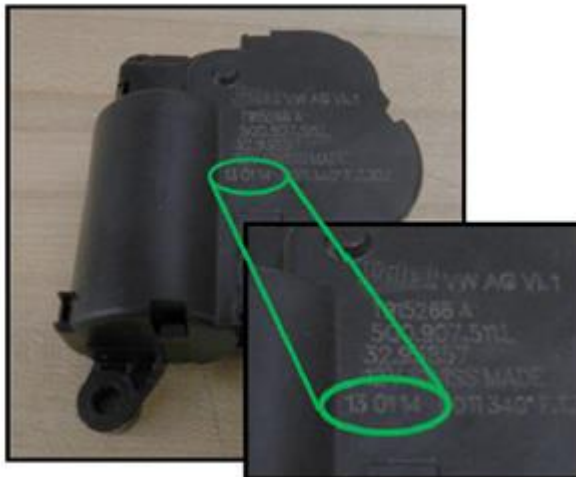
87-15-01 HVAC Temperature and Recirculation position motor noise (Clicking) during operation

- During initial vehicle startup there is clicking noise behind the glove box.
- While operating the temperature controls, there is a clicking noise in the driver's side dash (right foot area).

**Check the production date.
Affected motors built before
August 14th 2014 (14.08.14)**

Verify the customer complaint by manually operating the temperature cabin adjustment and switching on and off the recirculation mode.

Note: The customer's concern must be duplicated to verify a motor failure.

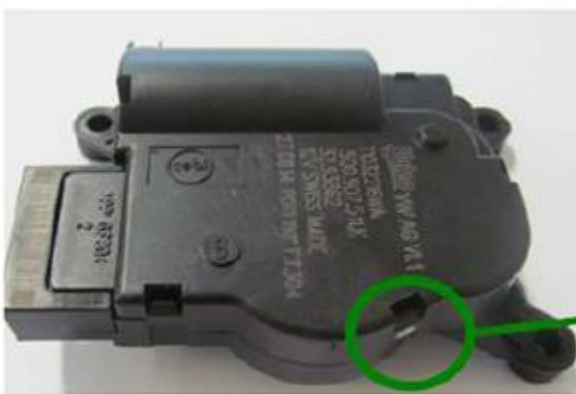
**Look for a white dot on corrected
position motors built on or after
August 14, 2014**
