Technical Service Bulletin

97 Rattle noise from front right dash panel area

97 15 52 2042450/1 November 11, 2015.

Model(s)	Year	VIN Range	Vehicle-Specific Equipment
A6, A7	2011 - 2017	All	Not Applicable

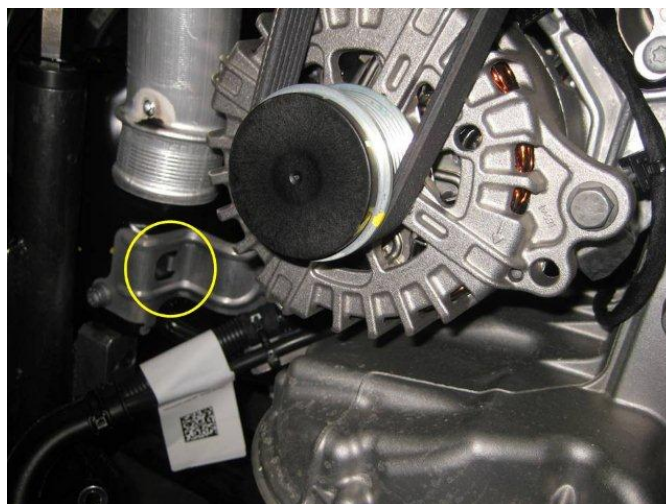
The bracket for the starter motor wiring harness has a locating tab that can vibrate.

Figure 1. Location of the wiring harness bracket.

1. Remove the bracket for the starter motor wiring harness. The bracket is located near the alternator (Figure 1).

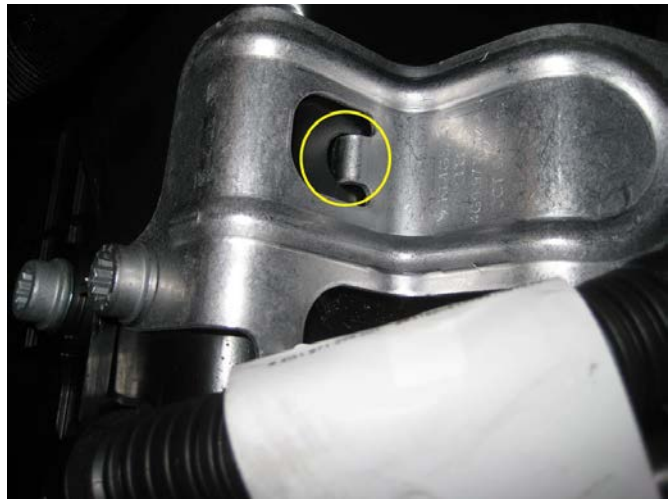
Figure 2. Locating tab before it has been wrapped with tape.

2. Wrap a 3" piece of fabric adhesive tape (D 373125A2) around the locating tab to prevent it from moving freely (Figure 2 and Figure 3).

The tape should be wrapped around the tab approximately four times so that it fits firmly in the hole. There will be some resistance when the wrapped tab is put back in the hole.

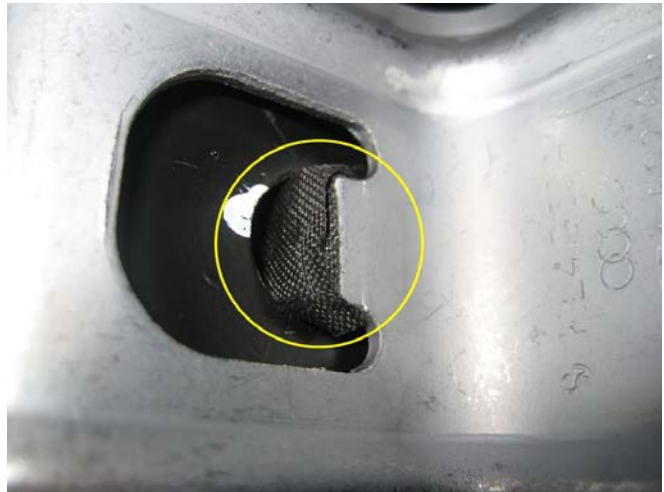
Figure 3. Locating tab after it has been wrapped with tape.

3. Reinstall the bracket.
