# Technical Service Bulletin

## 40 Shock absorber leaks: assessment aid

40 15 49 2018194/7 December 18, 2015. Supersedes Technical Service Bulletin Group 40 number 14-41 dated July 2, 2014 for reasons listed below.

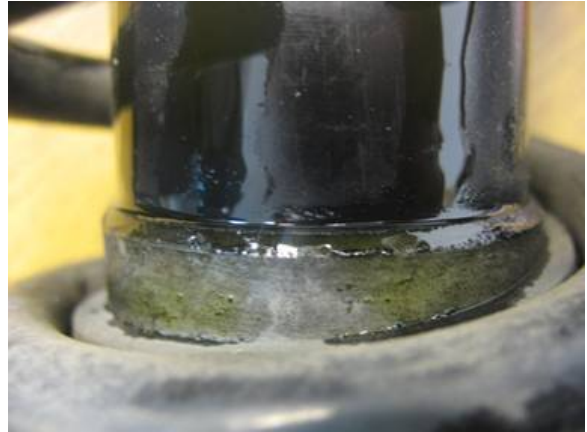
A leaking shock absorber is characterized by a wet film of oil running down the pipe (Figure 1 and Figure 2).

*Figure 1. A leaking shock absorber.*

Leaking shock absorbers need to be replaced.

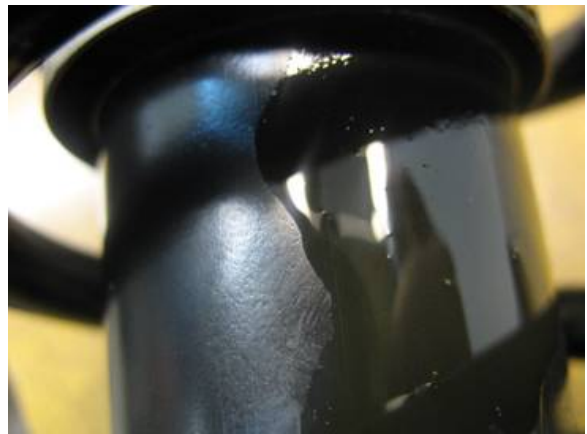
*Figure 2. A leaking shock absorber.*

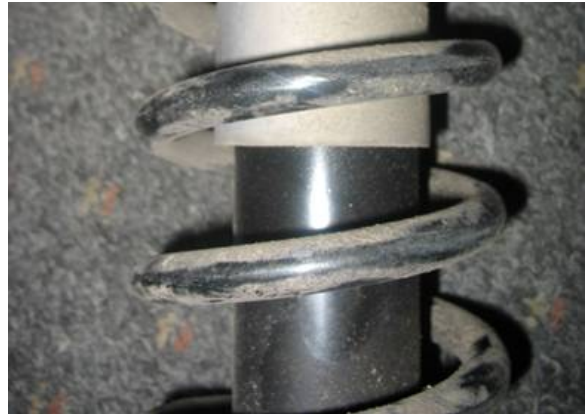
A light film of dried oil or oil marks on the pipe beneath the dust guard are not a clear indicator of a leaking shock. These marks are a result of residue from when the shock was filled during production, or of slight condensation in the seal area. This small amount of oil is for lubrication and it reduces wear on the seal (Figure 3 and Figure 4).

*Figure 3. A shock absorber that is not leaking.*

This condition does not affect the shock absorber. No repair is necessary.
