Technical Service Bulletin

20 MIL on (DTC P045600 - EVAP system leak detected NVLD (very small leak))

20 15 54 2035073/12 October 29, 2015. Supersedes Technical Service Bulletin Group 20 number 15-52 dated October 28, 2015 for reasons listed below.

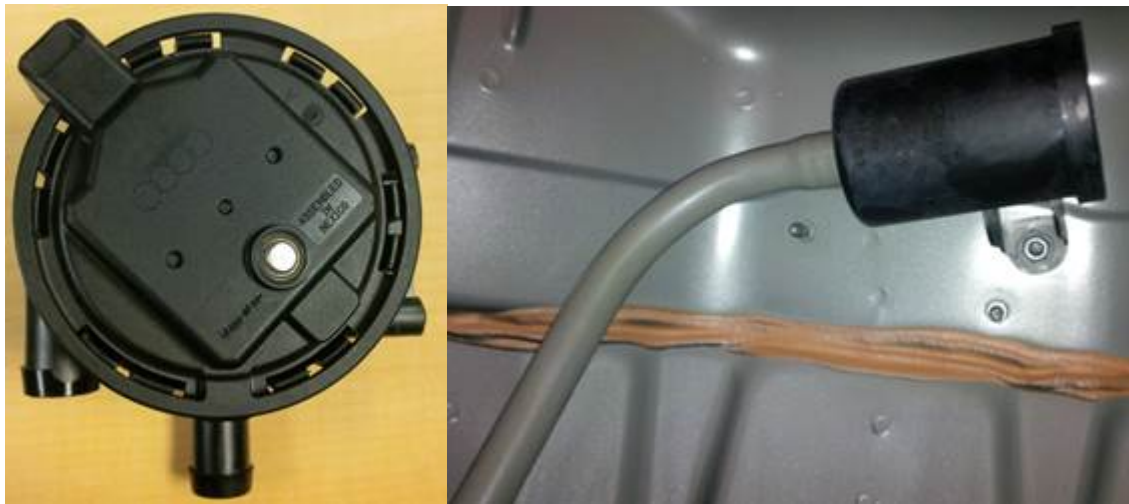
Figure 1. NVLD pressure sensor (left) and NVLD filter (right).

1. Ensure that **DTC P045600** (EVAP System Leak Detected NVLD (very small leak)) is stored in the engine control module (ECM), J623 (address word 01). If DTC P045600 is not present, this bulletin does not apply.
2. Replace the NVLD pressure sensor G400 and the NVLD filter with the latest part number available (Figure 1).

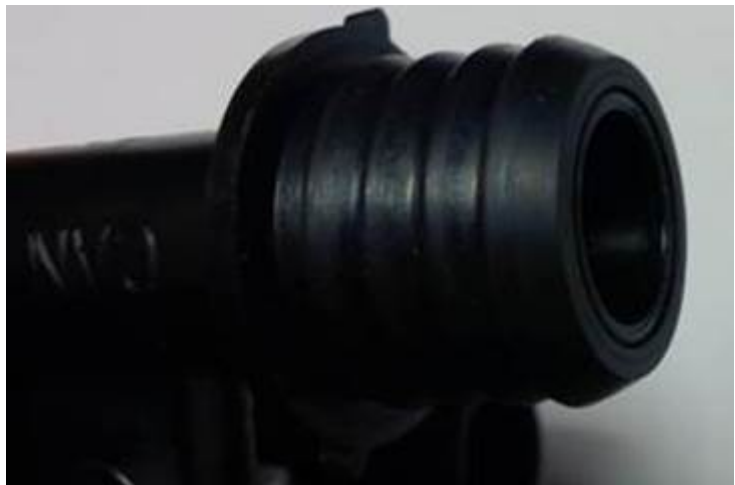
Figure 2. Align grommet and sensor outer edges.

- Align grommet and sensor outer edges (Figure 2).

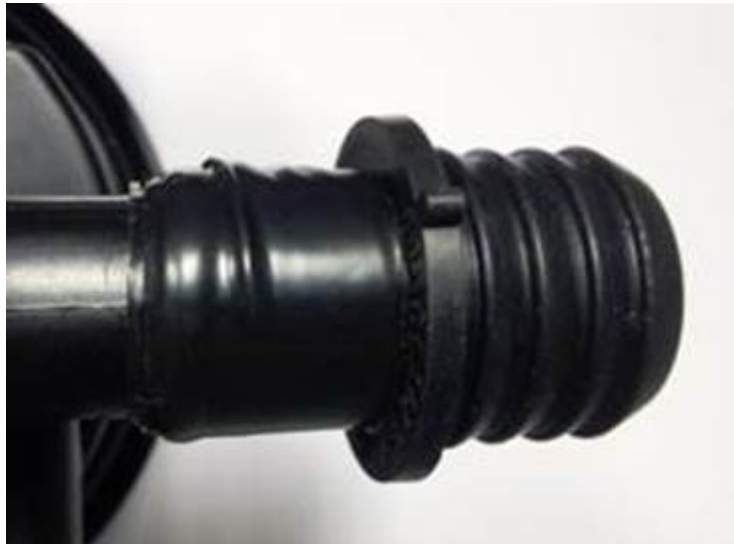
Figure 4. Vinyl layer supporting grommet.

- To aid installation, wrap several (~10) layers of vinyl tape behind the grommet to ensure that it does not slip during installation (Figure 3 and Figure 4).

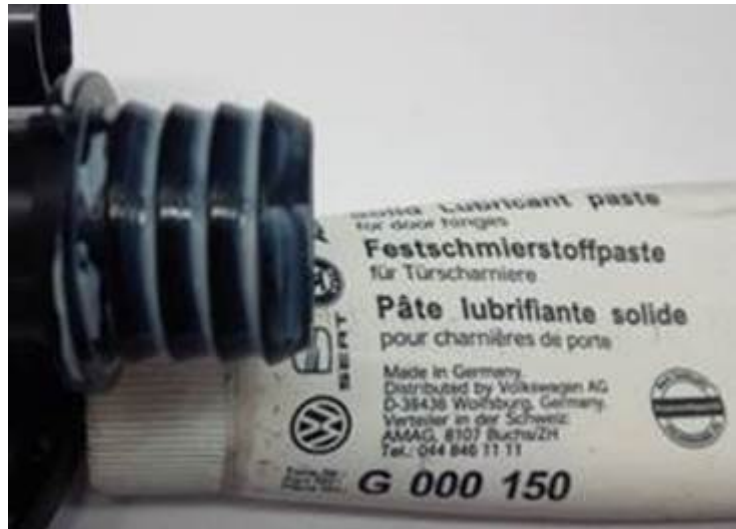
Figure 5. Grease film on outer surface of grommet.

- Apply a small amount of grease to create a film on the outer surface of the grommet before installing the sensor (Figure 5).

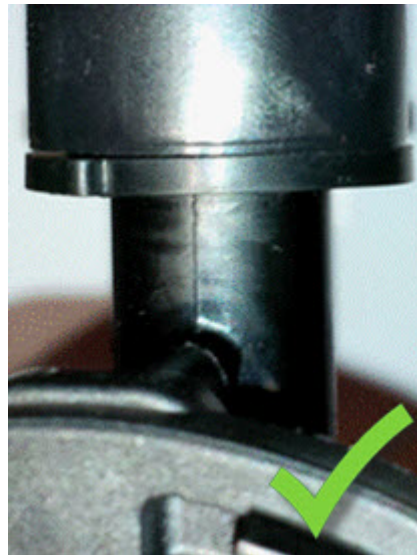
Figure 6. Correctly-installed sensor and grommet.

- When the sensor and grommet have been correctly installed, the grommet and canister will be flush (Figure 6). At this point, the vinyl tape can be removed (or it can be left in place).
