Technical Service Bulletin

87 Air conditioning does not blow cold

87 15 72 2042340/1 October 29, 2015.

Model(s)	Year	VIN Range	Vehicle-Specific Equipment
Q3	2015	All	Not Applicable
Q3	2016	000001 - 006133	Not Applicable

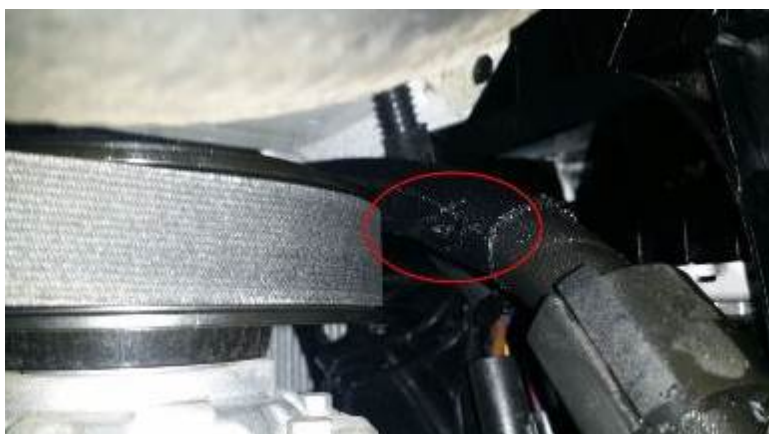
The technical diagnosis reveals that there is no refrigerant in the circuit. The refrigerant hose that connects the suction side of the compressor to the condenser is found to be damaged, as the rubber portion of the hose is making contact with the compressor pulley (Figure 1 and Figure 2).

A production issue with the assembly gauge used during assembly of the hose was found. This issue caused the hose to be assembled with an incorrect geometry. As a result, the lie intended to keep the hose away from the air conditioning compressor pulley was compromised.

Figure 1. Point of hose contact with air conditioning compressor pulley.

Replace the damaged refrigerant hose and ensure that the natural lie of the hose is away from the air conditioning compressor pulley. Evacuate and recharge the refrigerant circuit and replace any lost PAG oil that may have been discharged from the system. Failure to maintain the correct total amount of PAG oil in the circuit will lead to premature air conditioning compressor failure.

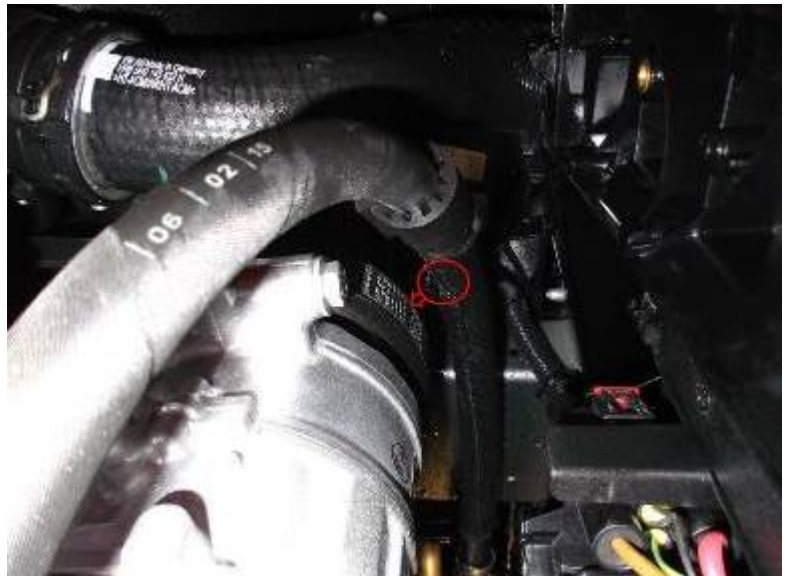
Figure 2. Point of hose contact with air conditioning compressor pulley – rear view.
