## REAR JCT BOX COVER UPGRADE

### DESCRIPTION

On the vehicles affected by this bulletin, to prevent premature corrosion of the rear junction box components, replace the junction box cover with a late model "central mount" cover.

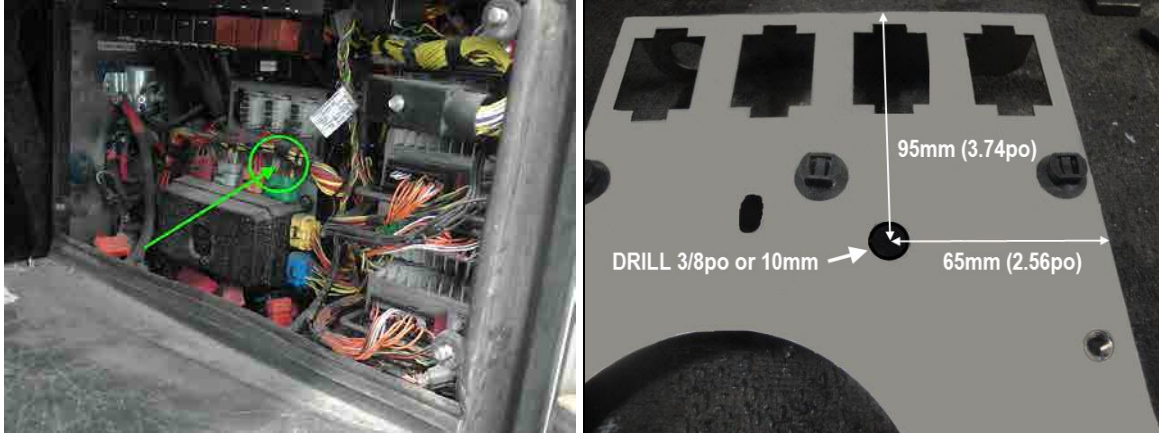
- 2) On the fuse box back plate, drill a 3/8" (10mm) hole following the template and image below (move away wires and harness as required).

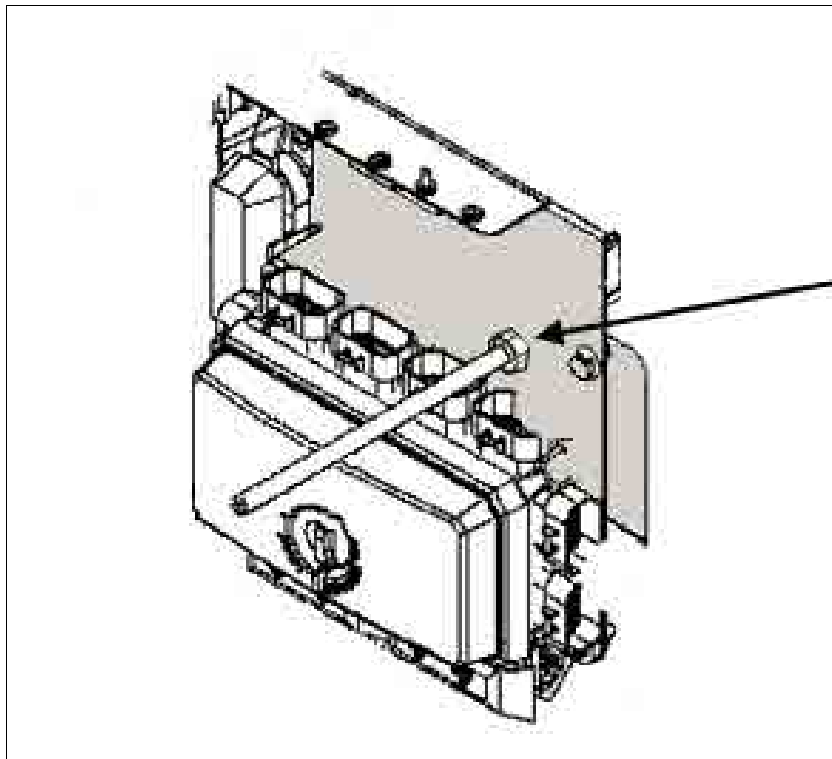
- 3) Insert a 3/8" stainless steel threaded rod of the correct length in the previously drilled hole (rod must stick out of the new central mount cover about 1/2" min), secure the rod to the back plate using two #500102 3/8 SS nuts, one on each side of the plate.

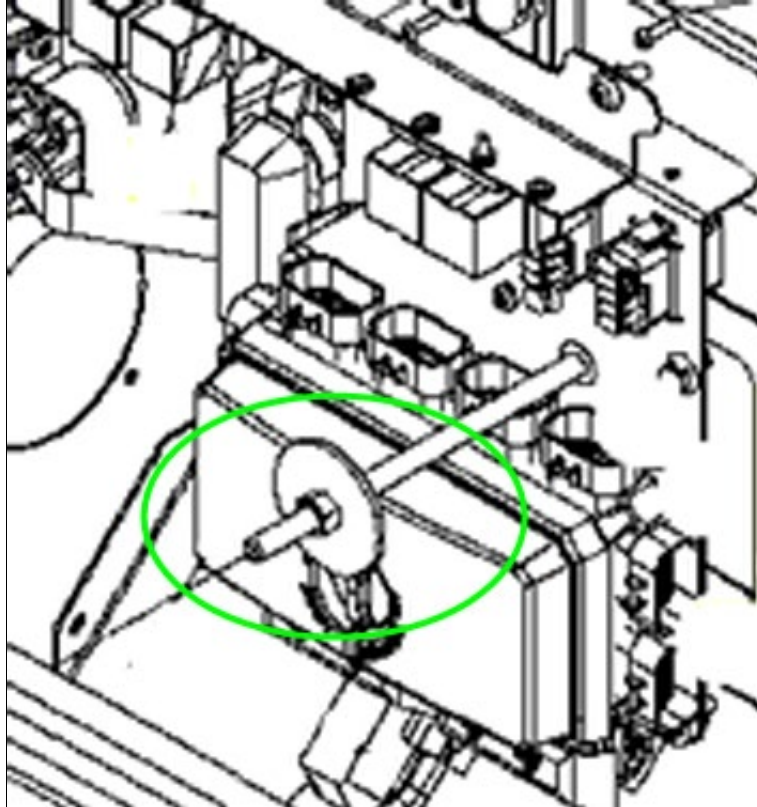
- 4) Install the #068704 washer on the rod (secured with a #500102 3/8 SS nut on both sides) at about one inch below the cover wing nut flange.

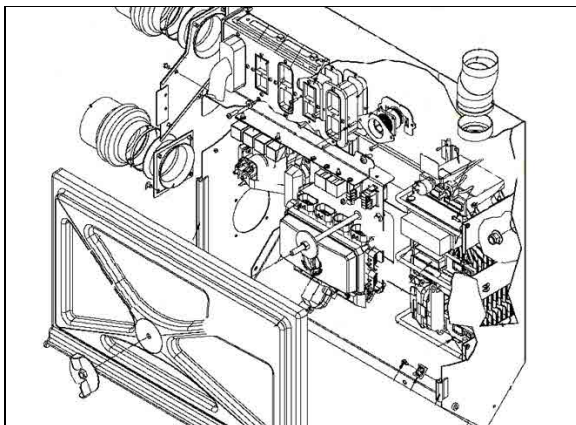
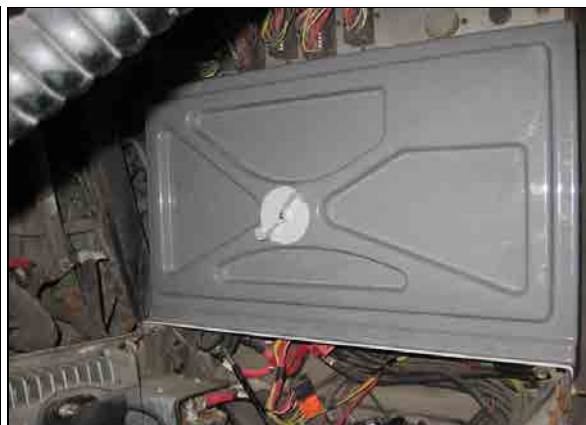
- 5) Install the old cover rubber seal on the new central mount cover and discard the old cover.
- 6) Install the new cover on the rear junction box and tighten it in place using the #068765 wing nut until the cover bottom-out on the rod flat washer.
