## WARRANTY BULLETIN

### WB15-06D

| SUBJECT : | 067954 CURRENT SENSOR INSPECTION AND REPLACEMENT | | |

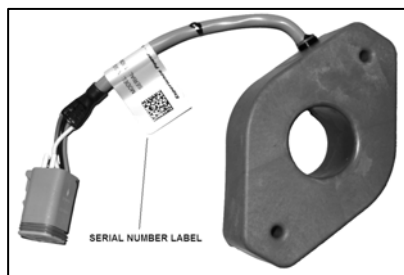
Figure 6: Typical Current Sensor.

2. Locate sensors next to batteries (Fig 7 & 8). Defective Sensors have a serial number starting with **14300, 14307 or 14314** (Fig 6). If found, consult **Table 2** below to confirm serial number is part of list.

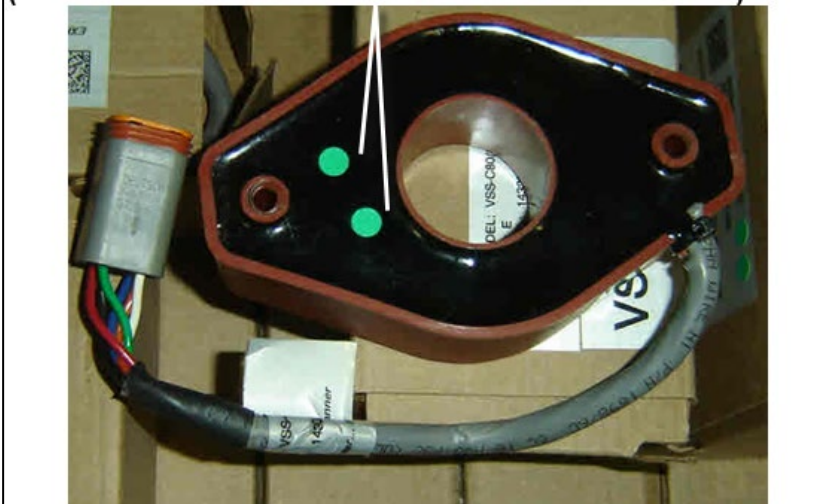
Figure 16 : Recalibrated “good” sensor

Also, note that green dot labels (Fig. 16) have been applied to the sensor to attest calibration by the supplier. Refer to **Table 1** below to know if part should be replaced.

**TWO GREEN DOTS: PART IS OK!  
(PART HAS BEEN RECALIBRATED BY SUPPLIER)**

*IF SERIAL NUMBER IS FOUND BELOW, REPLACE PART ONLY IF IT BEARS ONE GREEN DOT ;*

*IF PART BEARS TWO GREEN DOTS, PART IS CONSIDERED GOOD (NO REPLACEMENT) (FIG. 16)*
