# PREVOST

## WARRANTY BULLETIN

### WB15-10A

| SUBJECT : | ENGINE OIL FLEXIBLE TUBE INSPECTION<br>AND REPLACEMENT | | |

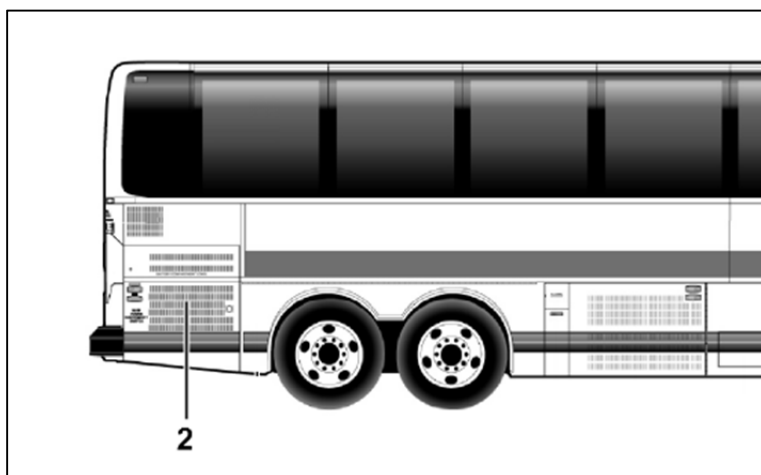
Figure 1

- Open curb side engine compartment door. (Item 2, Fig. 1)
- Visually inspect the lowest section of the oil fill tube. (Fig. 2) The hose connecting the steel tube to the oil pan should be green or blue. (Fig 3 & 4)
- If hose is black, perform replacement according to Step **B** below. Otherwise, this is the end of the bulletin.

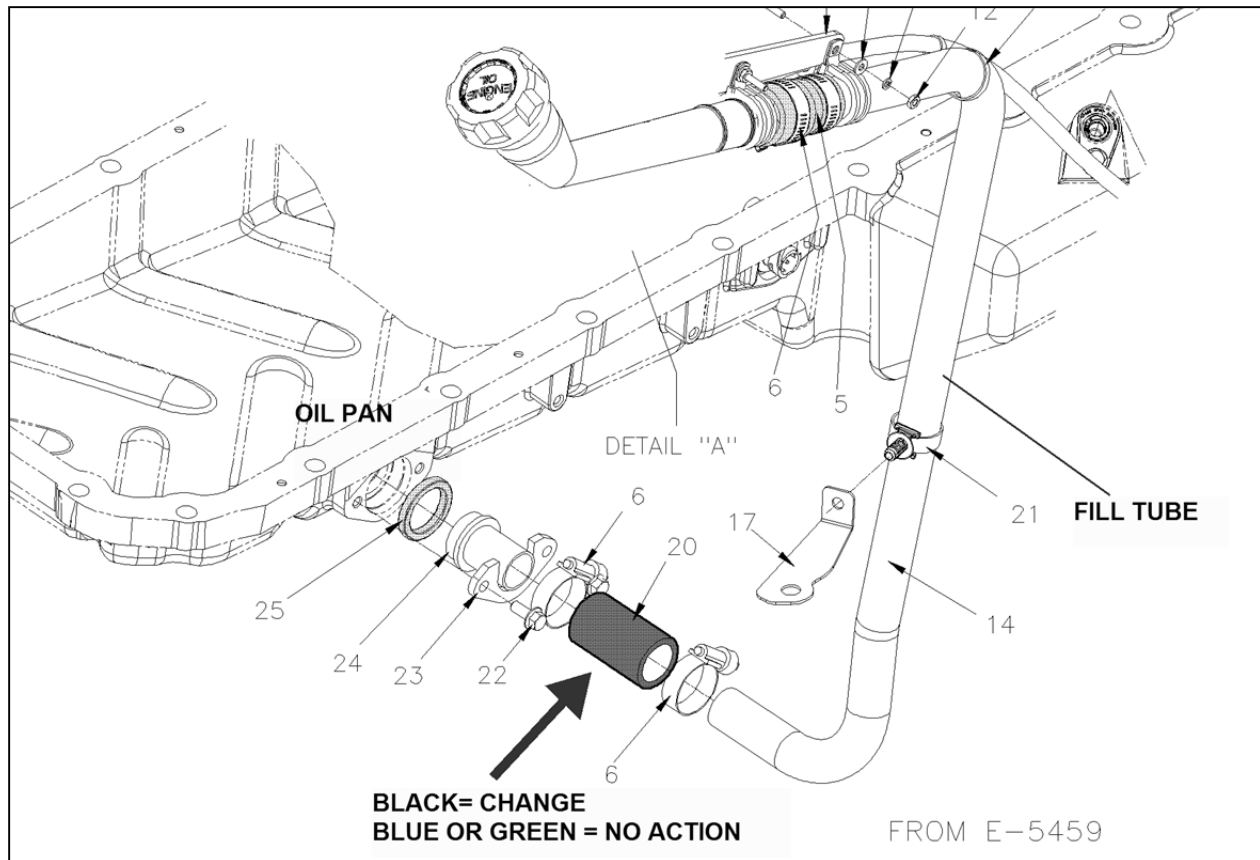
Figure 2

On the vehicles affected by this bulletin, inspect the lower oil fill tube flexible tube. If it is made of black material (EDPM), replace tube. Green and blue silicone hoses are accepted.

- 2) Using two mobile column lifts, jack vehicle about 38 cm (15 in) by drive axle to allow oil to move to the forward section of the oil pan.
- 3) Use a suitable container to collect any remaining oil that may drip while performing replacement.
- 4) Perform tube removal by undoing the two clamps. (Fig. 2) Dispose of tube according to regulations.
- 5) Install new tube 012933. Tighten clamps to 3,4 N-m (30 lbf-in).
- 6) Apply a torque seal of different color from the original seal to clearly mark change.
- 7) Lower vehicle. Confirm proper operation. Confirm installation is oil tight.

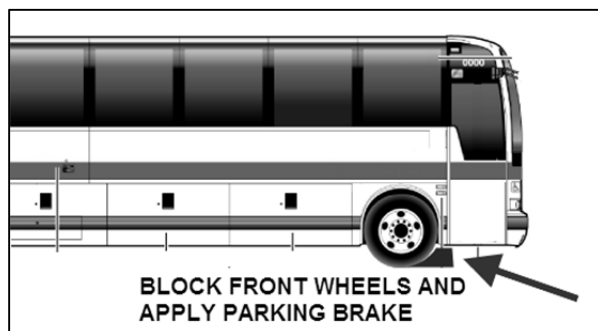
Figure 5

- 1) Apply parking brake and block front wheels.(Fig. 5)
