# ***SERVICE PROCEDURE***

**15504R1  
JUNE, 2015**

**SUBJECT: SAFETY RECALL**  
**Spring Brake Chambers on certain 9900, DuraStar<sup>®</sup>, LoneStar<sup>®</sup>, PayStar<sup>®</sup>, ProStar<sup>®</sup>, WorkStar<sup>®</sup>, and TranStar<sup>®</sup> model trucks, and CE commercial bus models built 28 July 2014 thru 23 February 2015 with feature code 04EVK or 04EXM Haldex Life Seal rear brake chambers.**

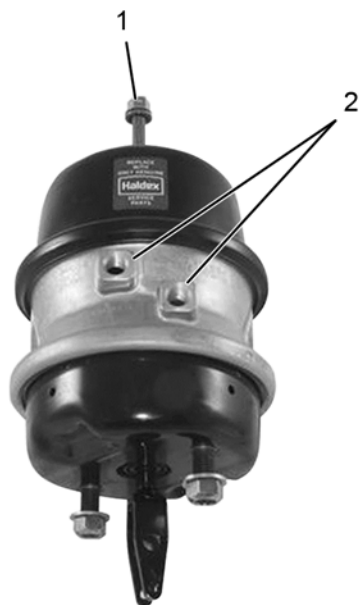
**Figure 2. Life Seal Chamber.**

1. Cage bolt
2. Square port (2)

7. Inspect rear axle brake chambers to determine if they are involved in this campaign by locating the following:
  - A life seal chamber will be equipped with an integrated cage bolt and square ports (Figure 2, Items 1 and 2).
  - A non-life seal chamber will be equipped with a mold (Figure 3, Item 1) used for storing the caging tool.

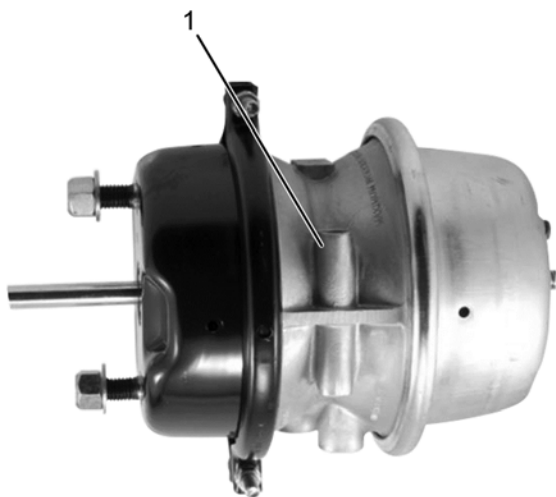
**Figure 3. Non-Life Seal Chamber.**

1. Caging tool mold for non-life seal chamber

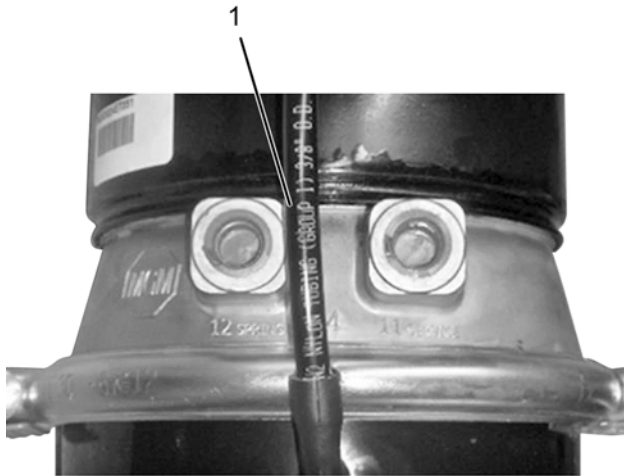
**Figure 6. Breather Tube.**

1. Breather tube

**NOTE: Some applications may require an MGM chamber as the replacement chamber. It is mandatory to position chamber so the breather tube is away from the road surface. Failure to comply may result in the chamber not working correctly and will void the brake warranty on these models.**
