Title: ProStar+ with MaxxForce 11/13L or N13 - LT EGR Core Removal and Insertion

Applies To: 2010 MaxxForce 11/13, N13, ProStar+113, ProStar+122

A faster, more effective procedure for Low Temp (LT) Exhaust Gas Recirculation (EGR) Cooler repair has been developed. This document will guide the user through the procedure of in chassis replacement of the cooler core on a ProStar+113 or ProStar+122 with a 2010 Emissions MaxxForce 11 or 13 or the 2013 Emissions N13. The new procedure will **REPLACE** LT cooler cleaning for fouling (plugging) and LT assembly replacement for internal leaks.

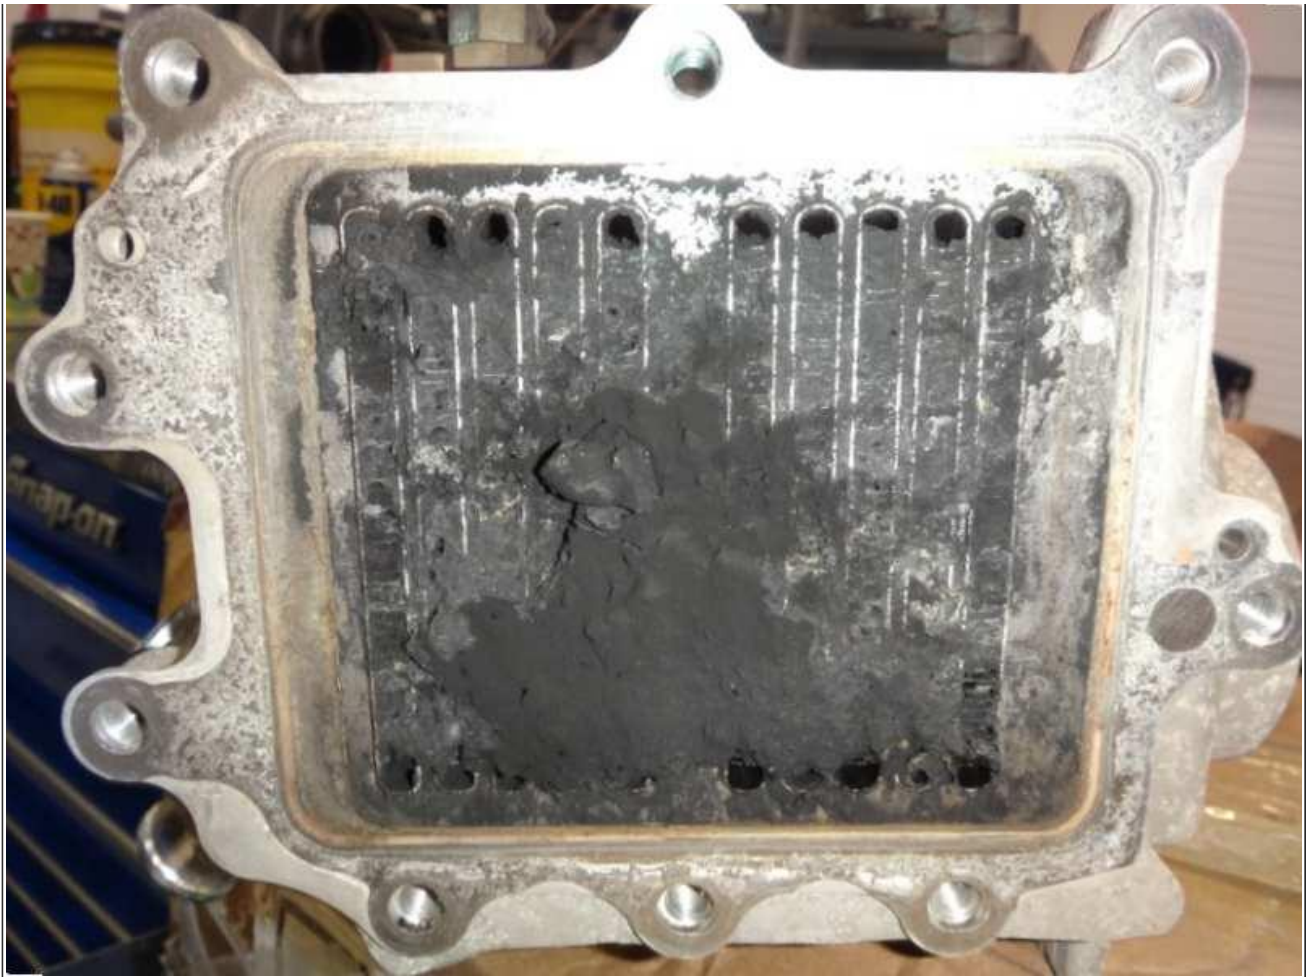
Figure 12: Soot Build-Up on the Core Face

Significant build-up will not allow the tool to sit against the core.

27. If necessary, scrape off soot build-up on the outlet of the core. The plate must sit flat against the face.
