Title: TranStar with MaxxFORce 11/13L or N13 - LT EGR Core Removal and Insertion

Applies To: 2010 MaxxFORce 11/13, 2010+ TranStar

A faster, more effective procedure for Low Temp (LT) Exhaust Gas Recirculation (EGR) Cooler repair has been developed. This document will guide the user through the procedure of in chassis replacement of the cooler core on a TranStar (8600) with a 2010 Emissions MaxxFORce 11 or 13 or the 2013 Emissions N13. The new procedure will **REPLACE** LT cooler cleaning for fouling (plugging) and LT assembly replacement for internal leaks.

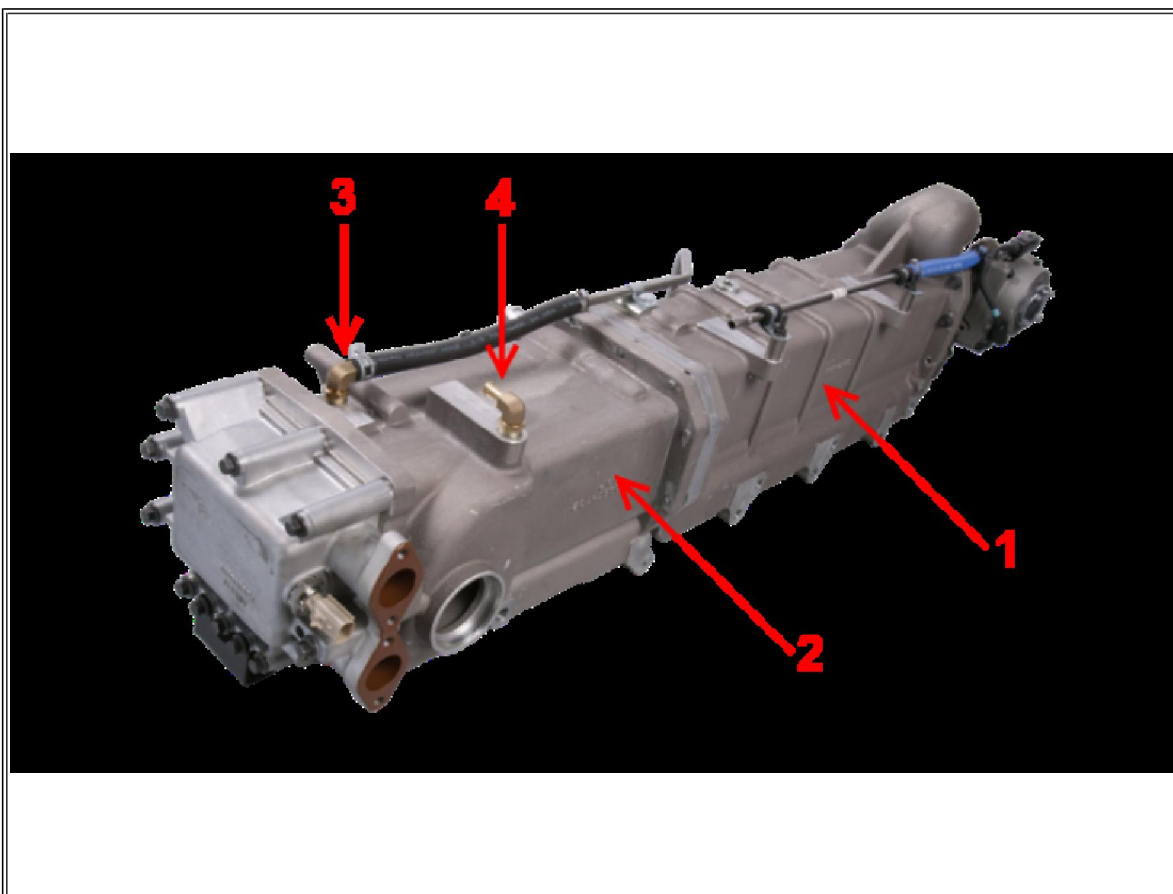
Figure 1: 2010 MaxxFace 11/13 EGR Cooler Assembly

- Item 1: High Temp (HT) Cooler
- Item 2: Low Temp (LT) Cooler
- Item 3: LT Cooler Pressure Test Port (dearation fitting)
- Item 4: HT Cooler Pressure Test Port (dearation fitting)

- An **internal** coolant leak in the Low Temp EGR cooler (reference **Figure 1** below for the cooler assembly notation), or
- EGR Low Flow (2659-21)

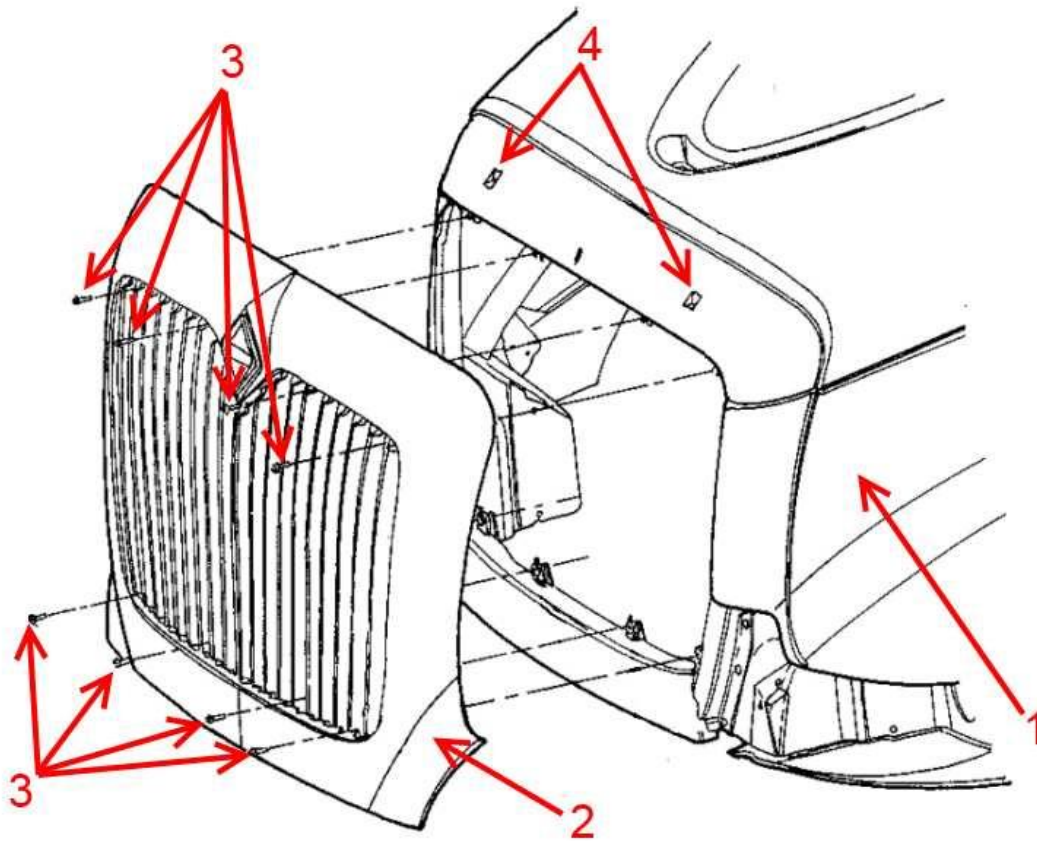
Figure 2: Front Grille Assembly

Item 1: Hood
 Item 2: Grille
 Item 3: Mounting Screws
 Item 4: Push Tab Slot

3. With the hood closed, remove the eight grille mounting screws (**Figure 2**, Item 3). Follow [TSI 13-09-01R](#) instructions for grille removal/install (instructions 3a-3e): ***NEW SECTION***

- a. Ensure vehicle is in a warm environment, as heat will aid tape removal.
- b. Open the hood and apply heat to underside of hood for 3-4 minutes. Make certain that the heat is applied where the hood overlaps with the top of the grille. Too much heat will discolor the hood and/or grille. Keep the heat gun moving. Tape is positioned ~1" above push tabs (**Figure 2**, Item 4)
- c. Close hood and position yourself in front of the hood, facing the vehicle.
- d. Firmly grasp the lower edge of the grille and pull outward/upward as if pivoting the grille about the upper edge where it meets the hood. Since the tape has such high retaining force, a minimum of two people lifting is recommended to maintain an even force across the bottom of the grille. Pull slowly!
- e. Once the grille and hood have separated, clean the tape residue from the hood and grille using 3M Tape Removal Kit.

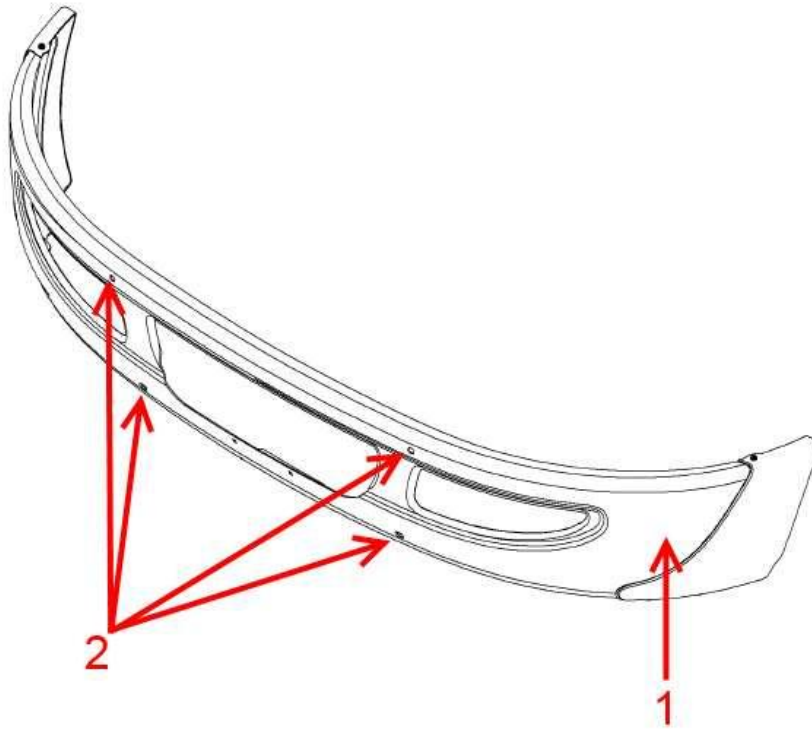
Figure 3: Front Bumper

Item 1: Bumper Assembly
Item 2: Mounting Bolts

4. Remove the four bolts from the front bumper (**Figure 3**, Item 2) and remove the bumper from the vehicle.

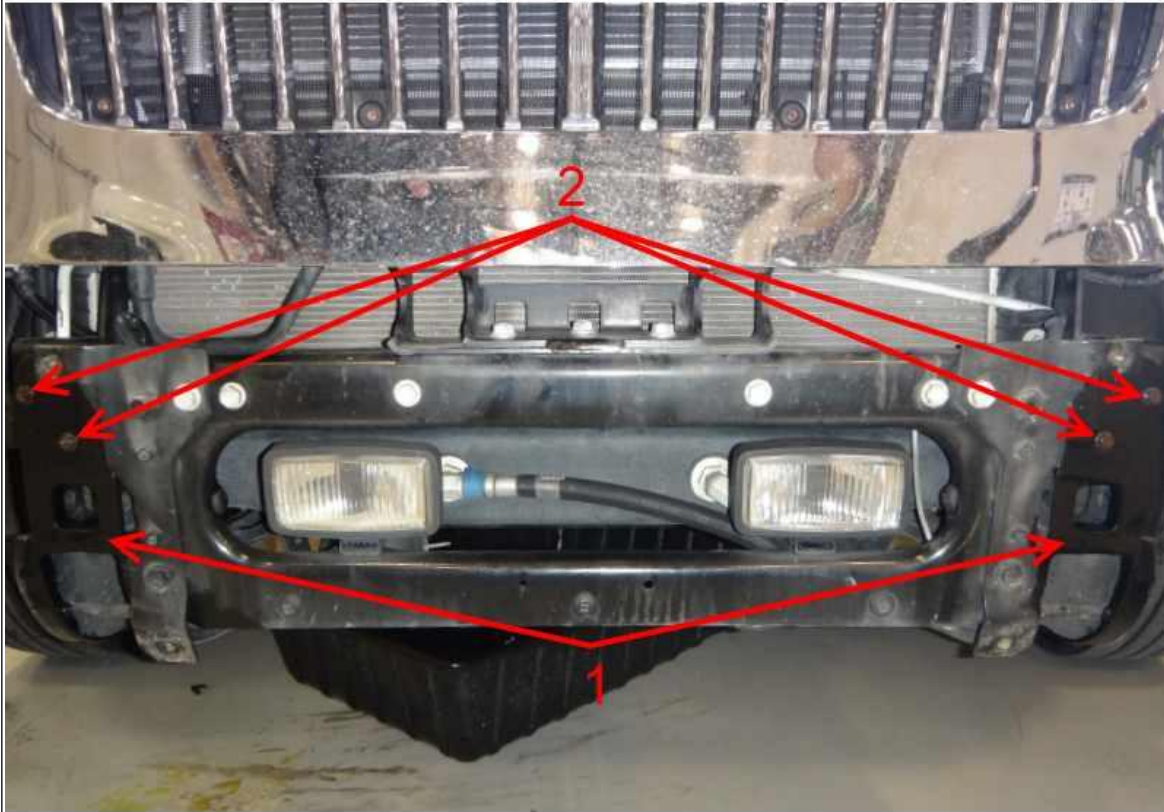
Figure 4: Torsion Bar Stop Bracket

Item 1: Torsion Bar Brackets
Item 2: Bracket Bolts

5. **With the hood open**, remove the four torsion bar stop bracket bolts (**Figure 4**, Item 2).

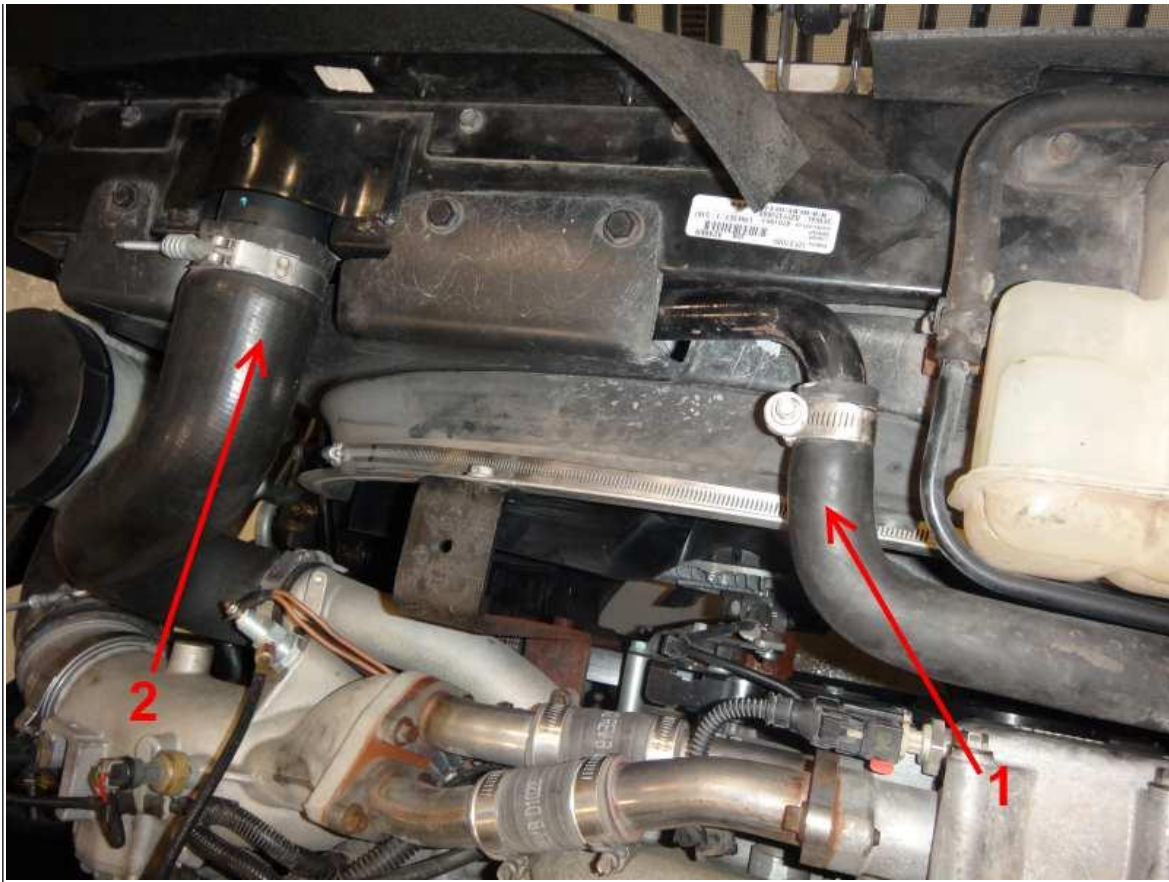
Figure 5: Radiator Hoses

Item 1: Low Temp Radiator Hose
Item 2: Radiator Hose

6. Remove the Low Temp Radiator (LTR) hose (**Figure 5**, Item 1).
7. Remove the Radiator hose (**Figure 5**, Item 2)

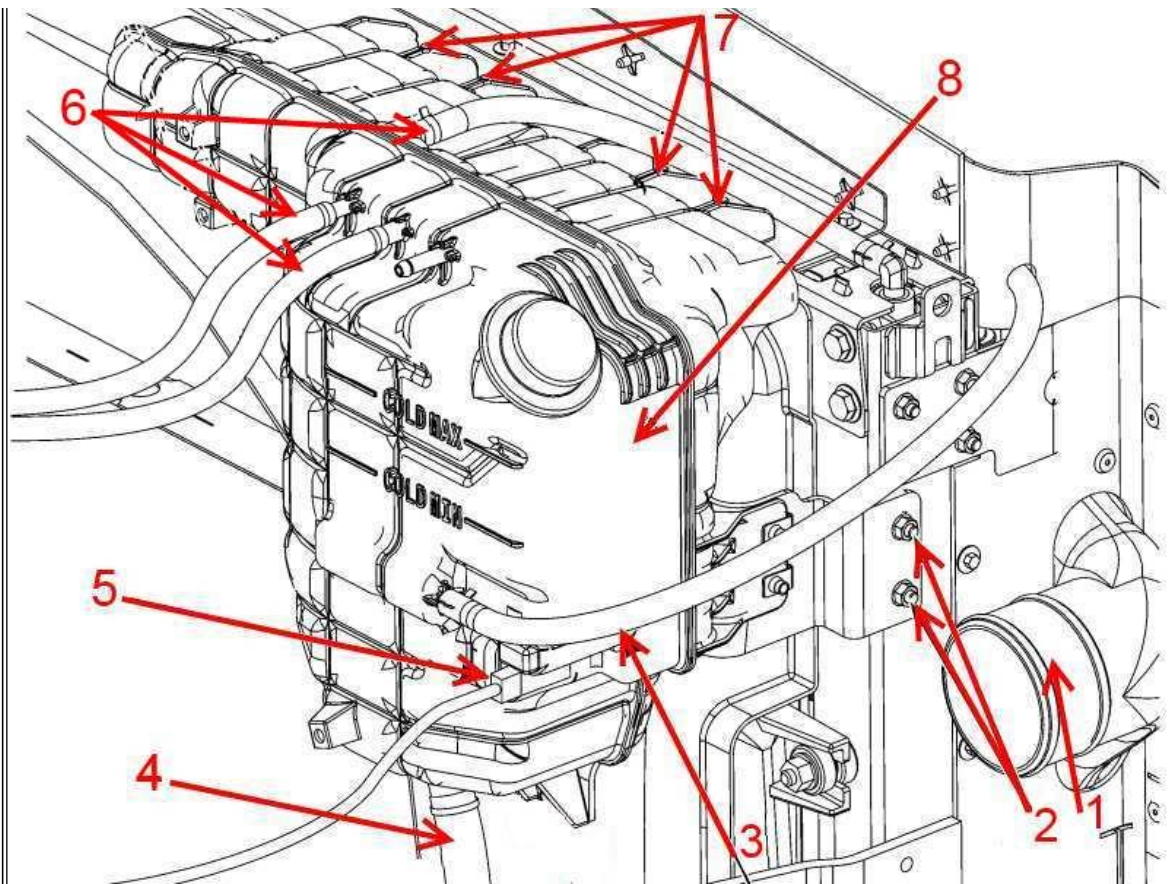
Figure 6: Deaeration Tank Assembly

- Item 1: HP CAC Inlet
- Item 2: Deaeration Tank Side Bracket
- Item 3: Radiator Deaeration Hose
- Item 4: Coolant Return Hose
- Item 5: Coolant Level Sensor
- Item 6: Engine Deaeration Hoses
- Item 7: Upper Tank Mount
- Item 8: Deaeration Tank

8. Loosen the clamp and remove the passenger side HP CAC inlet pipe (**Figure 6**, Item 1).
9. Remove the 3 or 4 deaeration lines from the tank (depending on configuration. **Figure 6**, Items 3 & 6).
10. Disconnect the engine harness from the Engine Coolant Level Sensor (**Figure 6**, Item 5).
11. Remove the deaeration tank return hose (**Figure 6**, Item 4).
12. Cut any zip ties holding the LT radiator hose to the tank.
13. Remove the two nuts securing the mounting bracket to the radiator (**Figure 6**, Item 2).
14. Remove the four nuts securing the top of the tank to the radiator (**Figure 6**, Item 7), and remove the deaeration tank.

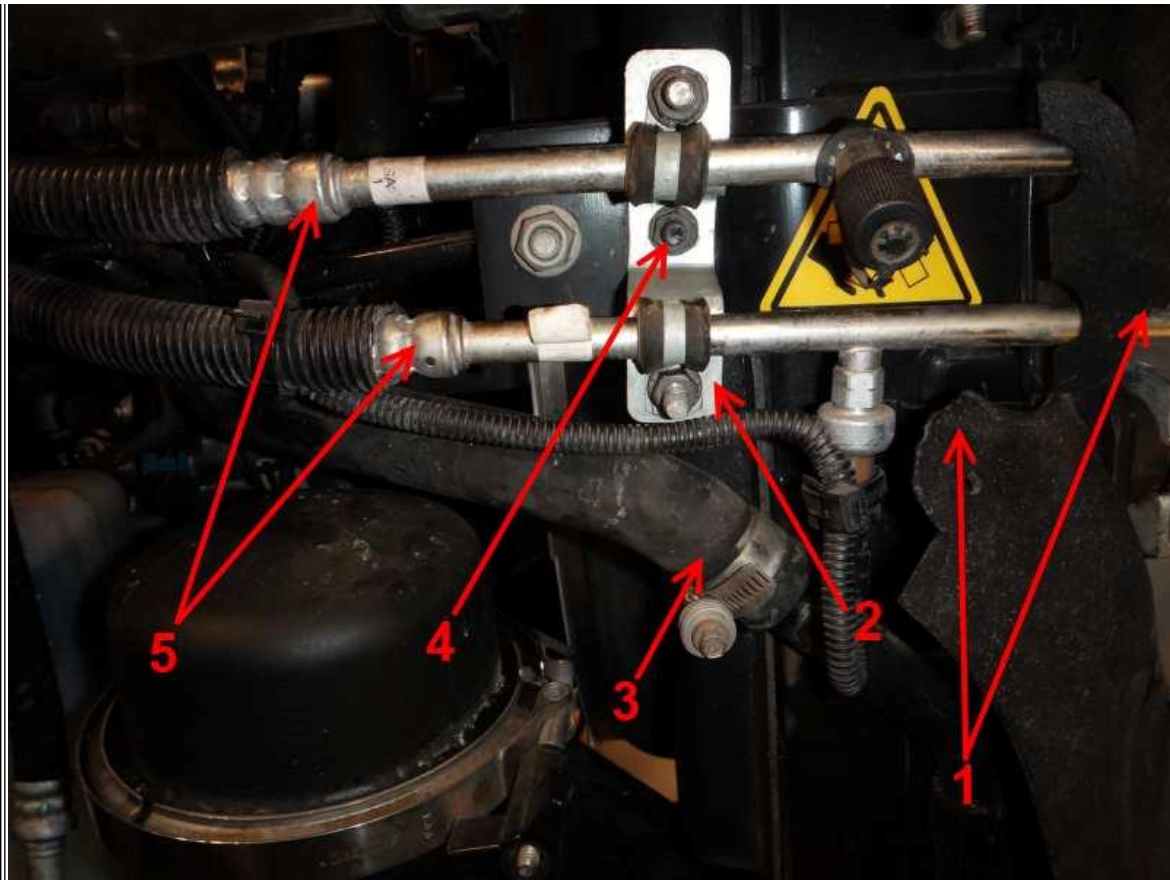
Figure 7: A/C Line Bracket

Item 1: Recirculation Seal
 Item 2: A/C Line Bracket
 Item 3: Low Temp Radiator Hose
 Item 4: A/C Bracket Nut
 Item 5: A/C Lines

15. Remove the nut securing the A/C condenser line bracket to the radiator (**Figure 7**, Item 4).
16. Loosen the hose clamp and remove the Low Temp Radiator (LTR) return hose from the return tube (**Figure 7**, Items 3).
17. Cut the recirculation seal to allow the condenser to swing around the engine (**Figure 7**, Item 1).

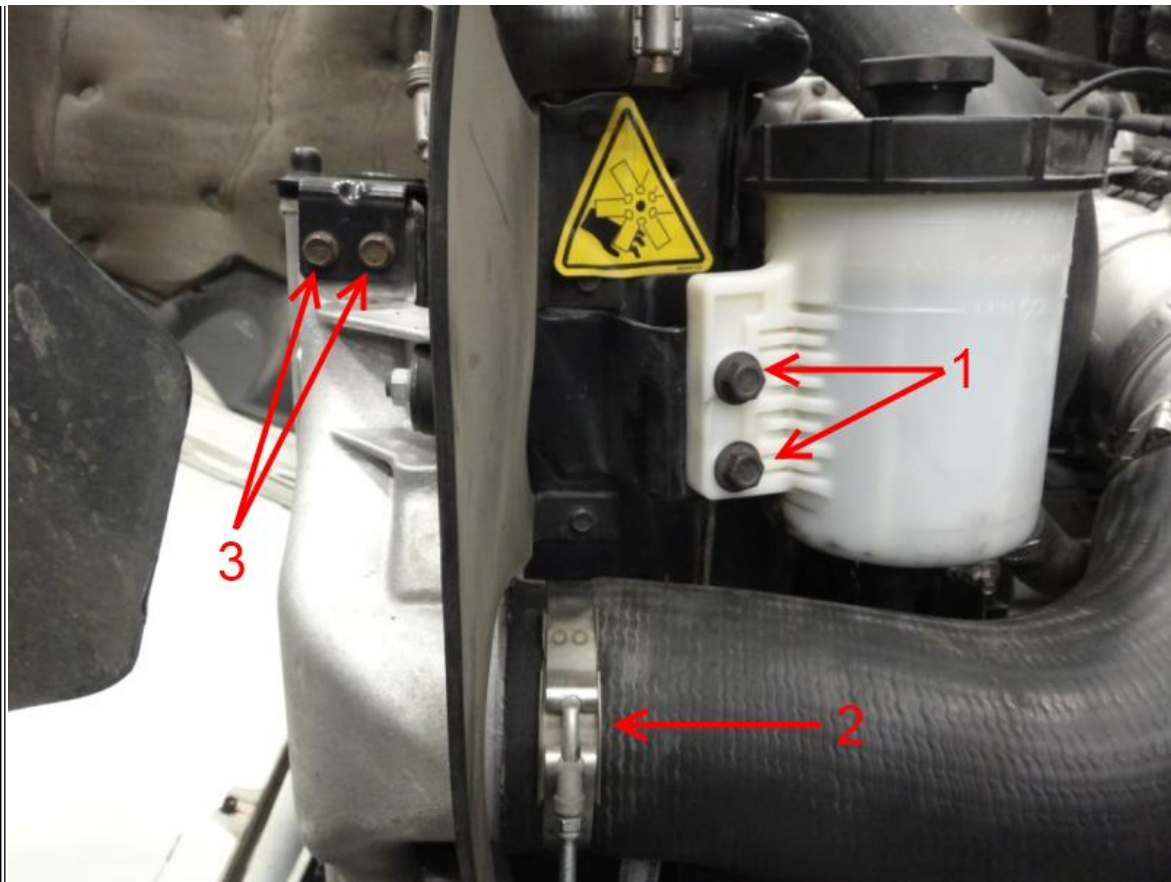
Figure 8: Driver Side HPCAC

- Item 1: Power Steering Reservoir Bolts
- Item 2: HPCAC Clamp/hose
- Item 3: Upper A/C Condenser Bracket

18. Loosen the driver side HPCAC outlet clamp and disconnect the HPCAC pipe (**Figure 8**, Item 2).
19. Remove the two power steering reservoir bolts, and reposition away from the radiator (**Figure 8**, Item 1).
20. Remove the two A/C Condenser support bracket bolts (Figure 8, Item 3).

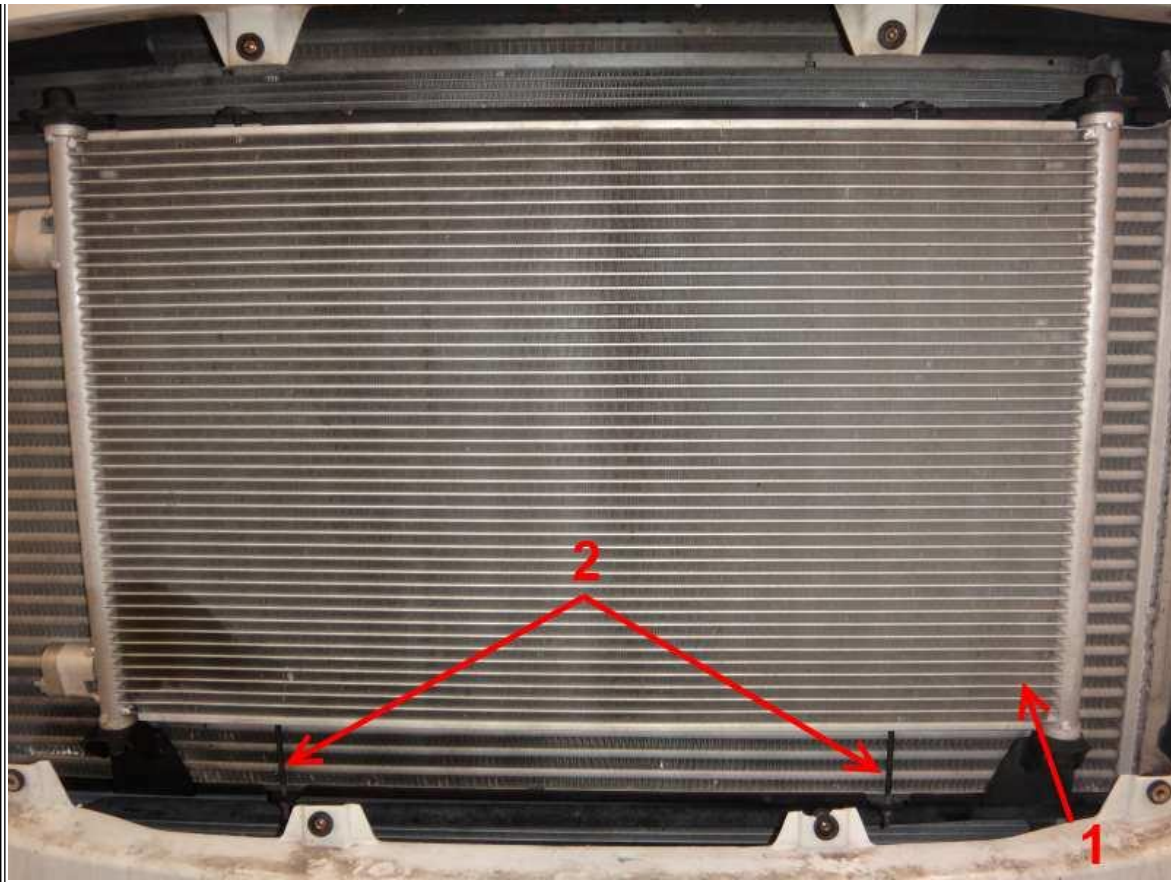
Figure 9: A/C Condenser Mounting

- Item 1: A/C Condenser
- Item 2: Condenser Stay Rods

21. Remove the four nuts and washers securing the A/C condenser to the HP CAC (**Figure 9**, Item 2).

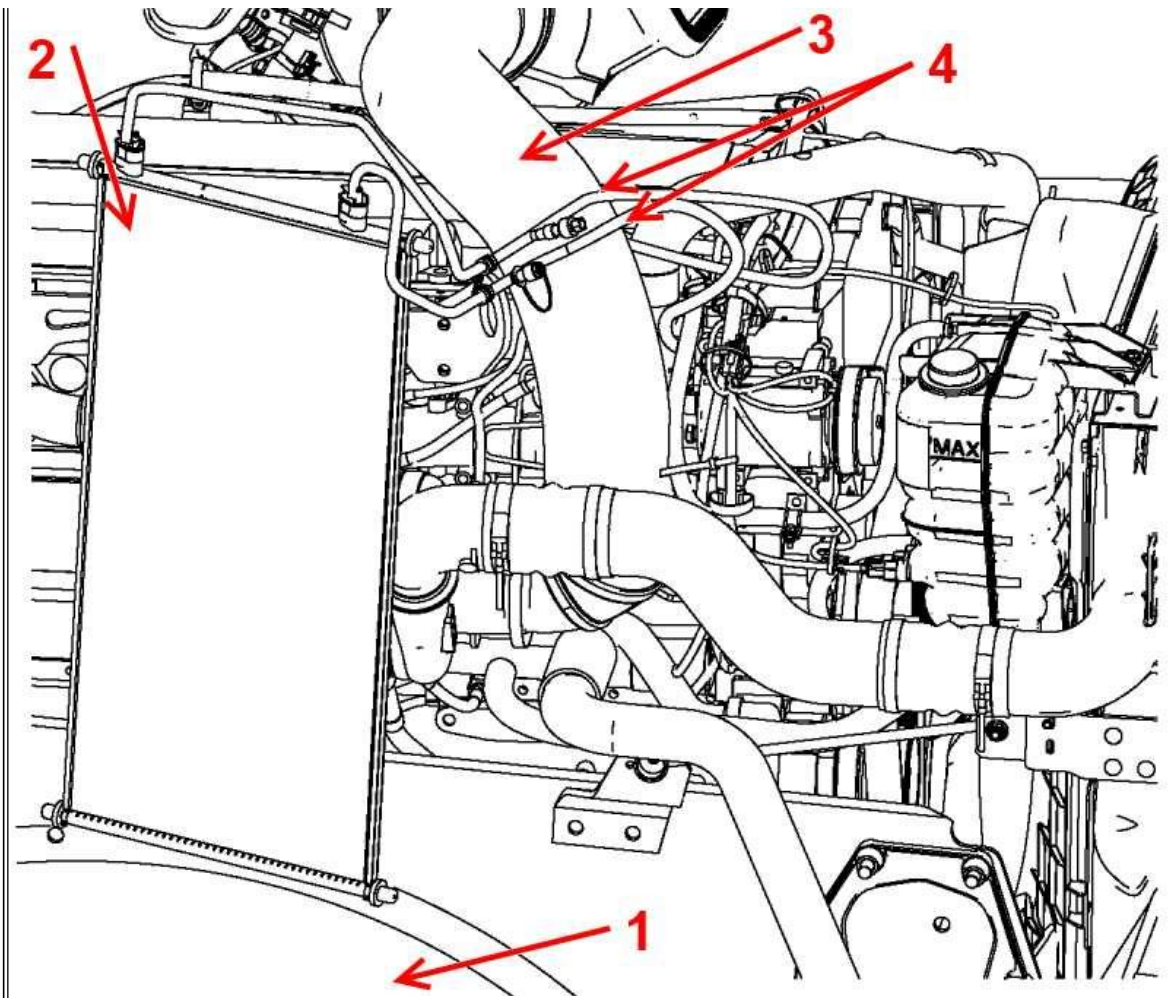
Figure 10: A/C Condenser Repositioning

- Item 1: Passenger Front Tire
- Item 2: A/C Condenser
- Item 3: Air Intake Pipe
- Item 4: A/C Lines

22. Carefully flip the A/C condenser over the cooling package and rest the passenger side on the passenger front tire (**Figure 10**). Secure the A/C lines to the intake pipe using a bungee cord or zip tie.

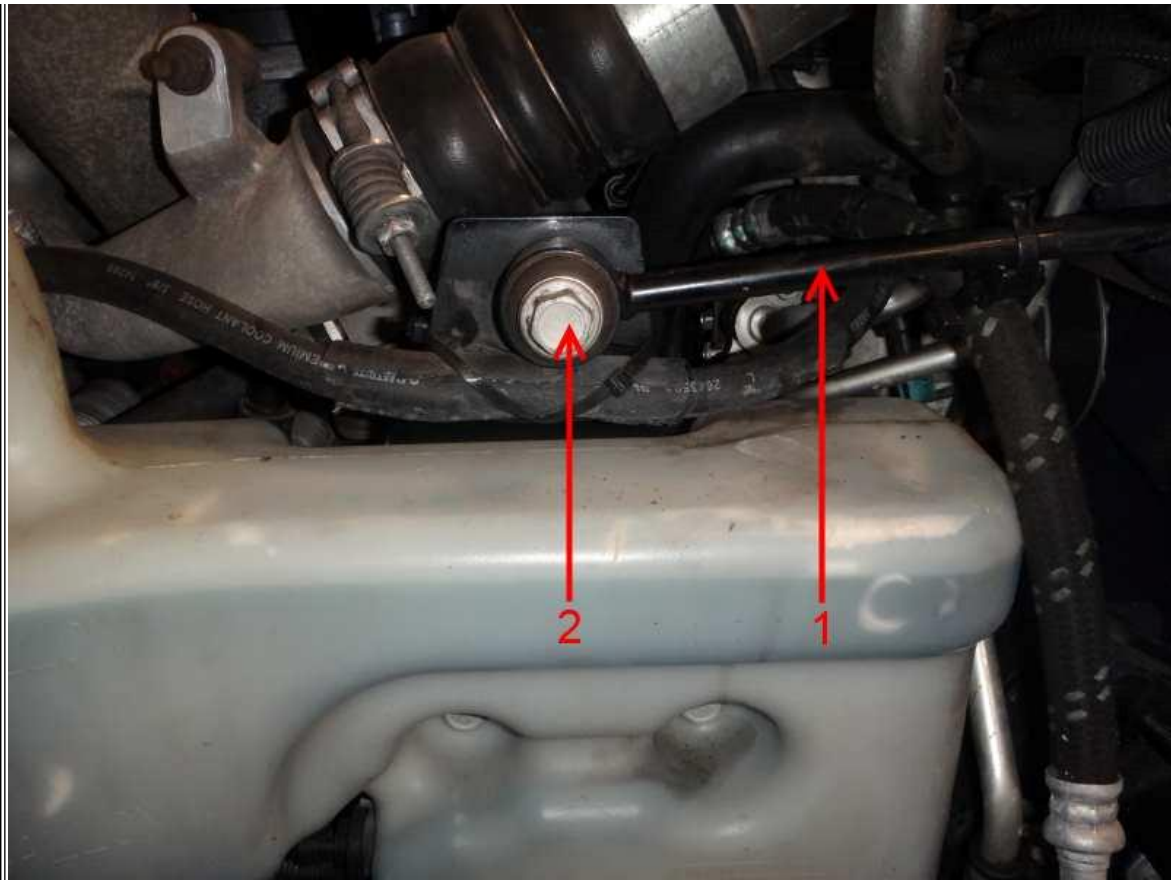
Figure 11: Passenger Side Radiator Support

Item 1: Radiator Support Rod
Item 2: Support Rod Nut/Bolt

23. Remove the nut and bolt from the passenger side radiator support rod, at the frame (**Figure 11**, Item 2).

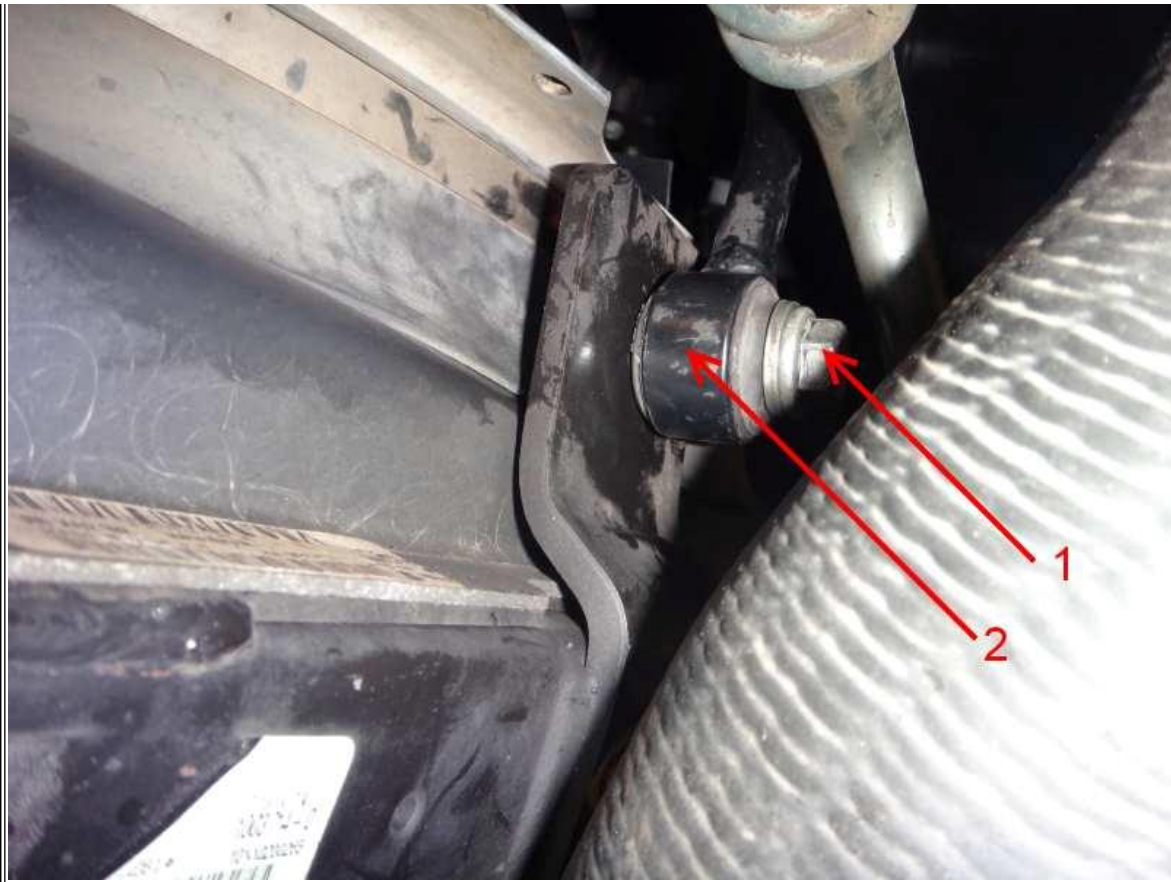
Figure 12: Driver Side Radiator Support

- Item 1: Support Rod Nut/Bolt
- Item 2: Radiator Support Rod

24. Remove the nut and bolt from the driver side radiator support rod, at the frame (**Figure 12**, Item 1).
25. Tilt the cooling package forward, allowing room for LT Core removal.

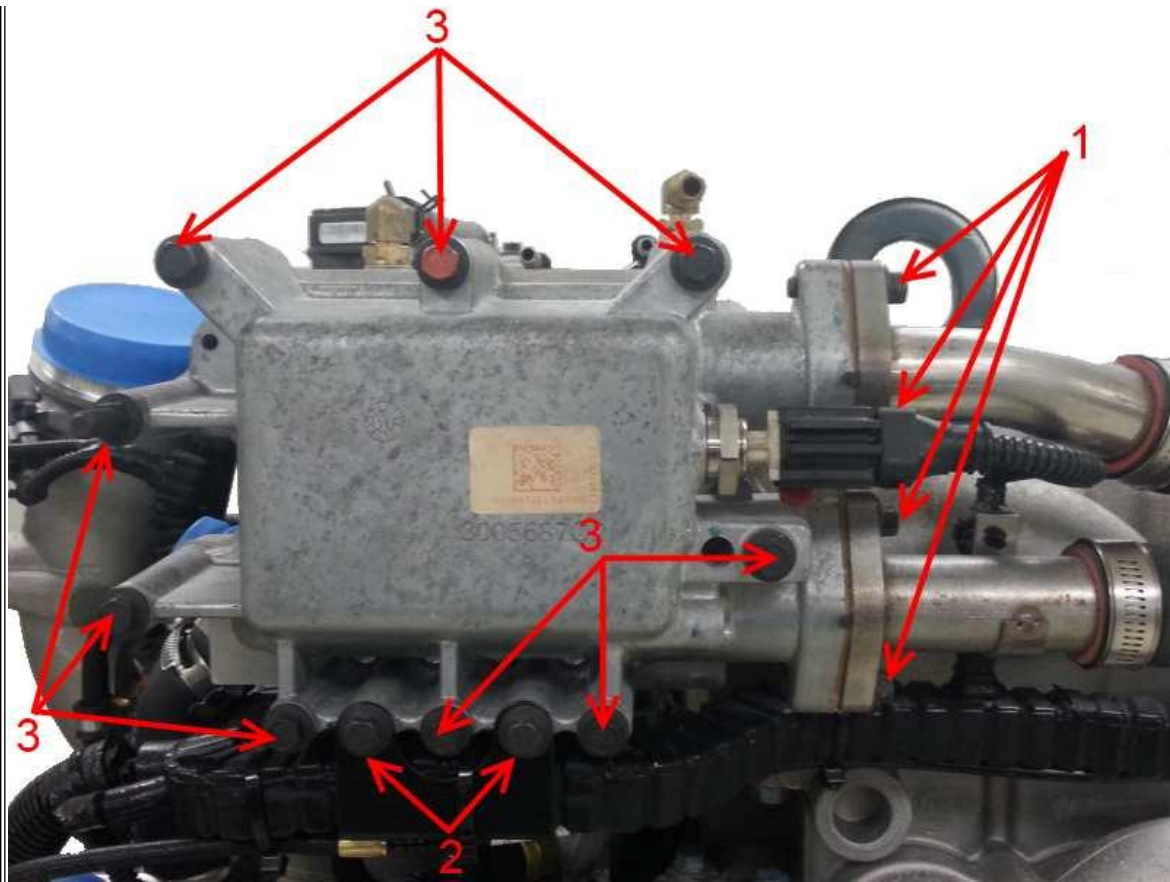
Figure 13: EGR Outlet Cover, Bolts and Tubes

- Item 1: EGR Outlet Tube Bolts
- Item 2: Engine Harness Bracket Bolts
- Item 3: EGR Outlet Cover Bolts

26. Disconnect the engine harness from the EGR Temperature (EGRT) sensor.
27. Remove the four bolts holding the outlet tubes to the front cover--discard the gaskets (**Figure 13**, Item 1).
28. Remove the two bolts holding the engine harness, and reposition as necessary, for front cover removal (**Figure 13**, Item 2).
29. Remove the eight bolts and one stud bolt from the front cover, and remove (**Figure 13**, Item 3).

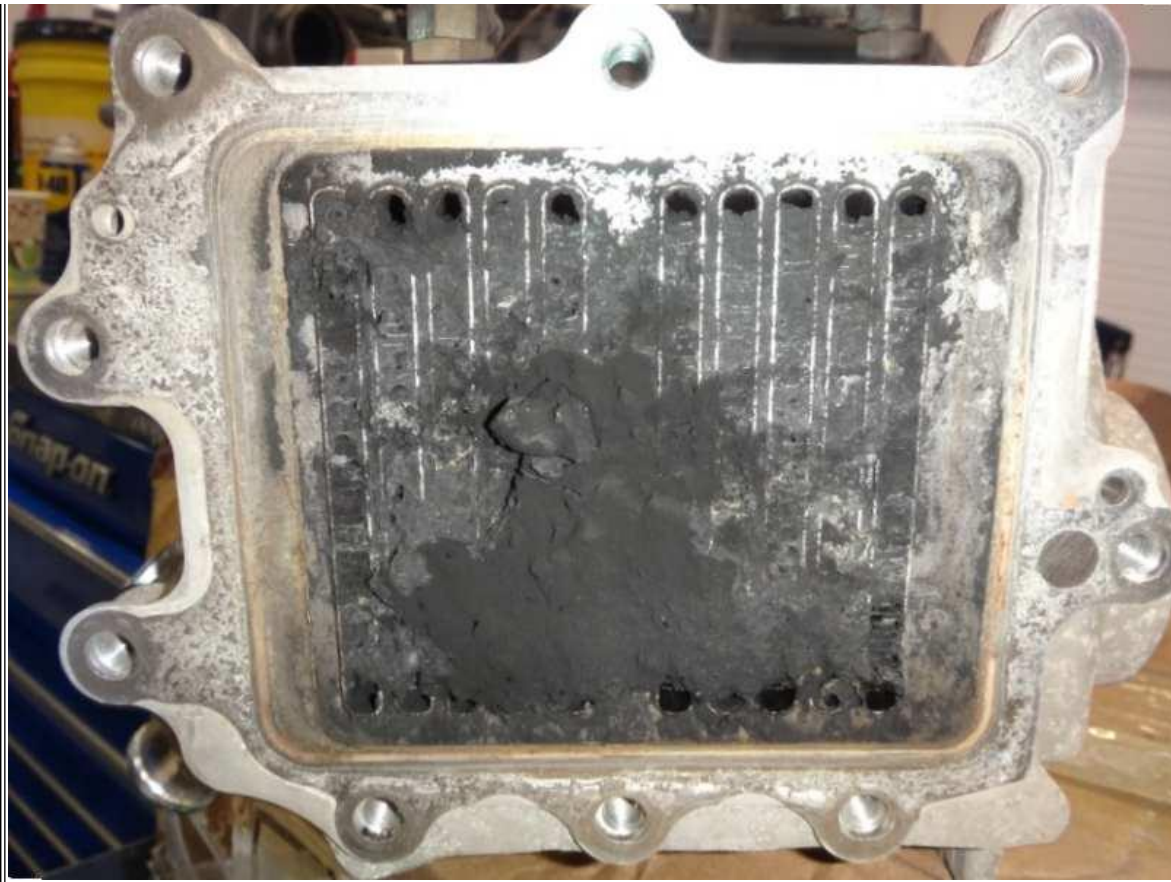
Figure 14: Soot Build-Up on the Core Face

Significant build-up will not allow the tool to sit against the core.

30. If necessary, scrape off soot build-up on the outlet of the core. The plate must sit flat against the face.

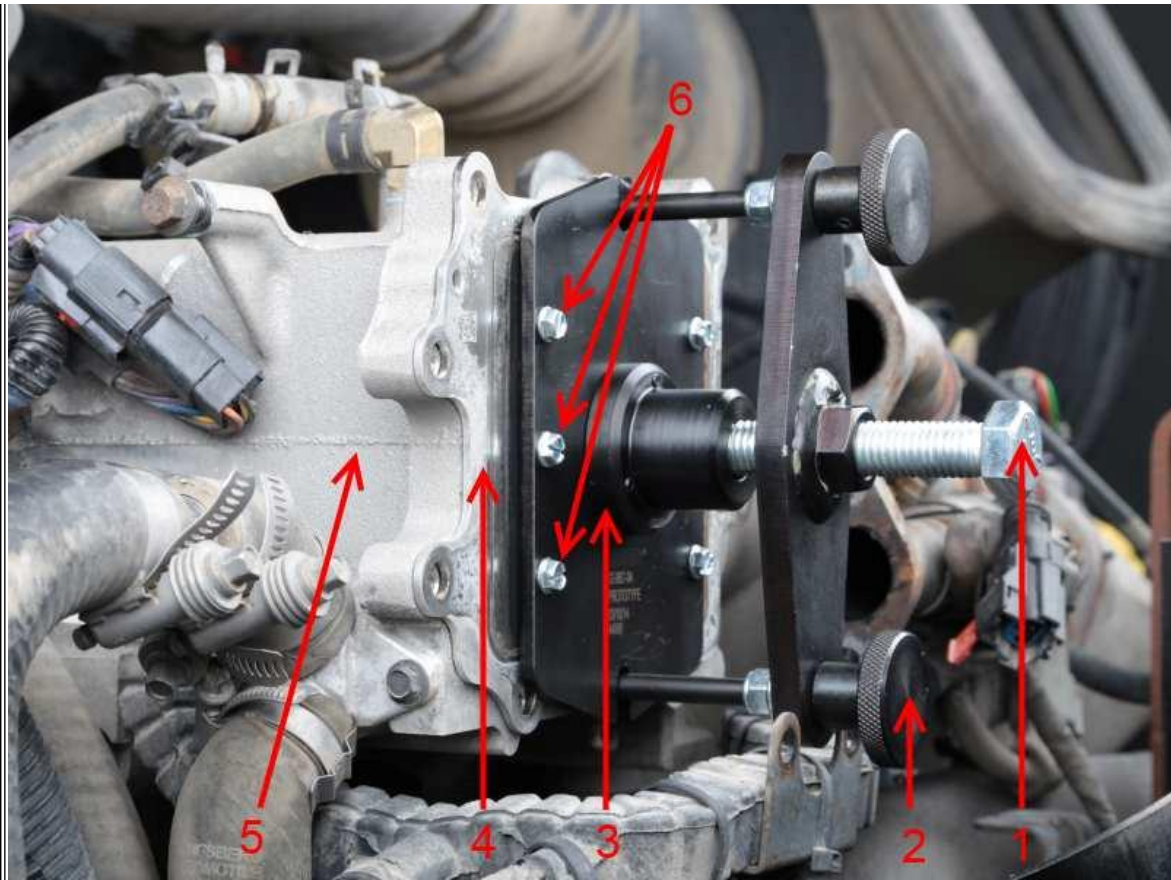
Figure 15: Low Temp EGR Core Extractor

- Item 1: Removal Bolt
- Item 2: Thumb Screws
- Item 3: Removal Plate
- Item 4: LT Core
- Item 5: LT Housing
- Item 6: Self Tapping Screws

31. Install the LT EGR Core Puller Tool (12-892-04), [per the tool instructions](#).
32. Back out the bolt (**Figure 15**, Item 1) until the core pulls loose (typically 3/4" from the housing).
33. Remove the tool and pull the core from the housing.

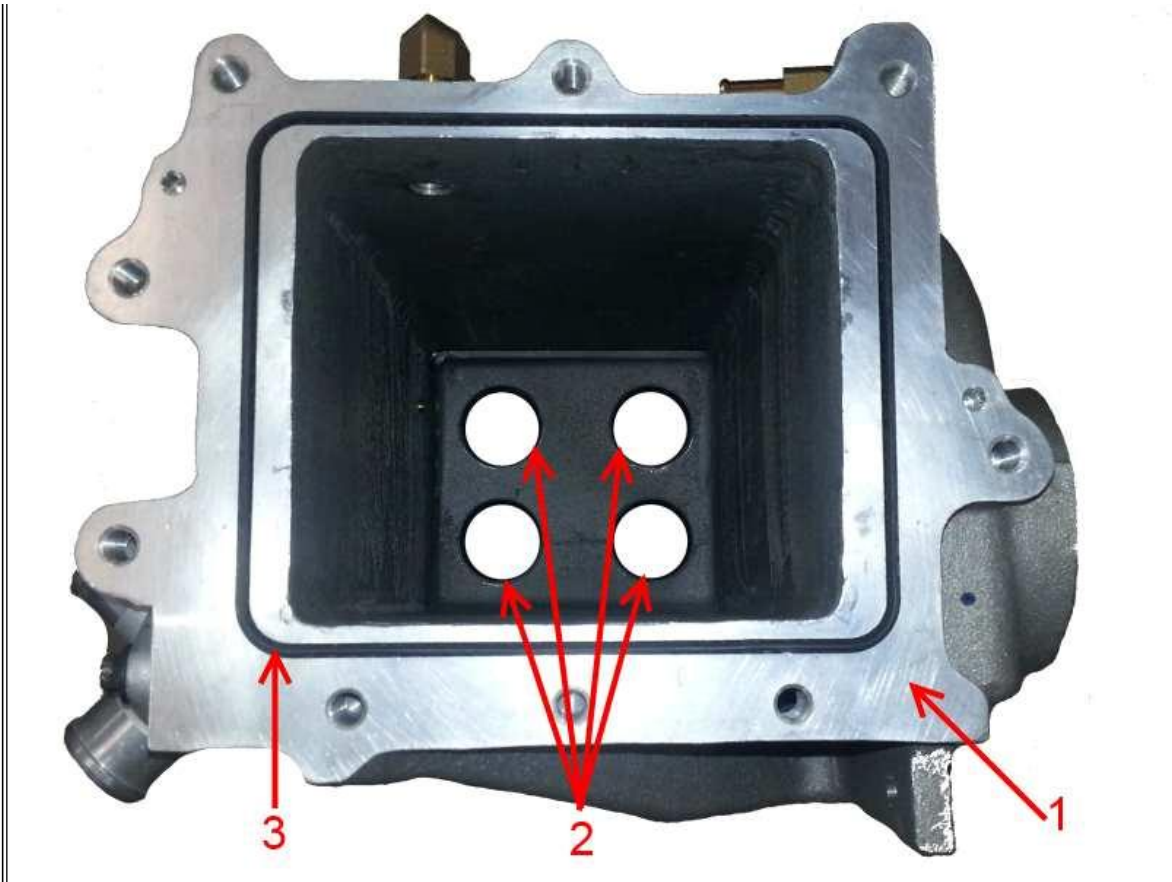
Figure 16: Low Temp Cooler Housing Face

- Item 1: Housing
- Item 2: Core O-Rings
- Item 3: Housing Seal

34. Remove the housing seal and discard (**Figure 16**, Item 3)
35. Use a seal pick to remove the four o-rings at the housing inlet and discard (**Figure 16**, Item 2).

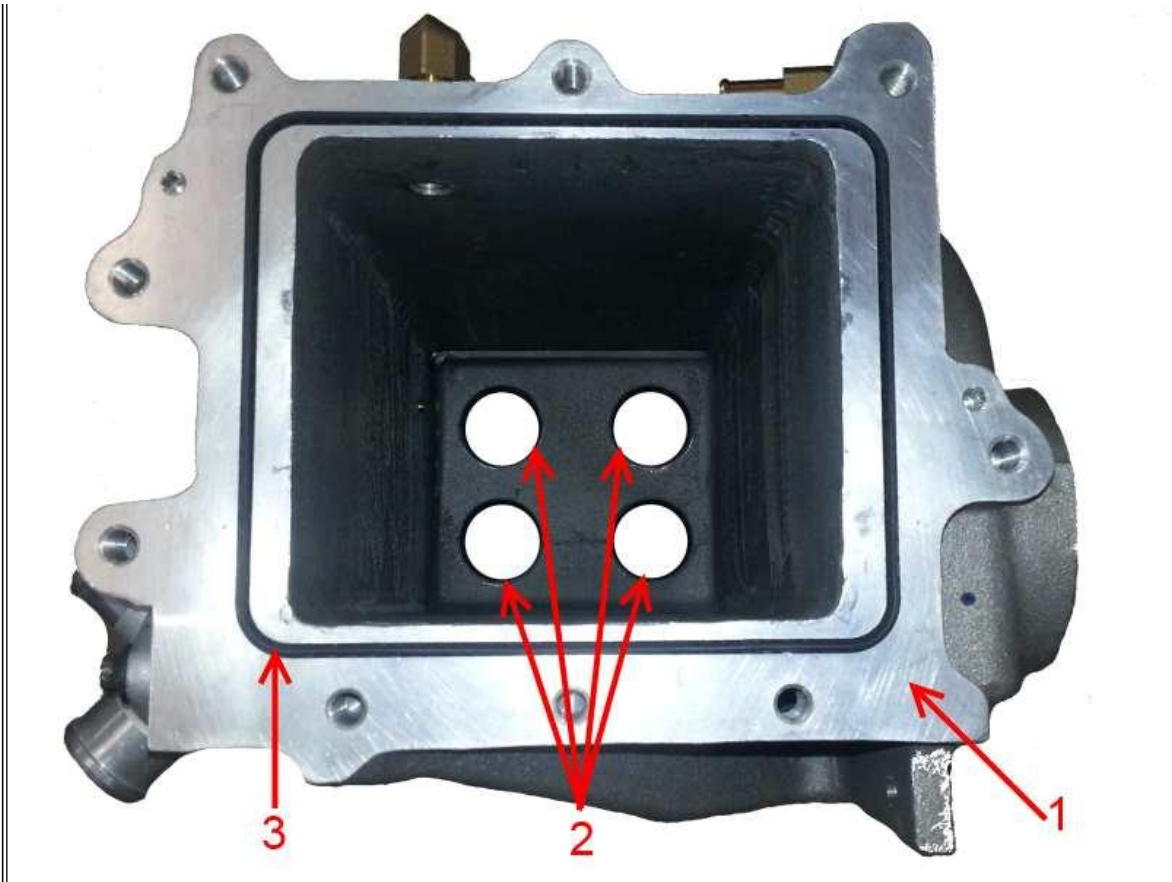
Figure 17: Low Temp Cooler Housing Face

- Item 1: Housing
- Item 2: Core O-Rings
- Item 3: Housing Seal

1. Install the new seal into the LT housing (**Figure 17**, Item 3).
2. Clean the o-ring grooves of contaminates (soot). Coolant is not a concern, and will act as a lubricant.
3. Install the new o-rings from the LT core kit (**Figure 17**, Item 2).

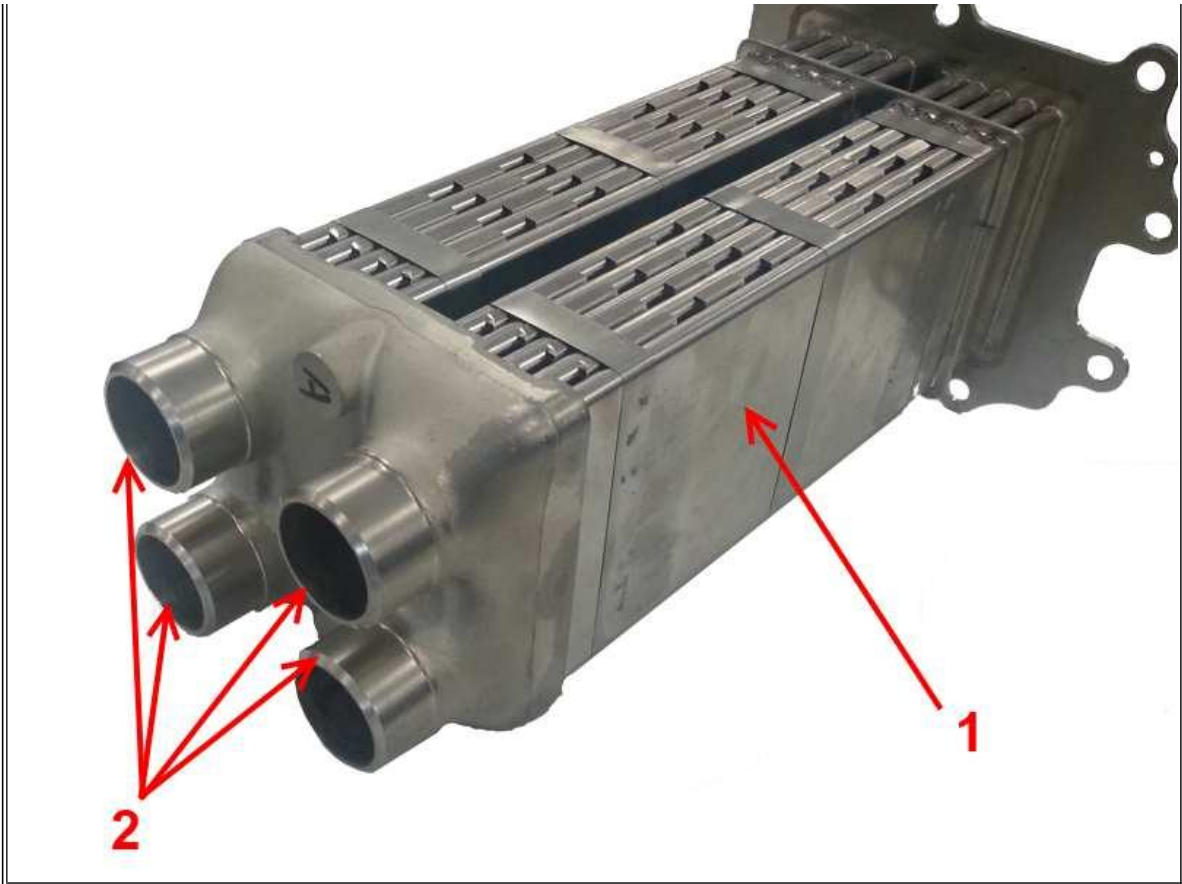
Figure 18: Low Temp Cooler Inlet Manifold

- Item 1: Low Temp EGR Cooler Core
- Item 2: Inlet Manifold Ports

4. Use P80 to lubricate the LT core inlet manifold and the four o-rings in the LT housing.
5. Insert the core into the housing and maneuver it into the o-rings.

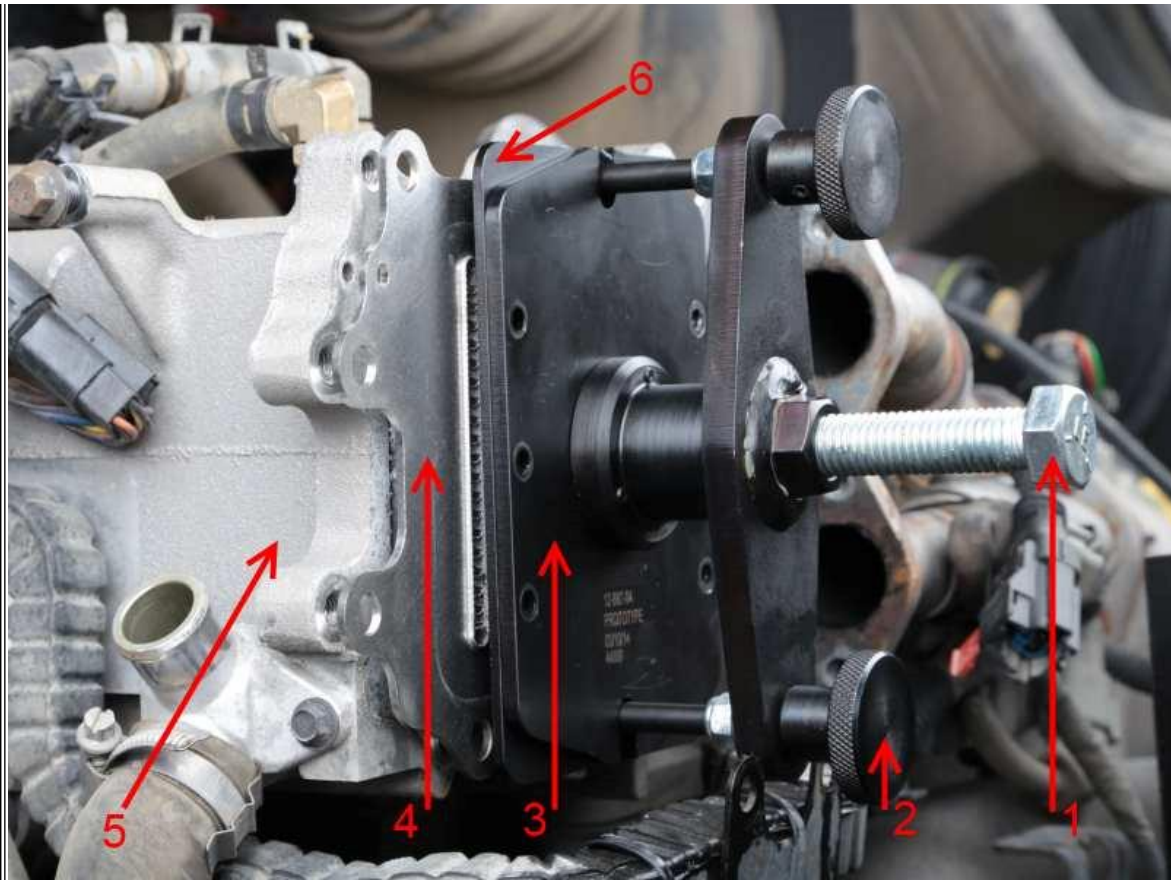
Figure 19: Low Temp Core Install Tool

- Item 1: Insertion Bolt
- Item 2: Thumb Screw
- Item 3: Removal Plate
- Item 4: LT Core
- Item 5: LT Housing
- Item 6: Installation Plate

6. Install the LT Core installation tool, per the tool instructions.
7. Press the EGR cooler core into the housing **until the core header plate makes contact with the housing seal.**

DO NOT over-torque the bolt, as damage to the core may result. Typical installation will take less than 5 lb-ft of torque to drive the core in. It is normal for the core to sit a couple millimeters off the face of the housing, and will seat/seal when the front cover is installed.

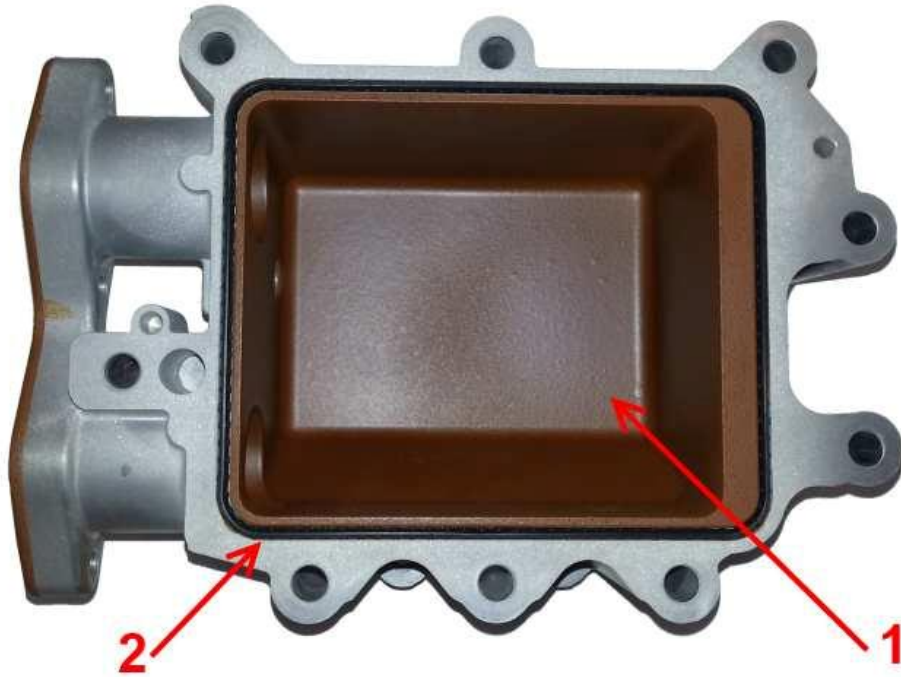
Figure 20: EGR Outlet Cover

- Item 1: Front Cover
- Item 2: Ring Seal

8. Inspect the front cover for reuse--Review [IK1201087 - Front Cover Reuse Guidelines](#) for direction.
9. Remove the seal from the groove and discard.
10. Insert the new seal from the LT Core kit.
