Title: TranStar with MaxxFORce 11/13L or N13 - LT EGR Core Removal and Insertion

Applies To: 2010 MaxxFORce 11/13, 2010+ TranStar

A faster, more effective procedure for Low Temp (LT) Exhaust Gas Recirculation (EGR) Cooler repair has been developed. This document will guide the user through the procedure of in chassis replacement of the cooler core on a TranStar (8600) with a 2010 Emissions MaxxFORce 11 or 13 or the 2013 Emissions N13. The new procedure will **REPLACE** LT cooler cleaning for fouling (plugging) and LT assembly replacement for internal leaks.

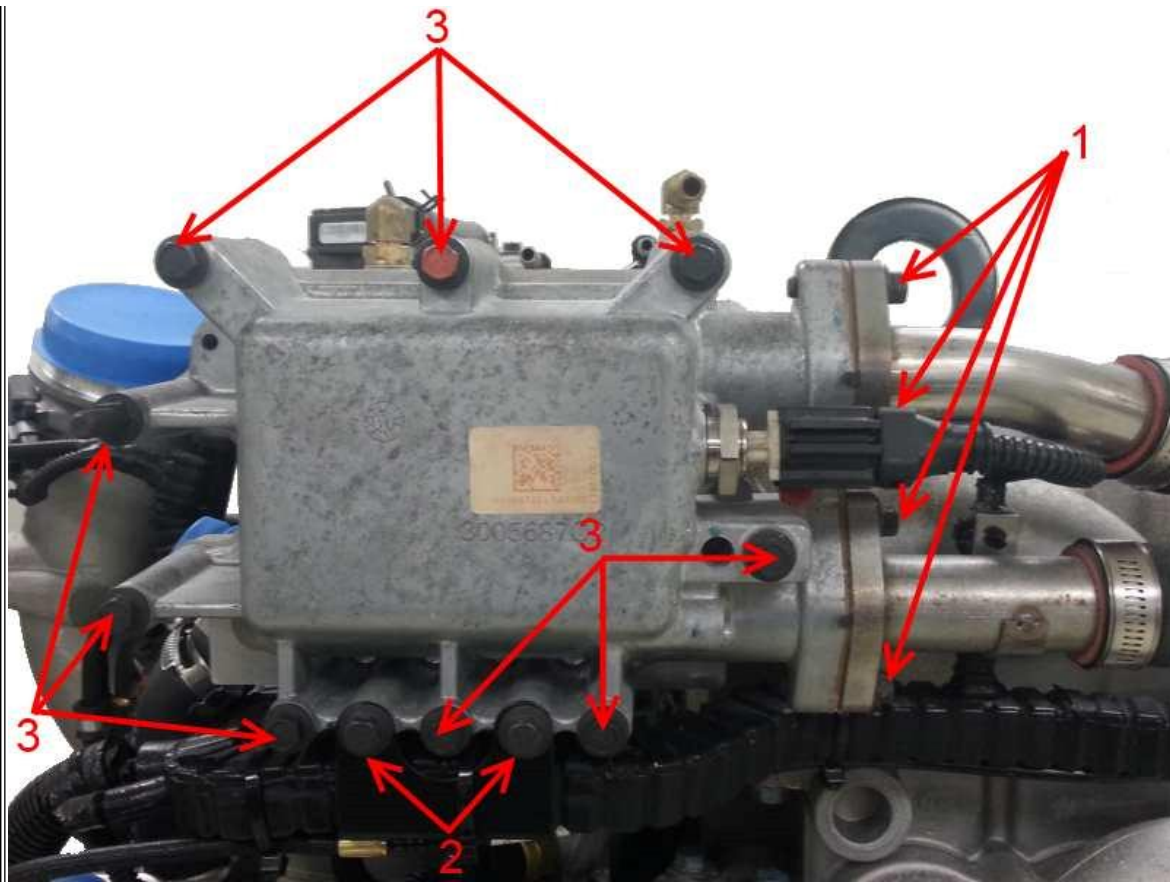
Figure 21: EGR Outlet Cover, Bolts and Tubes

- Item 1: EGR Outlet Tube Bolts
- Item 2: Engine Harness Bracket Bolts
- Item 3: EGR Outlet Cover Bolts

11. Install the front cover, noting the location of the stud bolt in **Figure 21**.
12. Hand tighten all bolts then torque in a criss-cross pattern to 18 lb-ft (24 N-m).
13. Install the four bolts for the EGR outlet tubes, using new gaskets from the kit (**Figure 21**, Item 1).
14. Install the two engine harness bracket bolts (**Figure 21**, Item 2).
15. Connect the EGRT sensor.

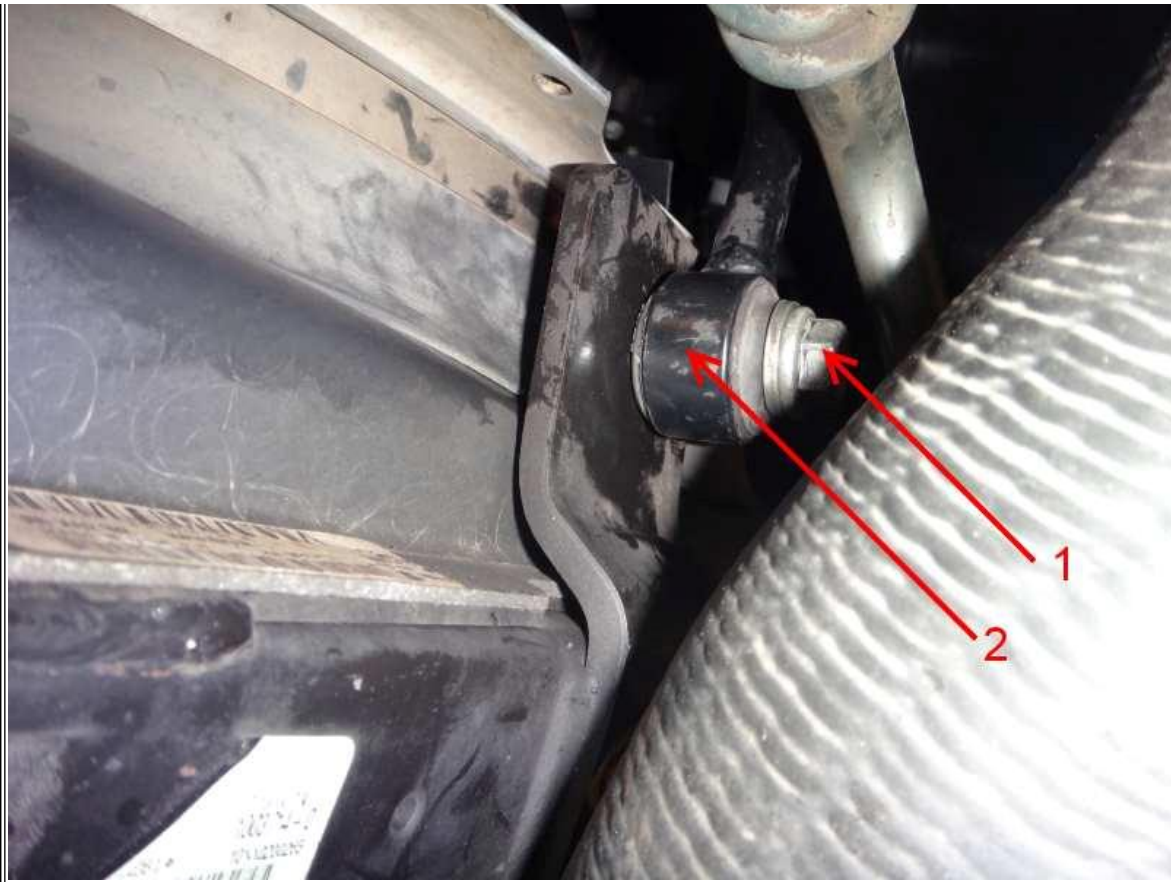
Figure 22: Driver Side Radiator Support

- Item 1: Support Rod Nut/Bolt
- Item 2: Radiator Support Rod

16. Install the driver side radiator stay rod and torque to 85 lb-ft (115 N-m).

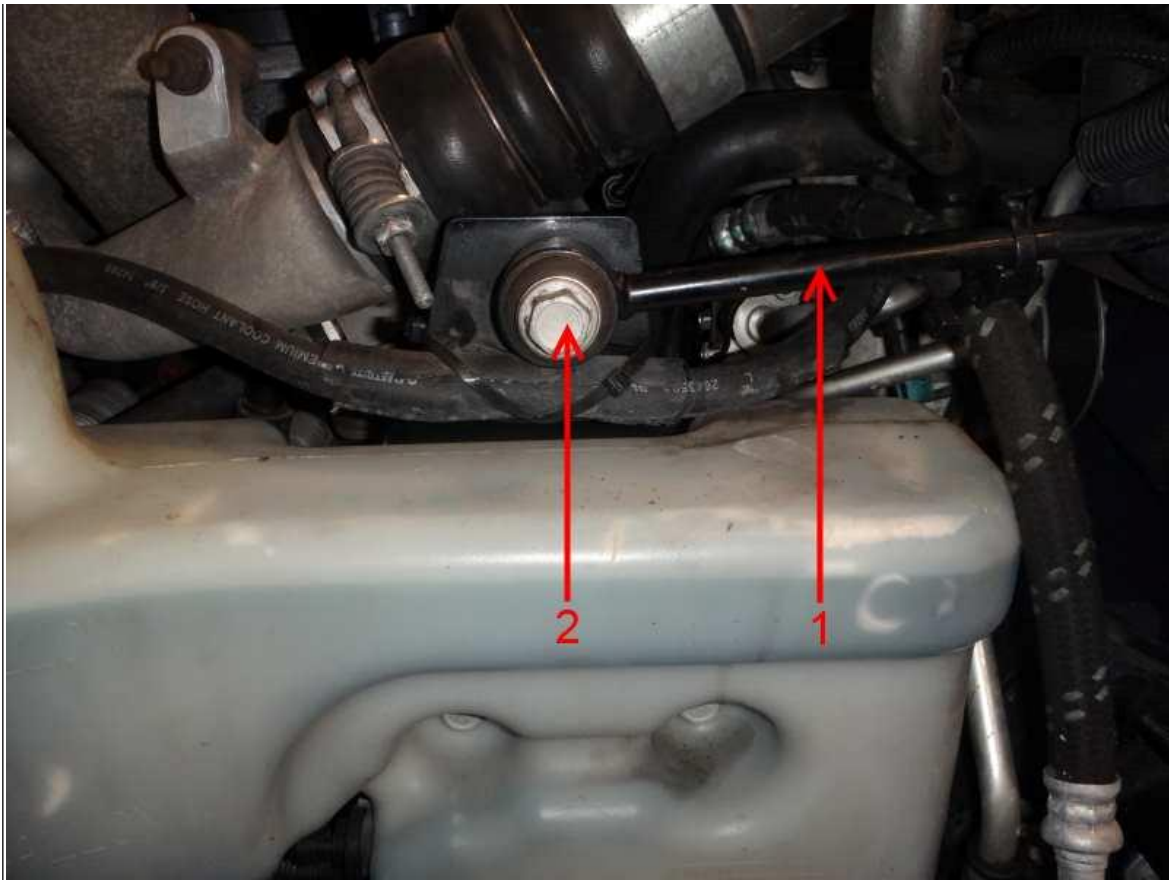
Figure 23: Passenger Side Radiator Support

- Item 1: Radiator Support Rod
- Item 2: Support Rod Nut/Bolt

17. Install the driver side radiator stay rod and torque to 85 lb-ft (115 N-m).

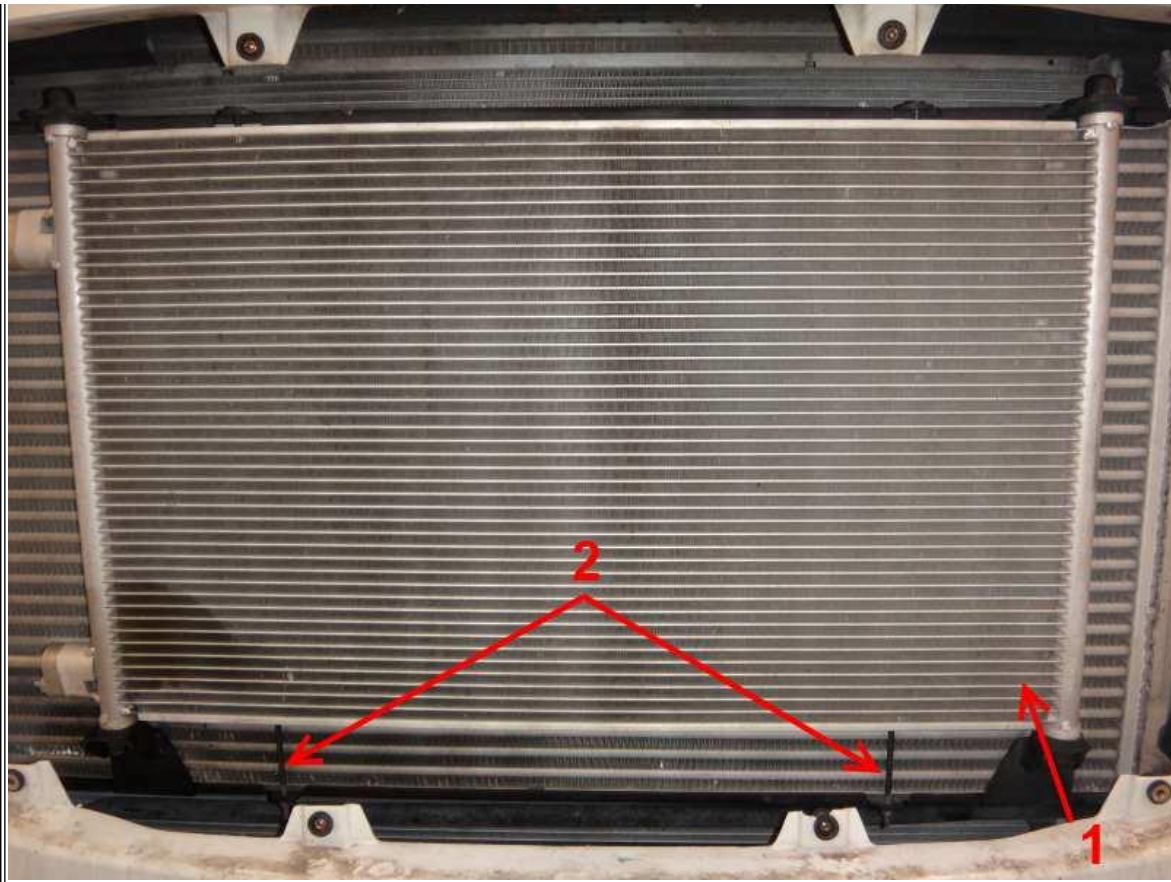
Figure 24: A/C Condenser Mounting

- Item 1: A/C Condenser
- Item 2: Condenser Stay Rods

18. Install the A/C Condenser Stay Rods

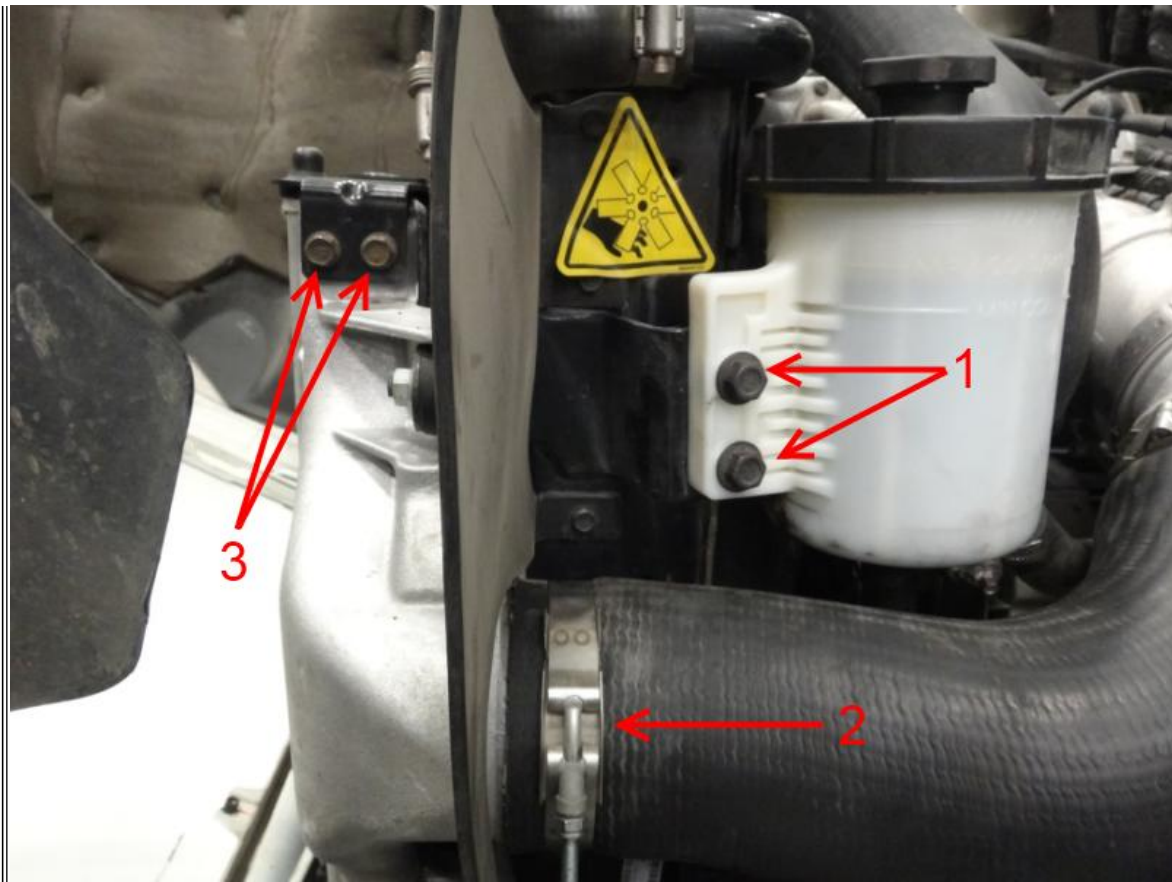
Figure 23: Driver Side HPCAC

- Item 1: Power Steering Reservoir Bolts
- Item 2: HPCAC Clamp/hose
- Item 3: A/C Bracket bolts

19. Position the power steering reservoir (**Figure 23**, Item 1) and torque the bolts to 14 lb-ft (19 N-m).
20. Install the HP CAC outlet pipe and tighten the clamp (**Figure 23**, Item).
21. Install the A/C condenser support bracket and bolts (**Figure 23**, Item 3).

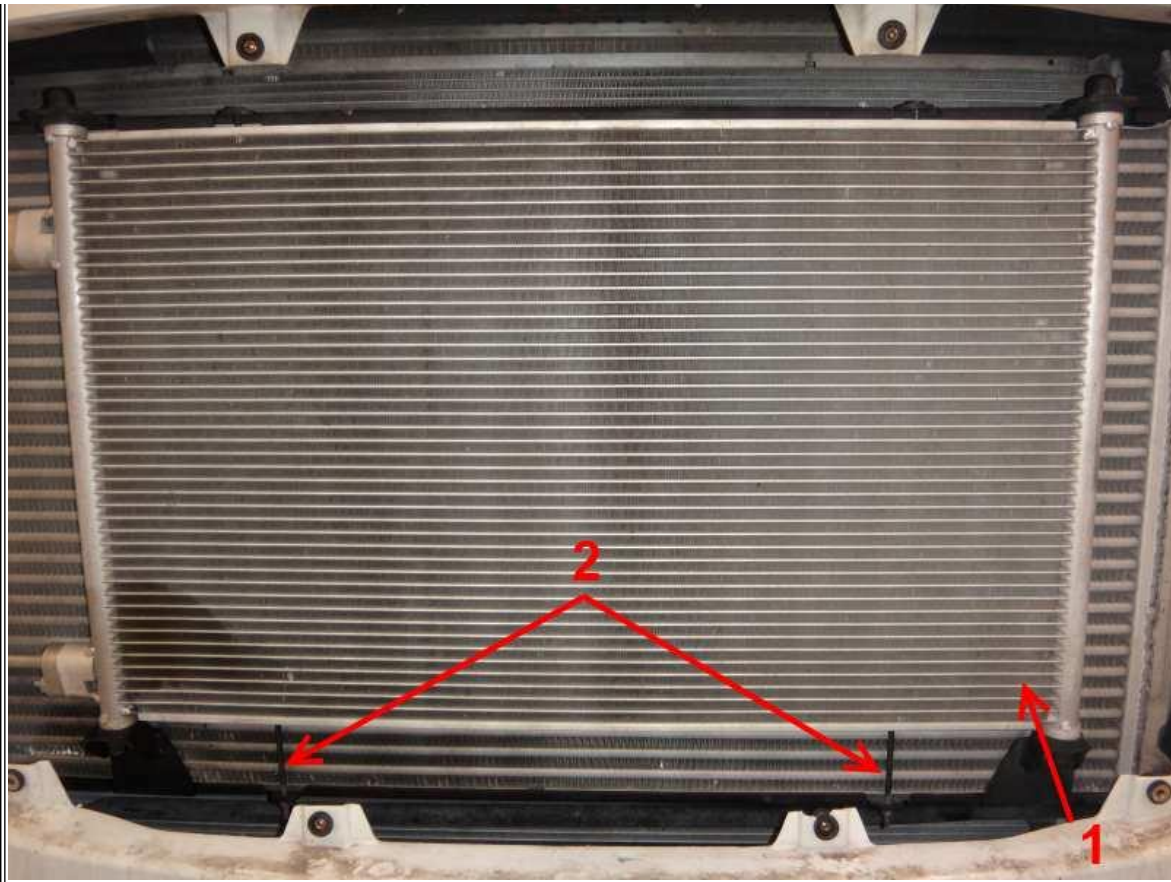
Figure 24: A/C Condenser Mounting

- Item 1: A/C Condenser
- Item 2: Condenser Stay Rods

22. Swing the A/C condenser over the engine and secure using the stay rods (**Figure 24**, Item 2)

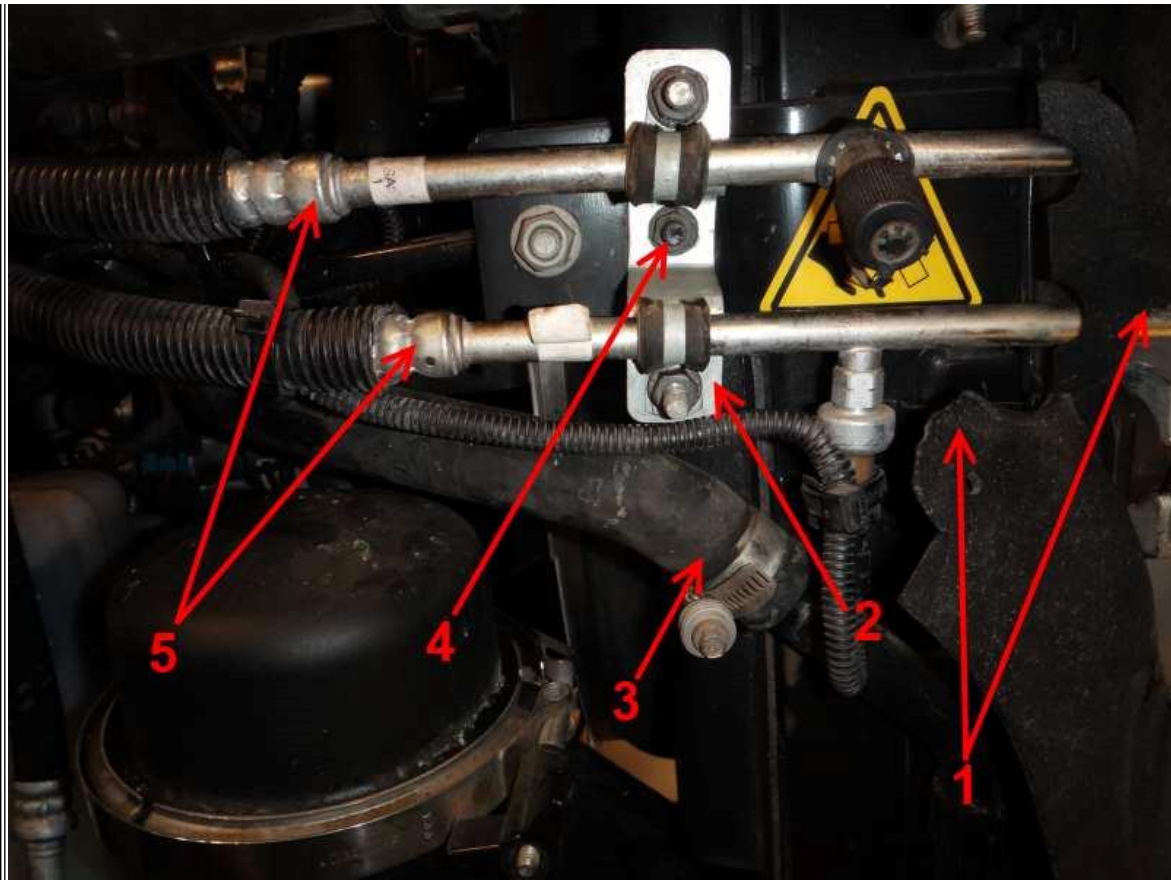
Figure 25: A/C Line Bracket

- Item 1: Recirculation Seal
- Item 2: A/C Line Bracket
- Item 3: Low Temp Radiator Hose
- Item 4: A/C Bracket Nut
- Item 5: A/C Lines

23. Attach the LTR hose and tighten the clamp (**Figure 25**, Item 3).
24. Install the A/C line bracket and torque the nut to 15 lb-ft (20 N-m) (**Figure 25**, Item 4).

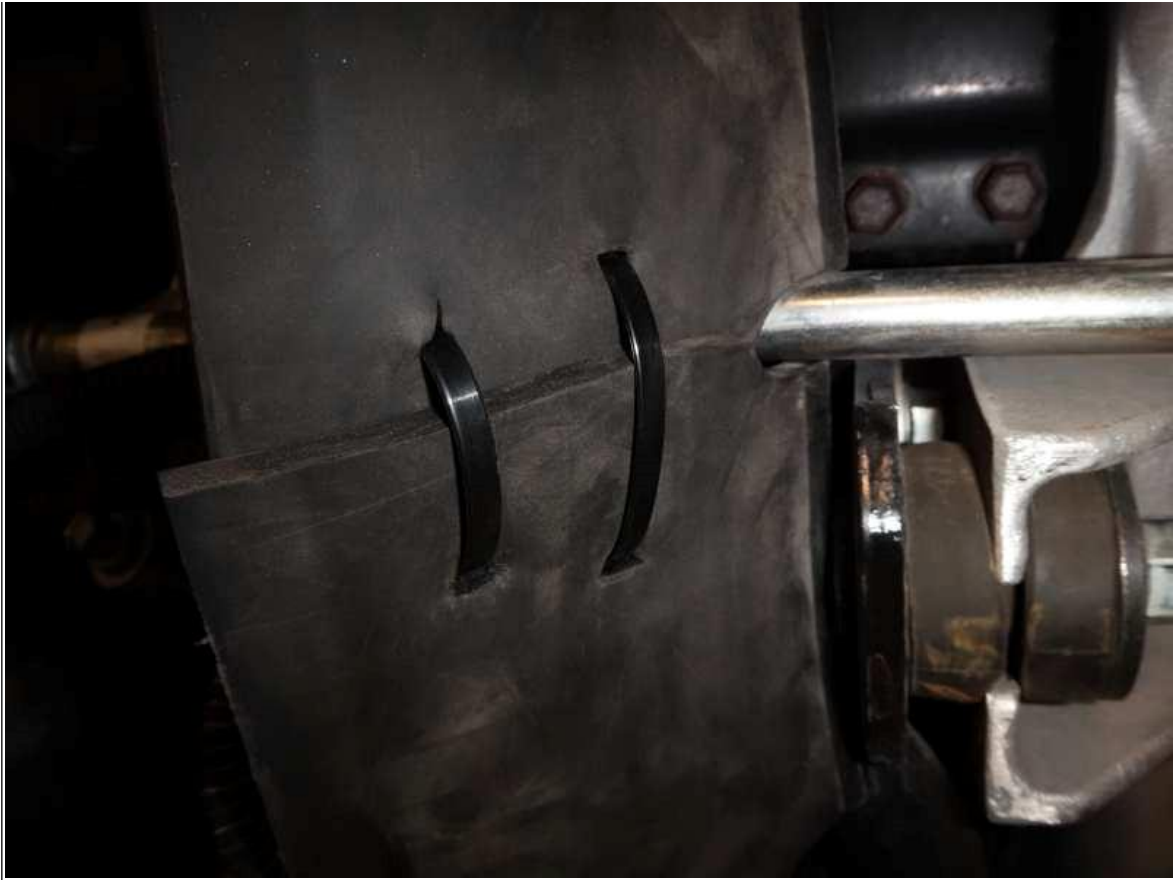
Figure 26: Recirculation Seal

25. Add holes to the recirculation seal and zip tie the halves together.

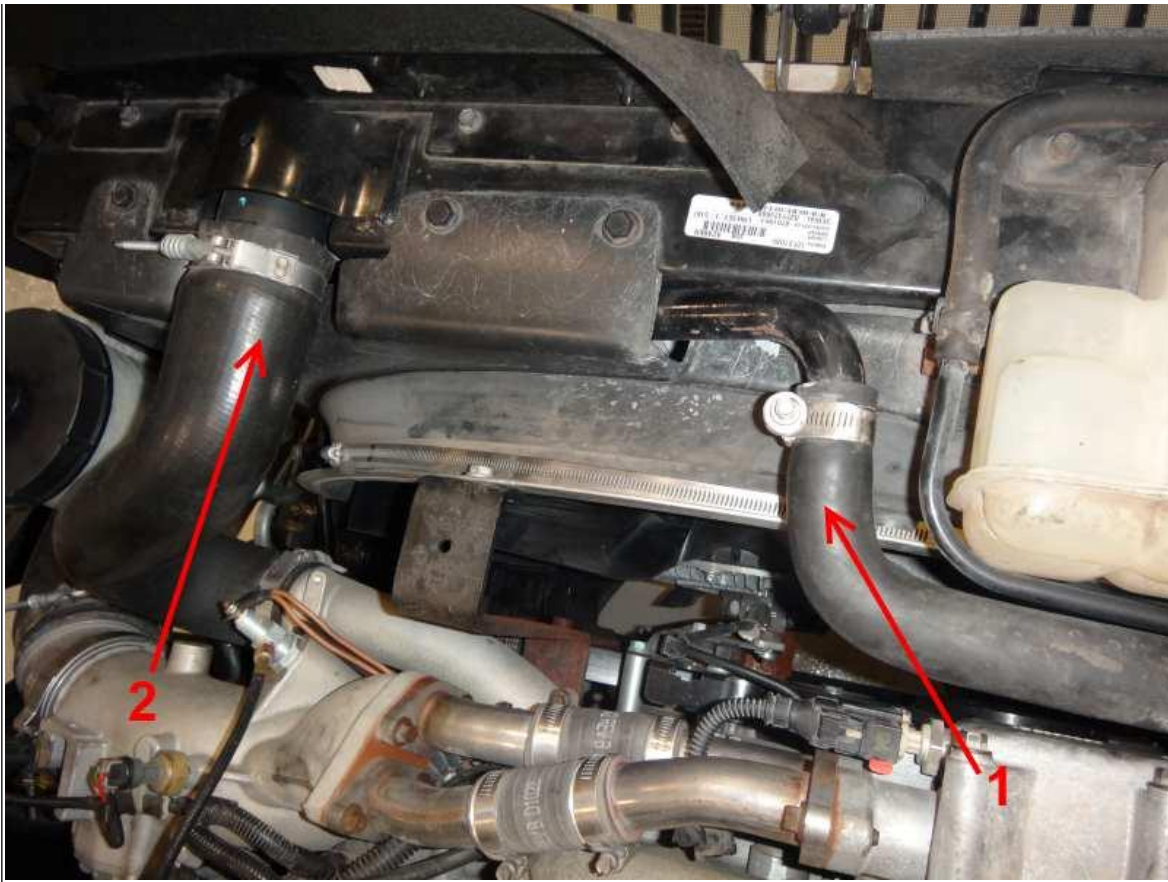
Figure 27: Radiator Hoses

- Item 1: Low Temp Radiator Hose
- Item 2: Radiator Hose

26. Attach the radiator hose and tighten the clamp (**Figure 27**, Item 2).
27. Attach the LTR hose and tighten the clamp (**Figure 27**, Item 1).

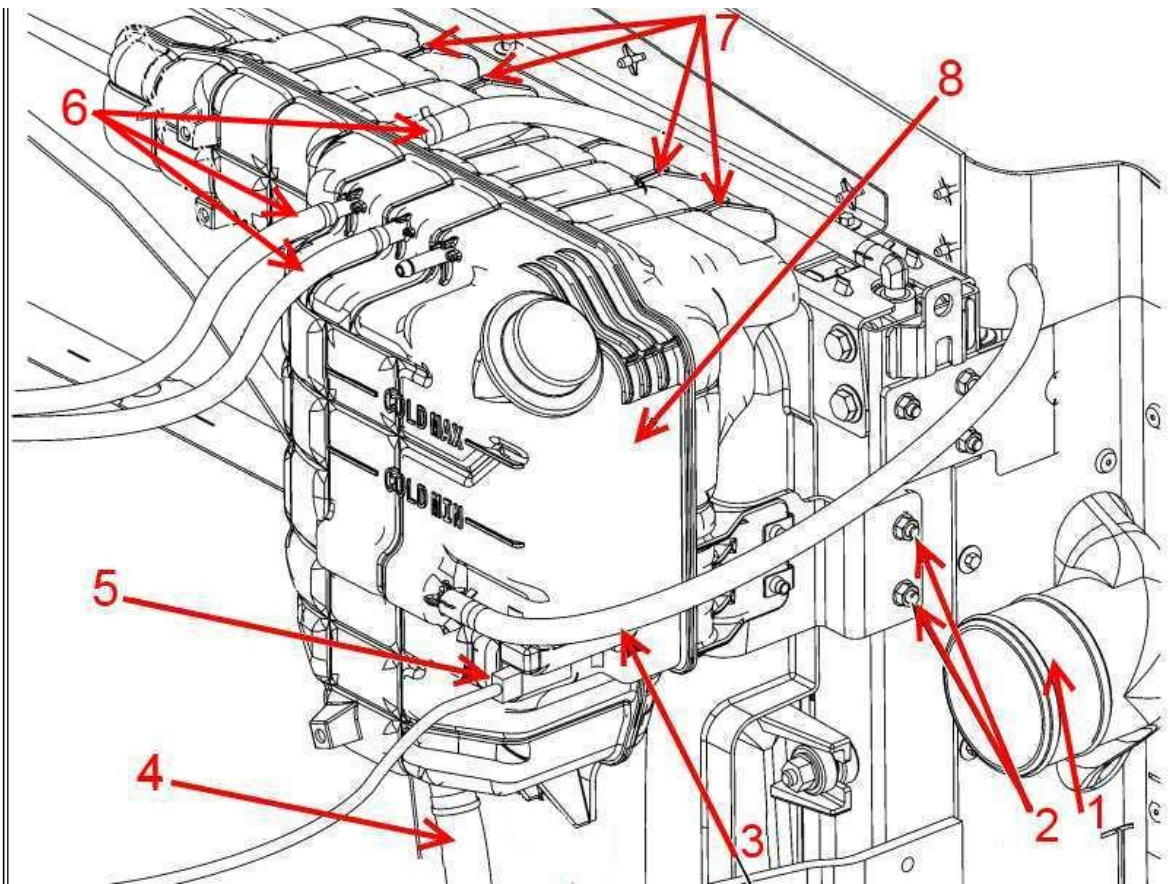
Figure 28: Deaeration Tank Assembly

- Item 1: HP CAC Inlet
- Item 2: Deaeration Tank Side Bracket
- Item 3: Radiator Deaeration Hose
- Item 4: Coolant Return Hose
- Item 5: Coolant Level Sensor
- Item 6: Engine Deaeration Hoses
- Item 7: Upper Tank Mount
- Item 8: Deaeration Tank

28. Attach the deaeration tank to the radiator. Install the four nuts to the top of the radiator (**Figure 28**, Item 7) and torque to 14 lb-ft (19 N-m).
29. Install the nuts securing the side bracket to the radiator (**Figure 28**, Item 2). Torque to 14 lb-ft (19 N-m).
30. Attach the wire harness to the coolant level sensor (**Figure 28**, Item 5).
31. Attach the coolant return line to the bottom of the deaeration tank (**Figure 28**, Item 4)
32. Attach the deaeration lines (**Figure 28**, Items 3 & 6).
33. Install the HP CAC (**Figure 28**, Item 1) and torque the clamp to 6 lb-ft (8 N-m).
34. Use the Coolant Management Tool to refill the cooling system. CONTINUE WITH STEP 33 WHILE THE COOLING SYSTEM IS FILLING.

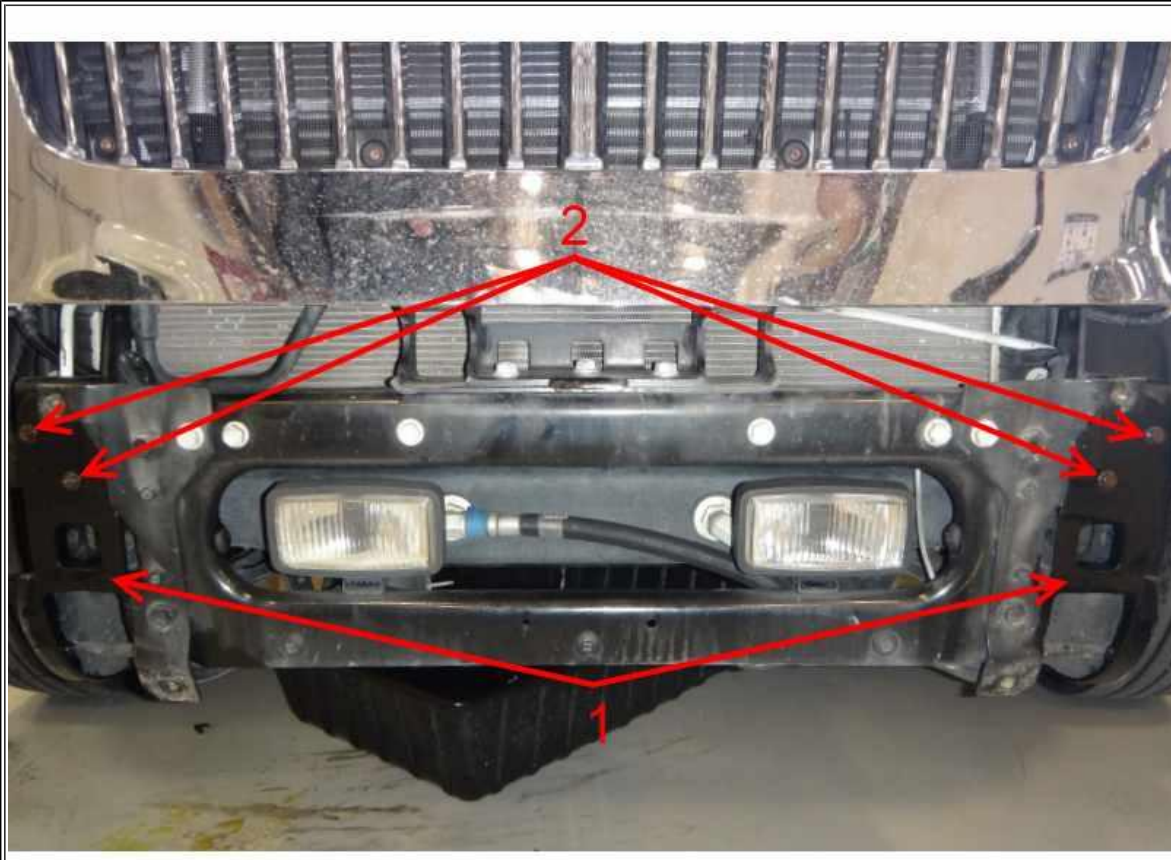
Figure 29: Torsion Bar Stop Bracket

- Item 1: Torsion Bar Brackets
- Item 2: Bracket Bolts

35. With the hood open, install the four bolts for the torsion bar stop brackets (**Figure 29**, Item 2).

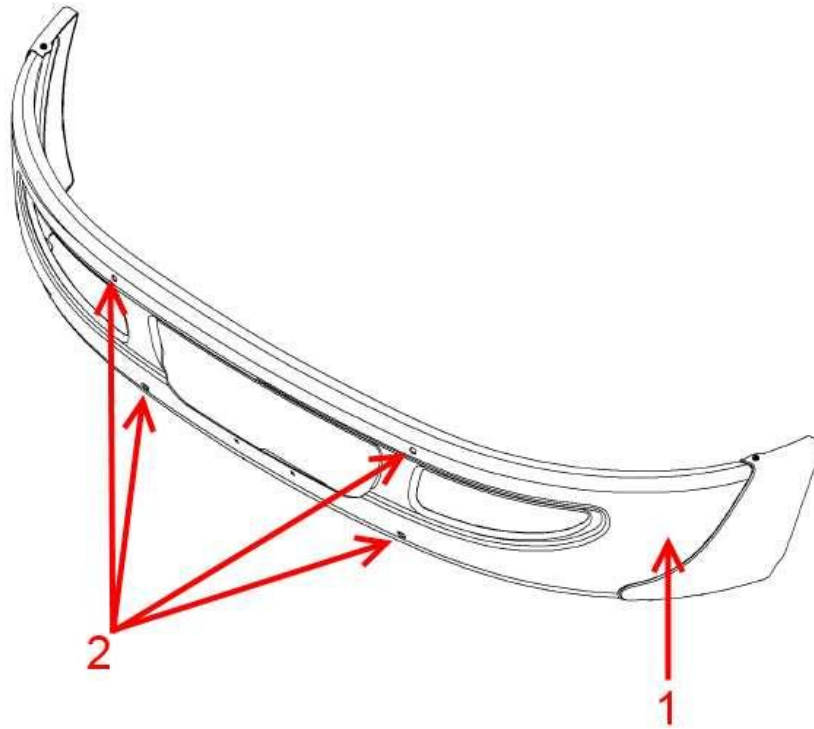
Figure 30: Front Bumper

- Item 1: Bumper Assembly
- Item 2: Mounting Bolts

36. Install the bumper and the four bolts securing the bumper to the frame (**Figure 30**, Item 2) .

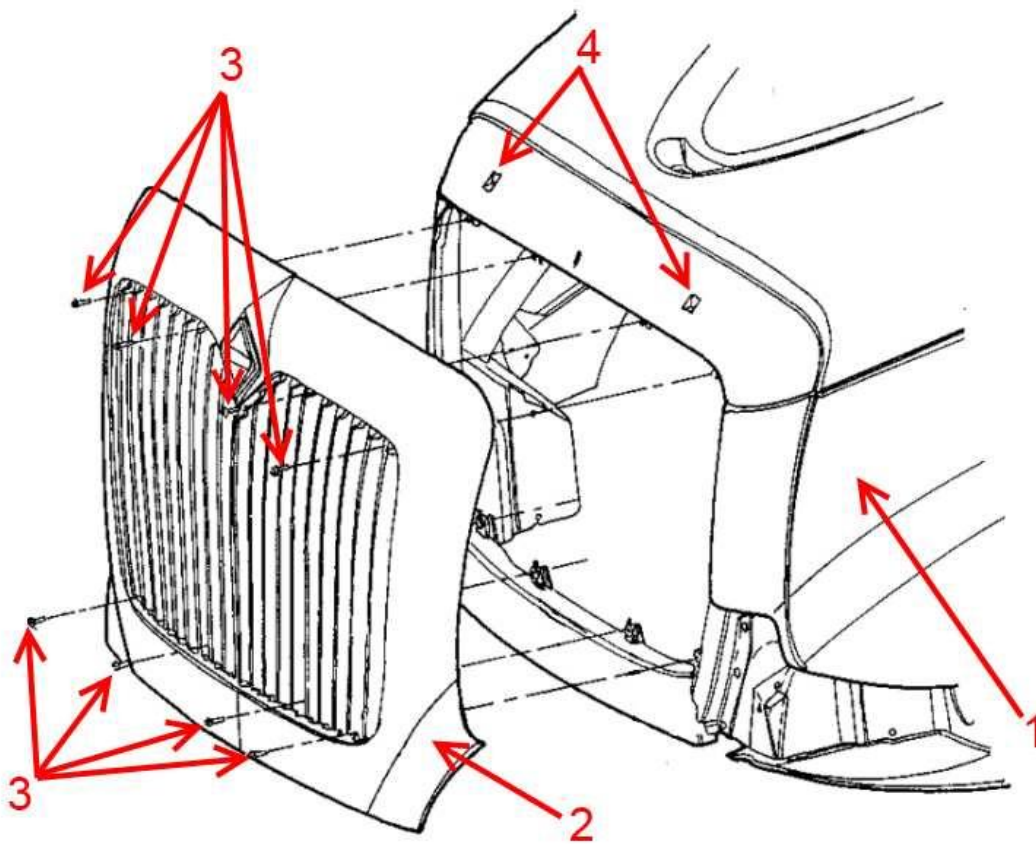
Figure 31: Front Grille Assembly

Item 1: Hood
 Item 2: Grille
 Item 3: Mounting Screws
 Item 4: Push Tab Slot

37. Install the front grille

- h. Press the grille down firmly against the hood. Apply approximately 20 pounds of force along the grille area above the tape.
- i. Secure using the eight grille mounting screws (**Figure 31**, Item 3).
