Special Bulletin

SP15-302

KNEELING ALARM REPLACEMENT Prevost vehicles

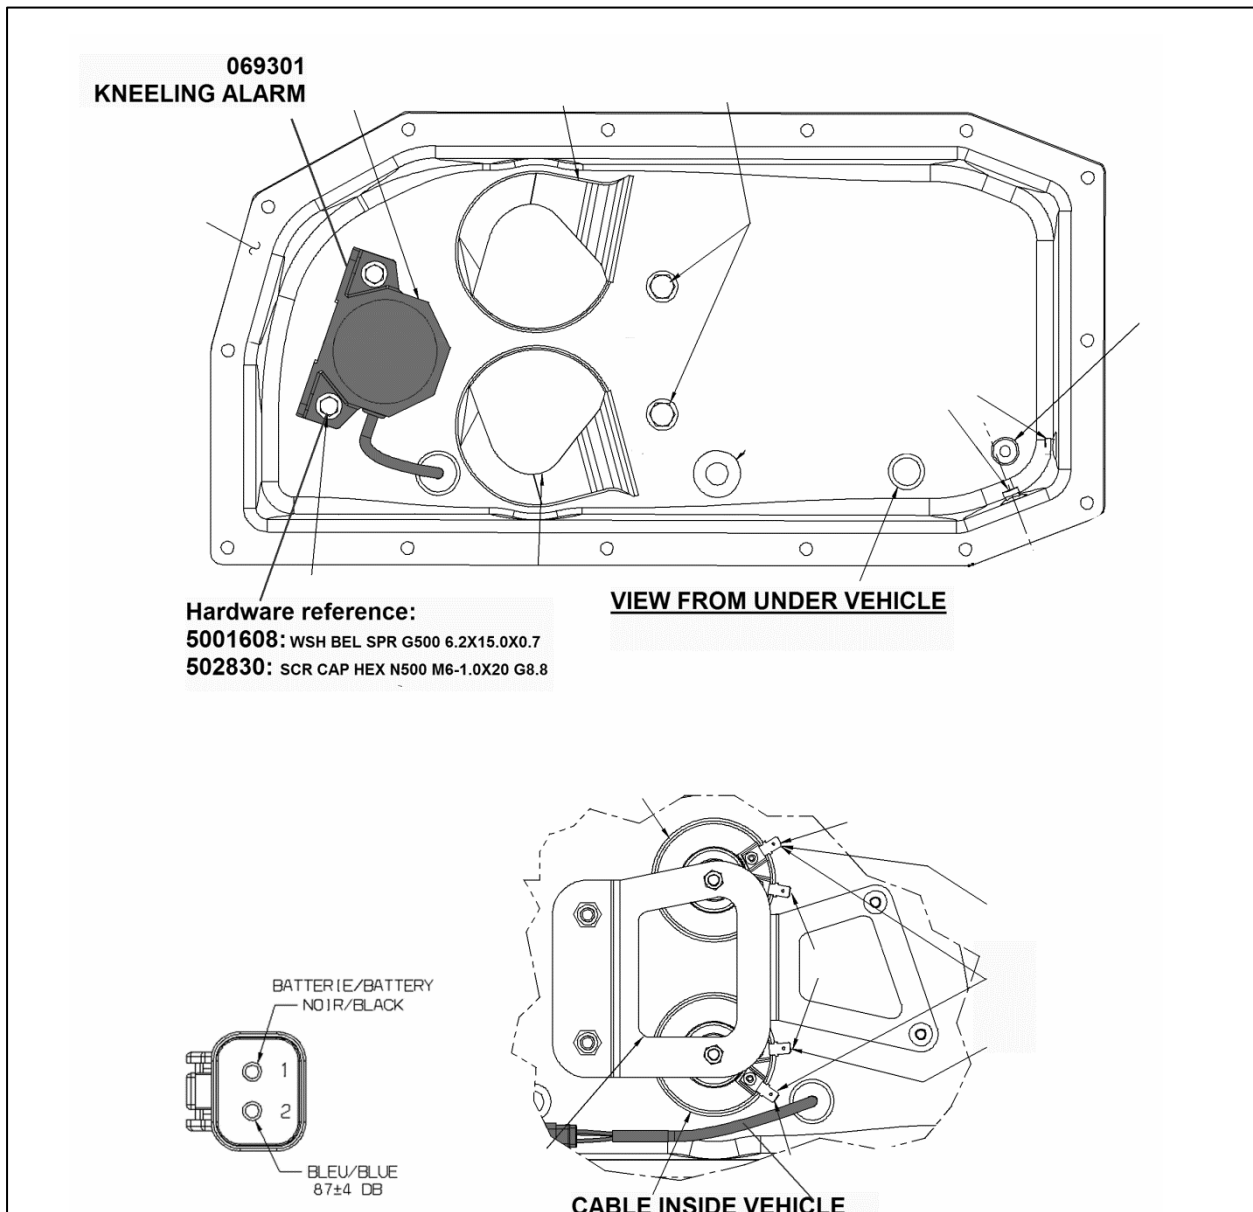
Figure 1

- 1) Lift vehicle with column lifts.
- 2) Locate the horn housing recessed in the under floor, curb side, under the entrance staircase.
- 3) Replace the kneeling alarm by 069301 (fig. 1). Pass wiring thru floor to inside of vehicle and reconnect. New connection is Blue –Black.
