## Service Information Bulletin

| SUBJECT | DATE |
|---|---|
| Symptom Diagnosis - Oil Leaks | September 2015 |

## 2 Potential Oil Leak Points - Symptoms

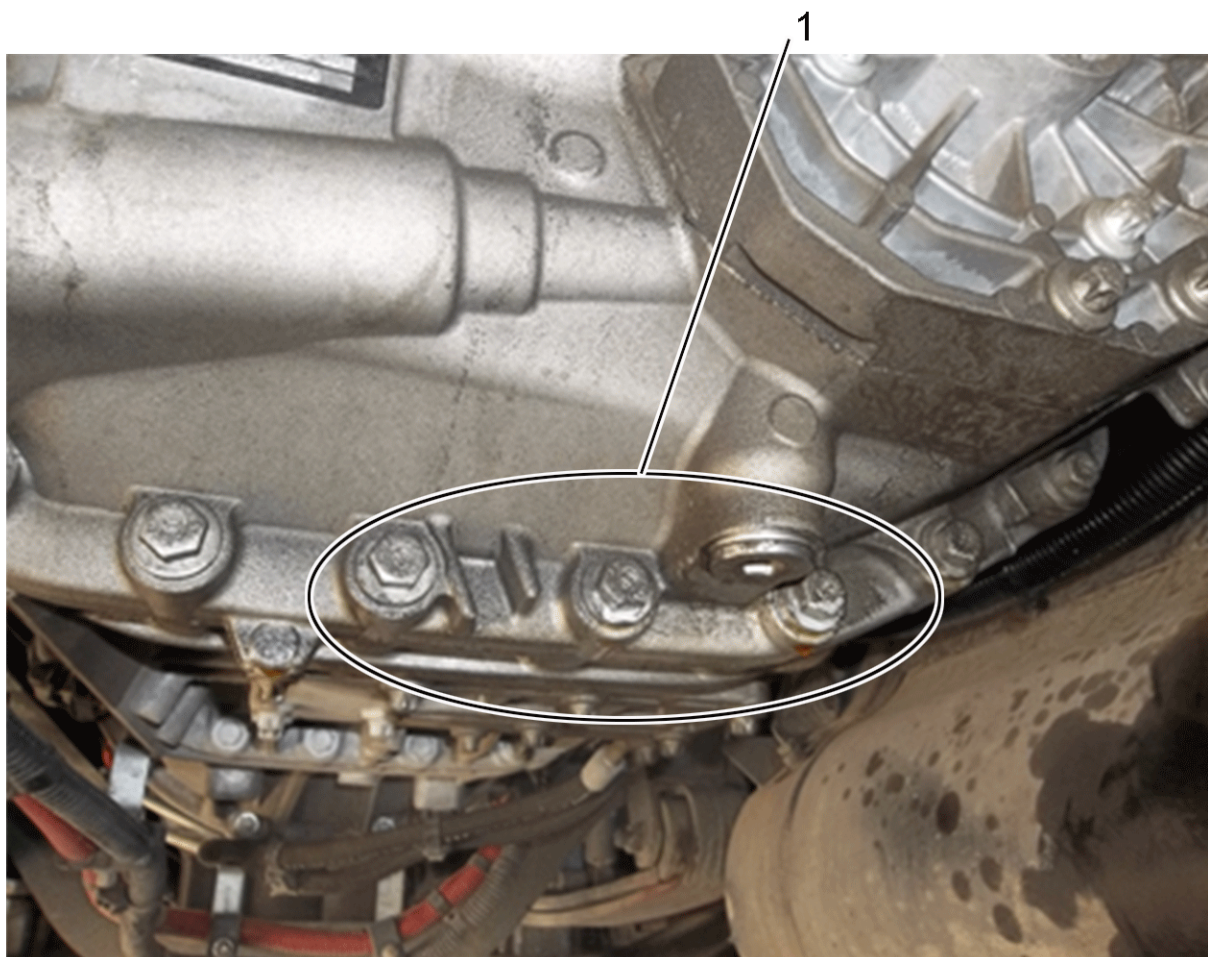
d260073

The breather vent is the most common leak area. Fluid is generally found on the lower rear case (1). See Figure 1. The breather area **MUST** be inspected as a possible leak source; see figures 2 and 3. If the leak is located at the vent, install a breather hose. Refer to section "Oil Vent Breather."

**Figure 1. Fluid Collects at this Location**

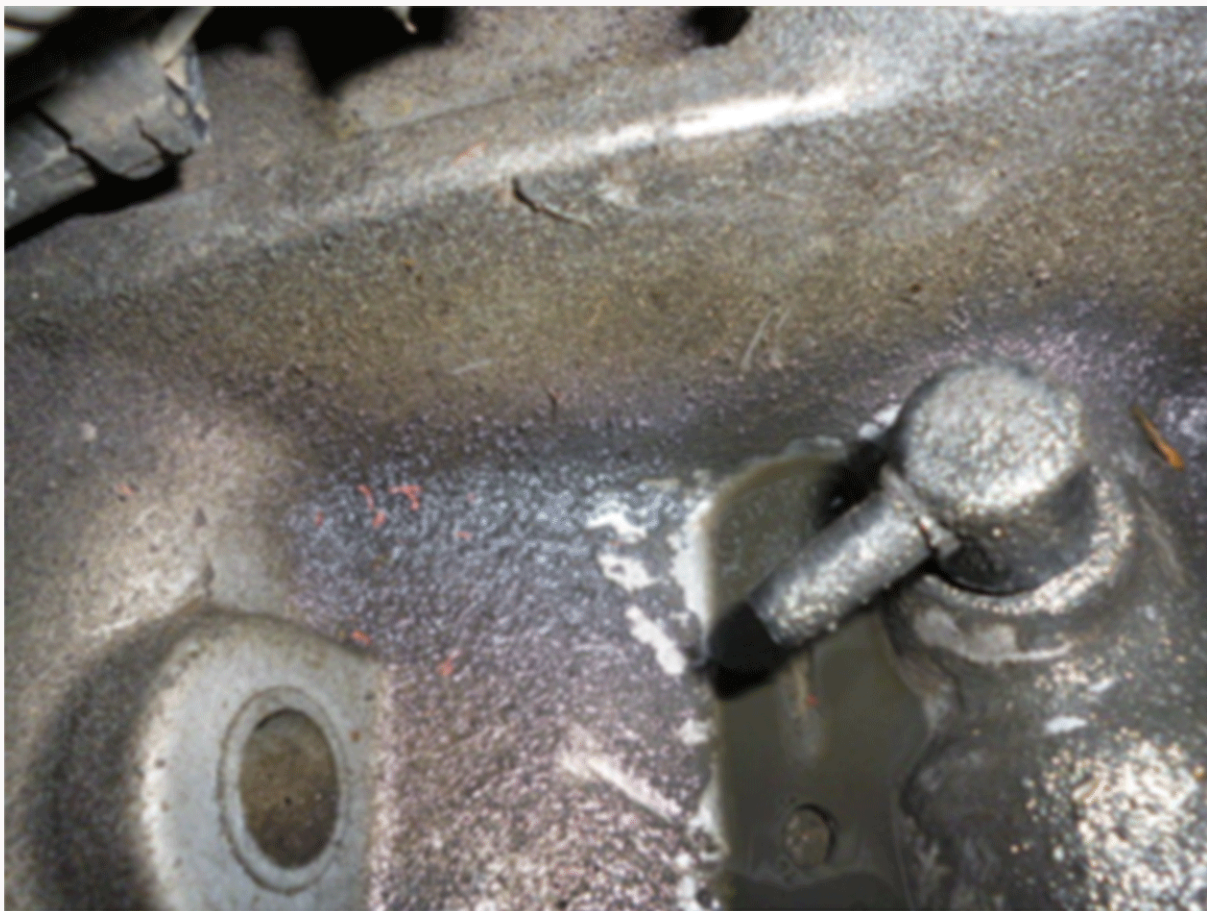
d260074

**Figure 2. Breather Vent Location**

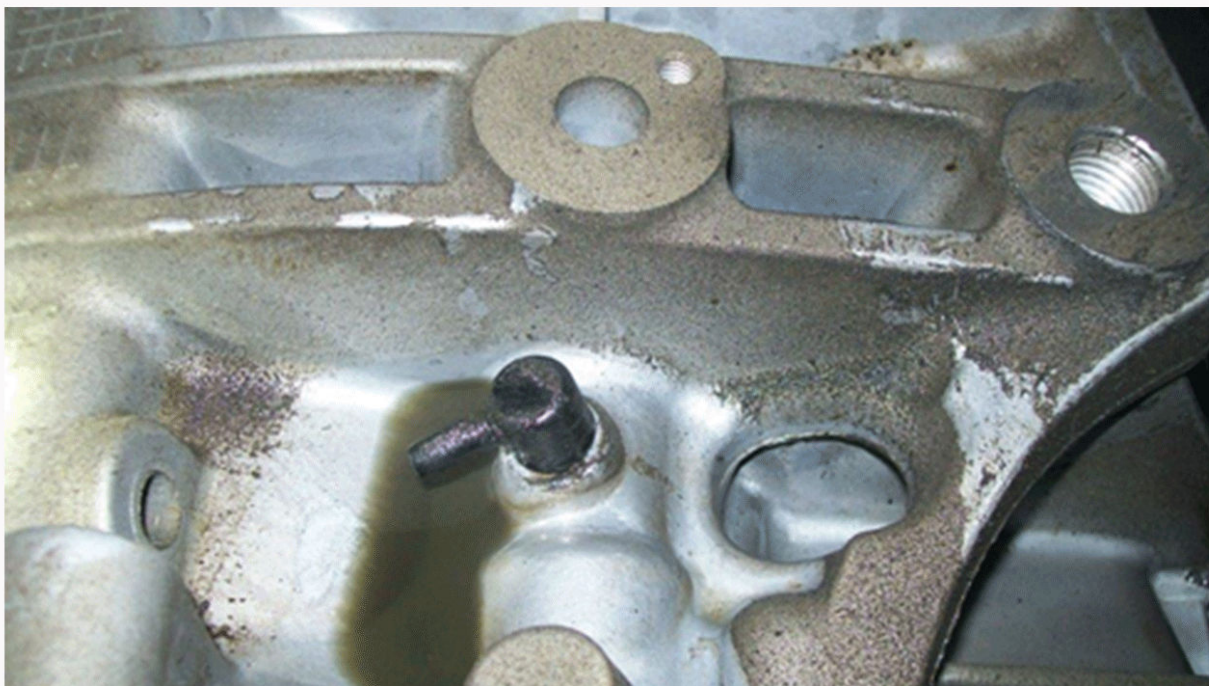
d260075

**Figure 3. Breather Vent Location**

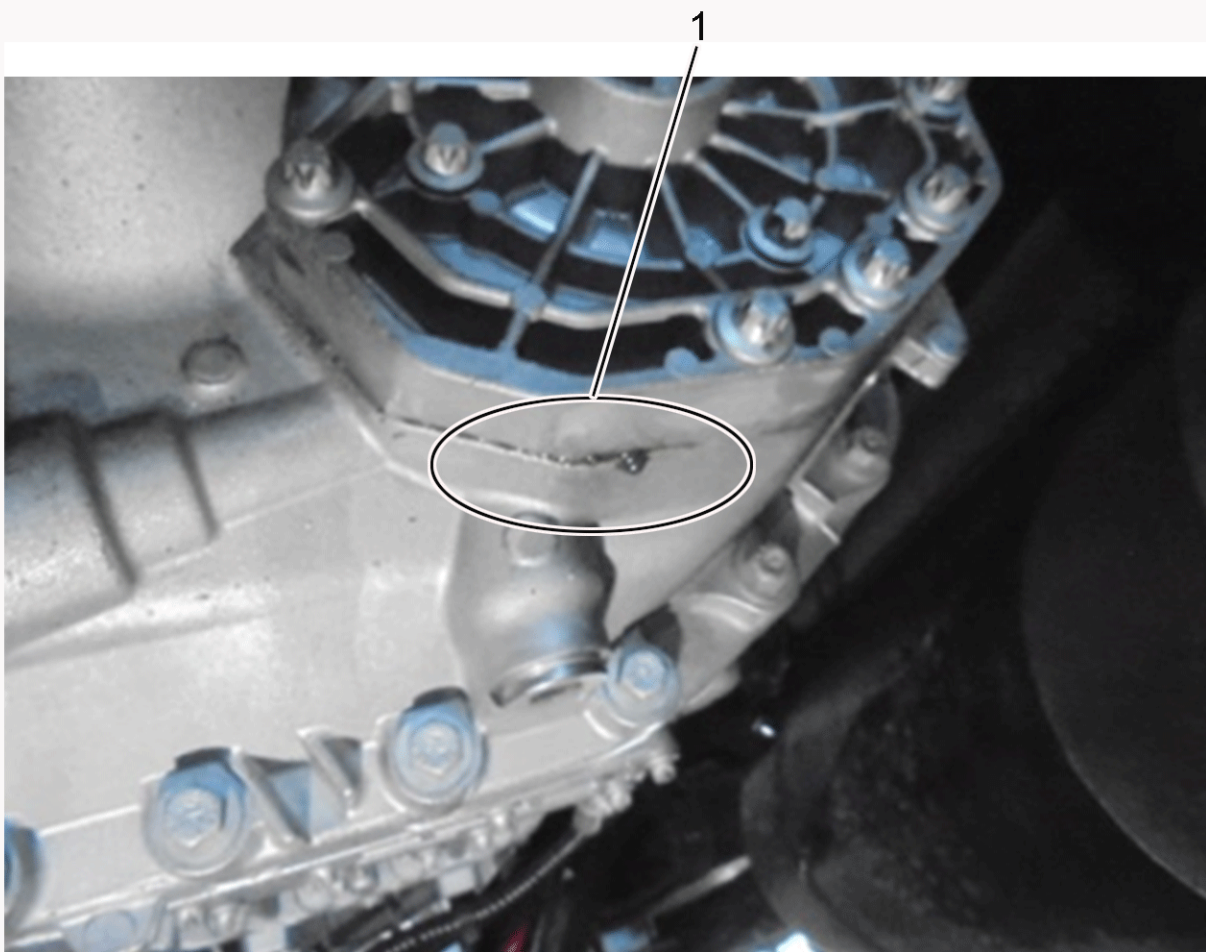
d260076

#### **Figure 4. Oil Pump Cover**

Always check the breather area first, as fluid may be migrating down from the top of the transmission. Clean the area of the suspected leak, road test vehicle, and, if the leak persists, reseal oil pump cover (1); see Figure 4. Refer to section "Oil Pump Cover".

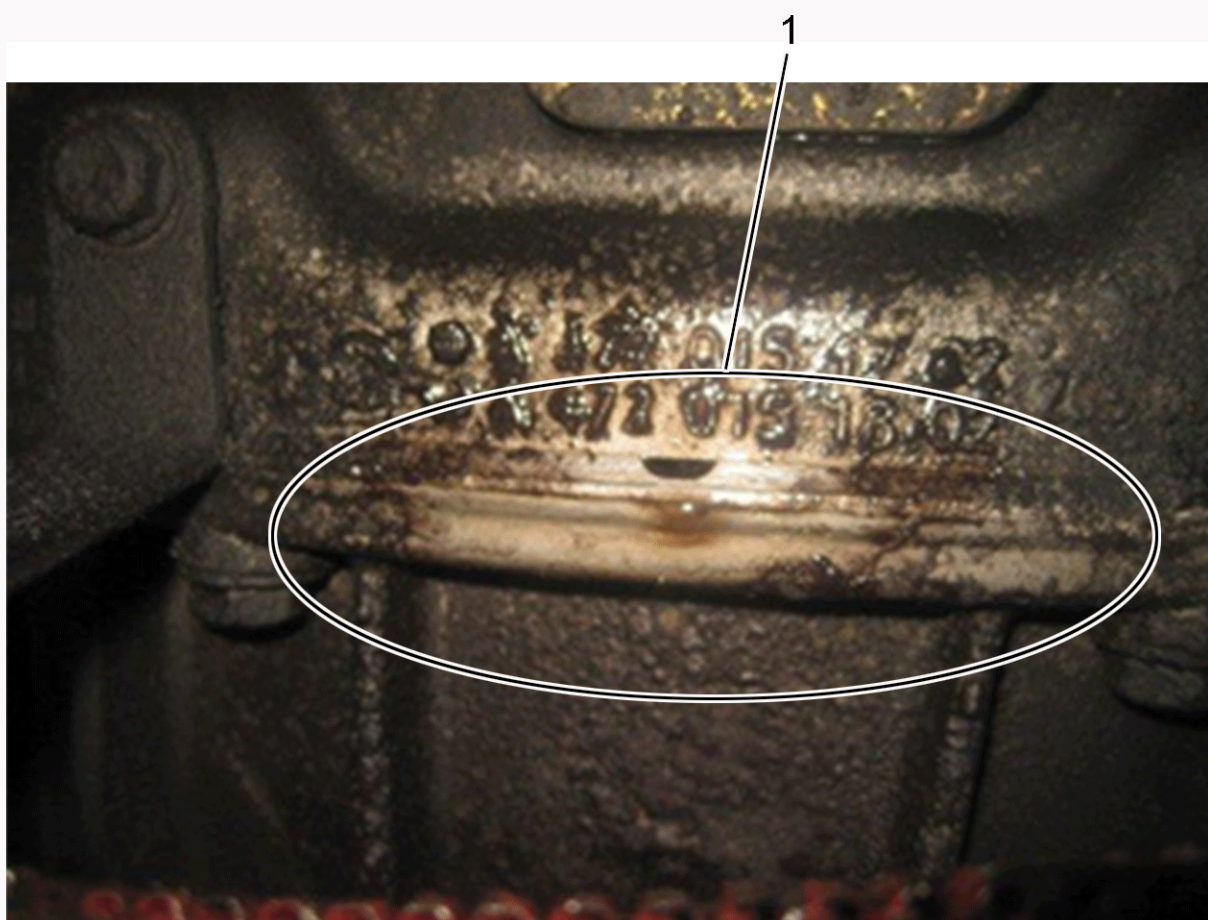
d260077

Oil may leak from the bell housing vent hole (1); see Figure 5. However, the actual cause of the leak may be the rear main seal (1); see Figure 6. Refer to section "Crankshaft Oil Seals".

Figure 5. Bell Housing Vent Hole

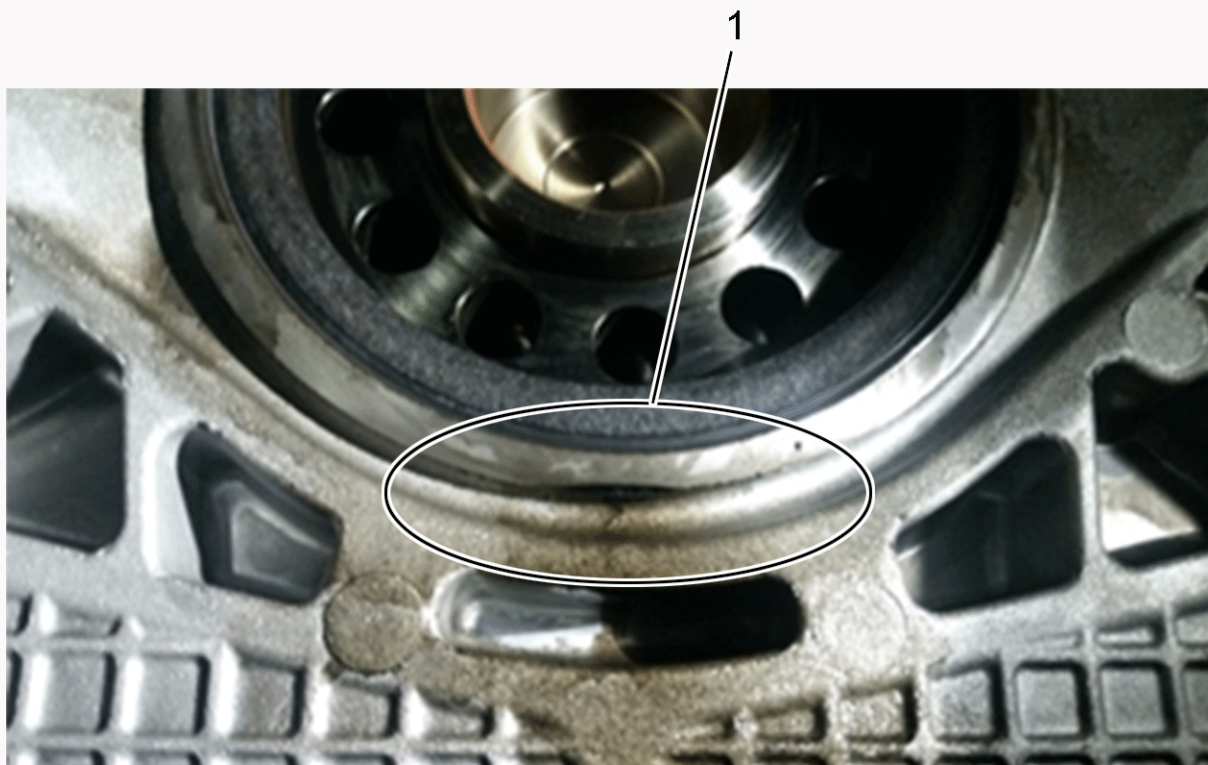
d260078

**Figure 6. Rear Main Seal****Counter Shaft Brake Housing Seals**

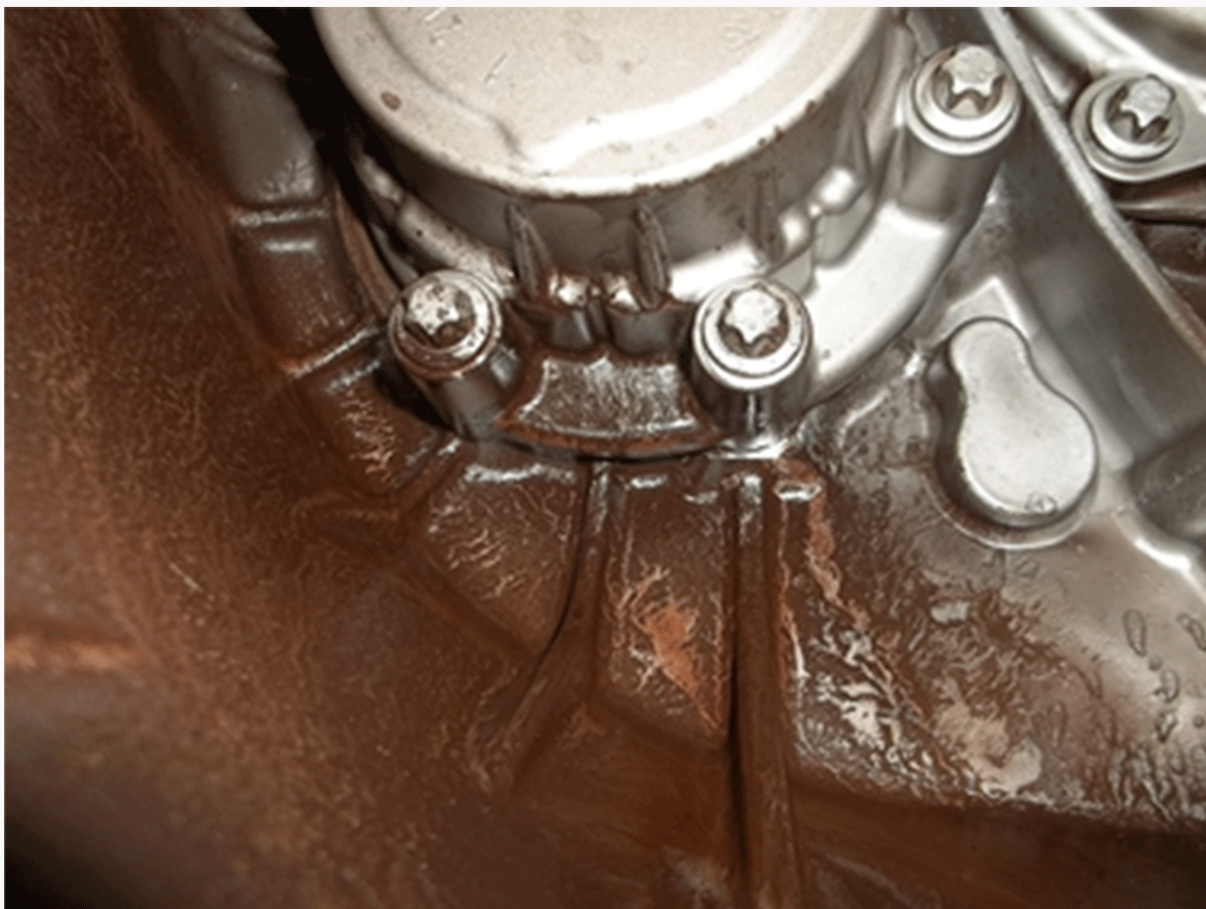
d260079

Oil may leak near the counter shaft brake housing seals; see Figure 7. Oil may also leak from the input shaft seal (1); see Figure 8 and 9. Refer to section "Input Shaft Seal."

**Figure 7. Counter Shaft Brake Housing Seal**

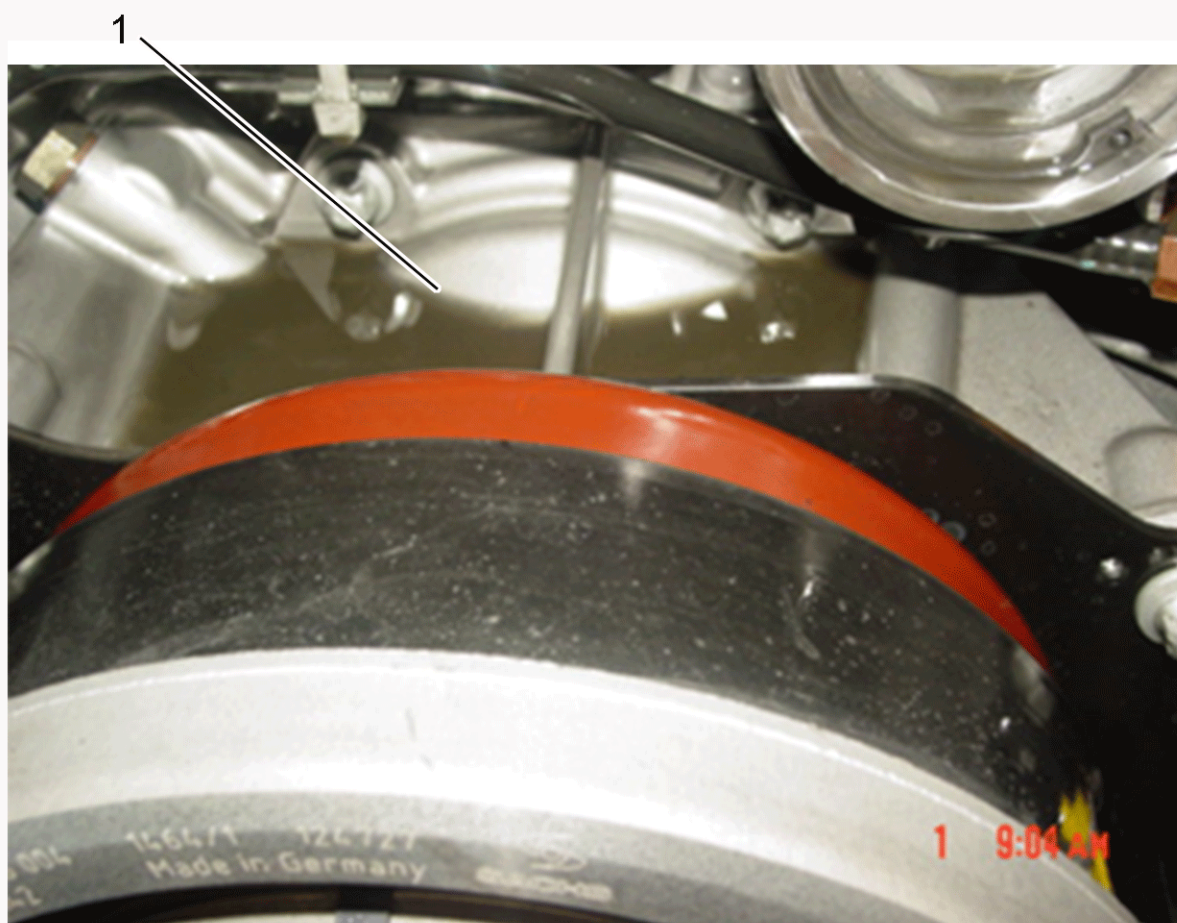
d260080

**Figure 8. Input Shaft Seal Leak Area**

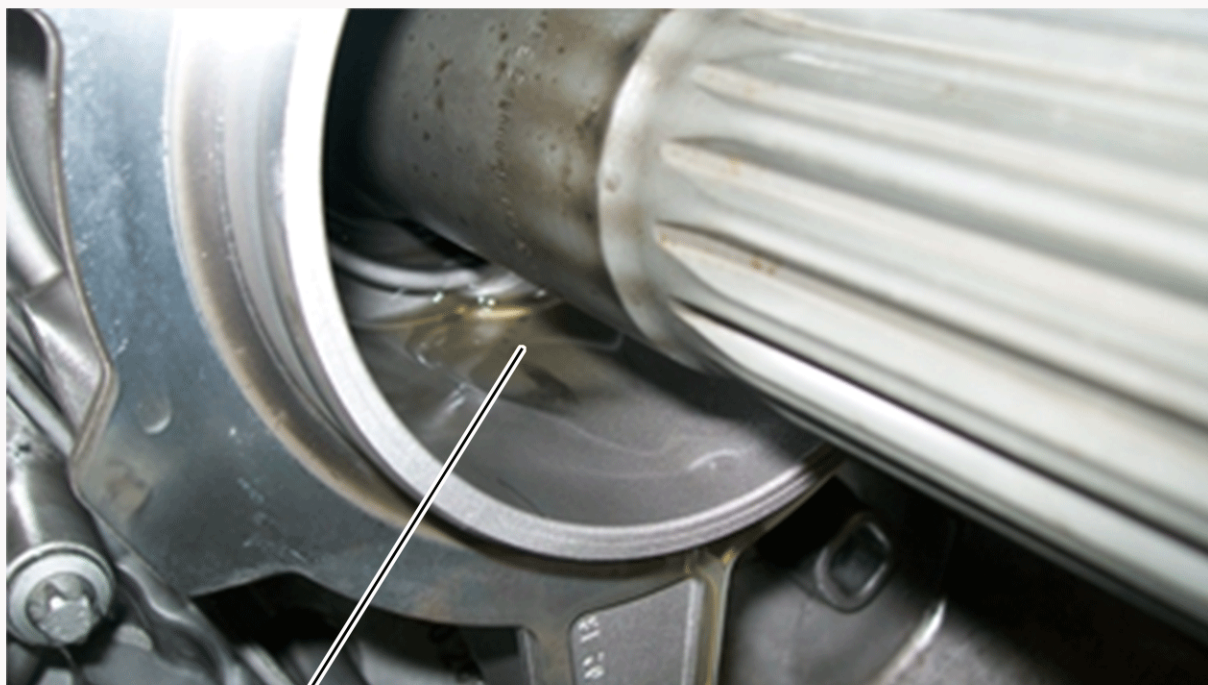
d260081

### **Figure 9. Input Shaft**

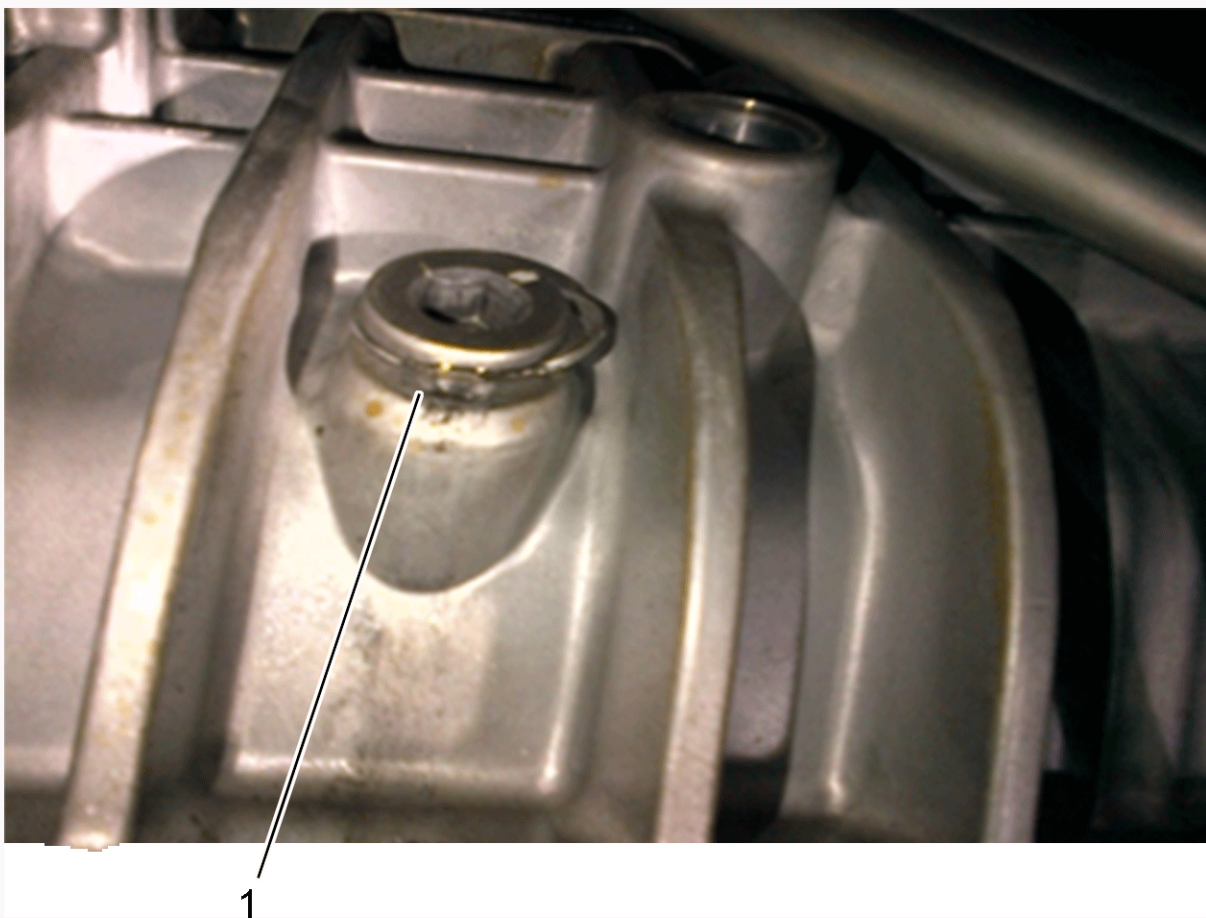
d260082

An oil fill plug that has been cross-threaded will leak (1); see Figure 10.

**Figure 10. Cross-threaded Oil Fill Plug**

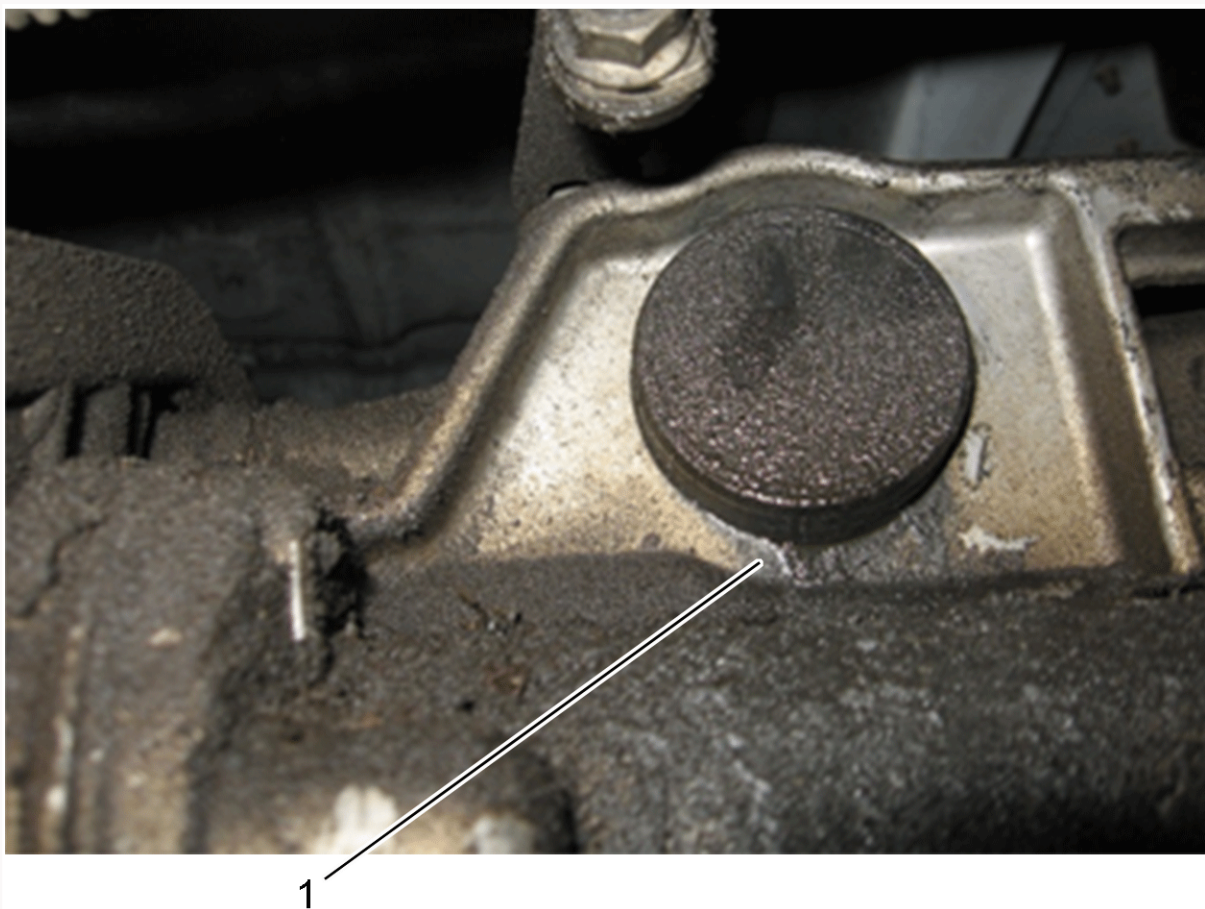
d260083

Fluid may be found on front lower section of the transmission. Inspect for a leaking rail cap (1); see Figure 11. The rail cap may be missing (1); see Figure 12.

**Figure 11. Leaking Rail Cap**

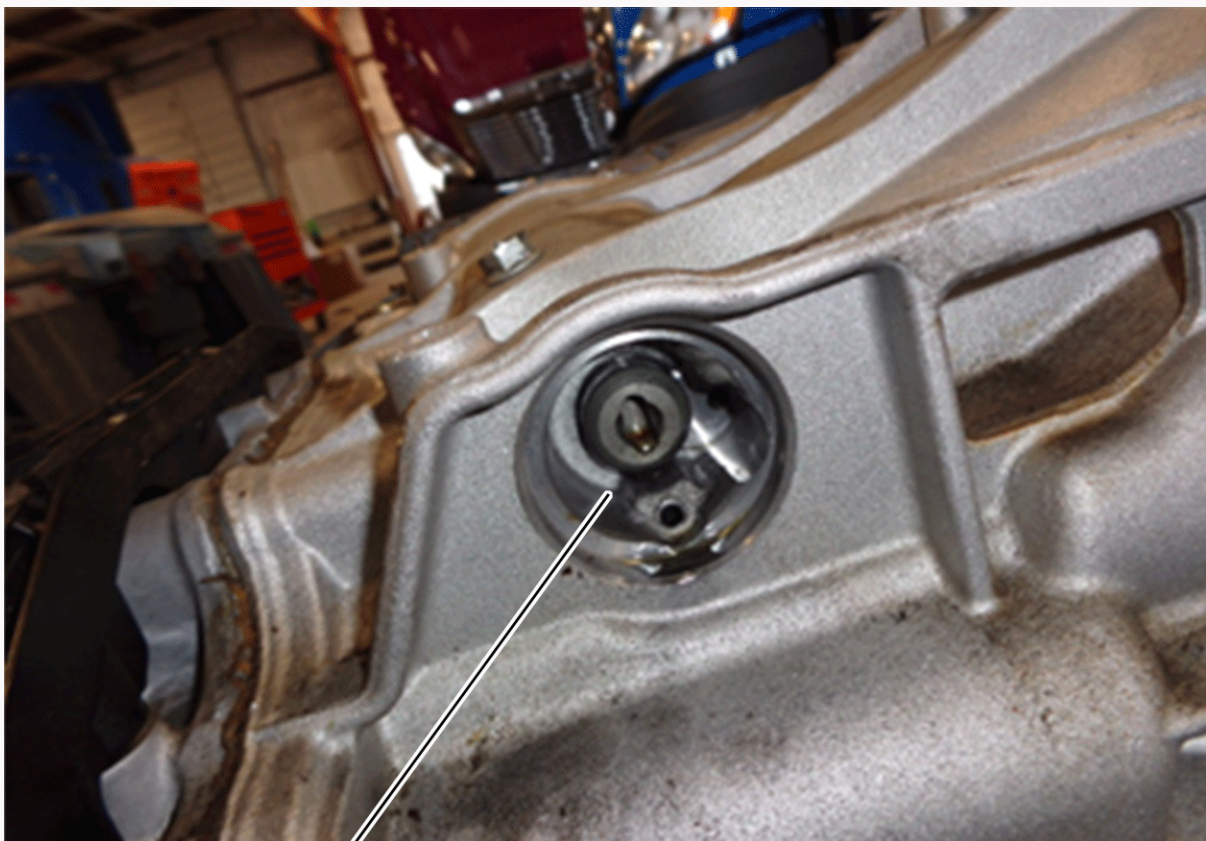
d260084

**Figure 12. Missing Rail Cap**
