Service Bulletin

Subject: Paint Chipping on Front Lower Bed Corners

Models: 2014 Chevrolet Silverado 1500
2015 Chevrolet Silverado
2014 GMC Sierra 1500
2015 GMC Sierra

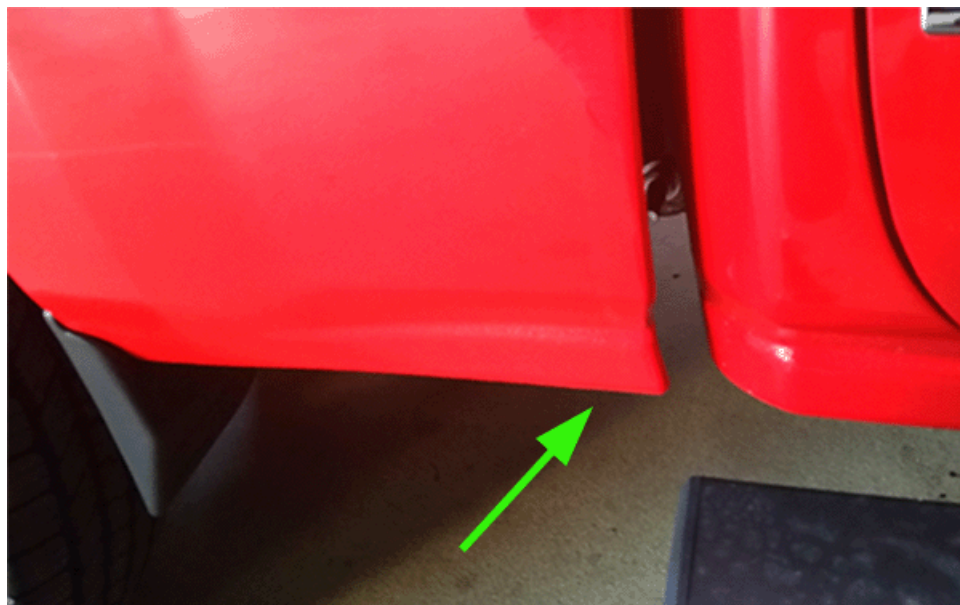
Some customers may comment about excessive paint chipping on the front lower bed corners of their trucks, as shown below. Many of these trucks spend a majority of their time on dirt roads or gravel roads

To better protect this area, a bed corner shield has been developed to protect this area. The shield is held on with double back tape. To Install the Bed Corner protector follow the below procedure
