# VW Elsa Newsletter

Edition 133: April 27, 2015

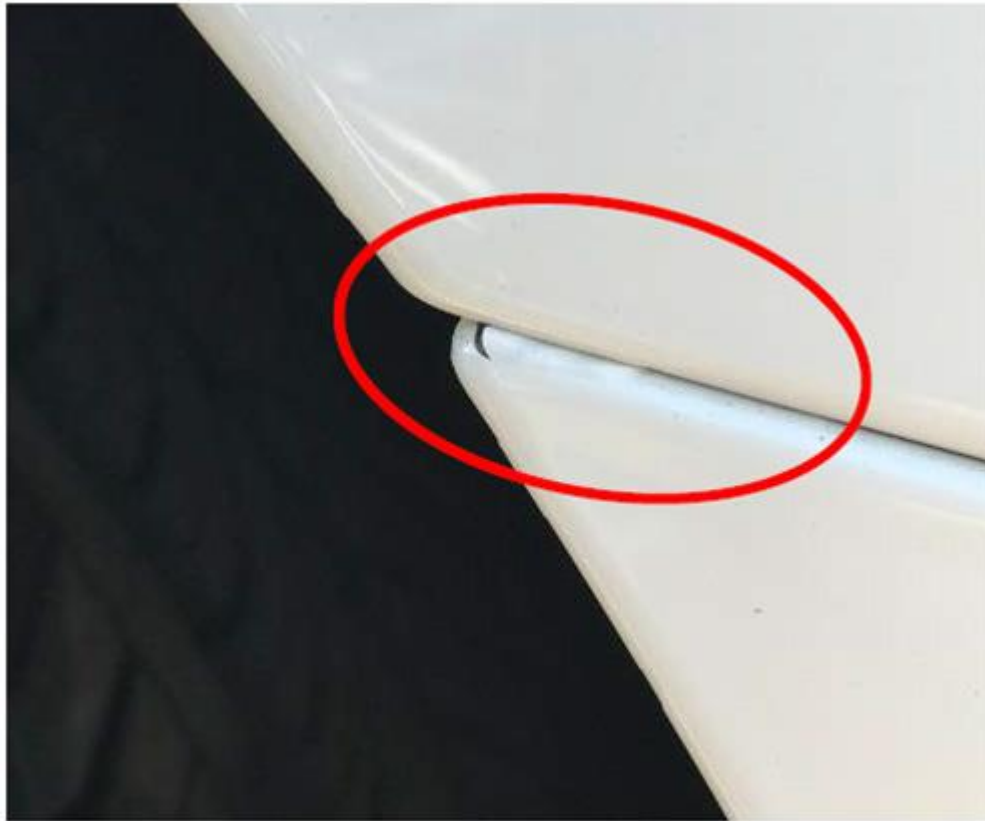
There have been cases identified where the paint is chipping/peeling on the rear bumper cover (see picture below). This issue was caused by process deviations at the supplier.

*Passat rear bumper cover – affected area*
