# UPDATE Technical Bulletin

## 91M4 UPDATE - Navigation SD Card

Model(s)	Year	Engine Code	Trans. Code
Golf/GTI	2015	All	All

This update has been proactively released due to incorrect SD Card provided during vehicle production.

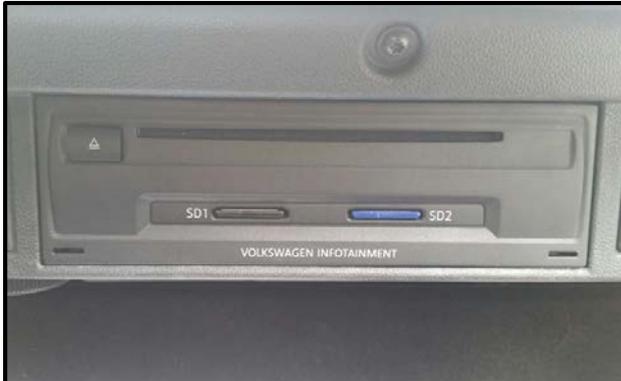
- Open the glove compartment.
- Identify the location of the Navigation SD card (SD1 or SD2).
- DO NOT remove the SD card at this time.

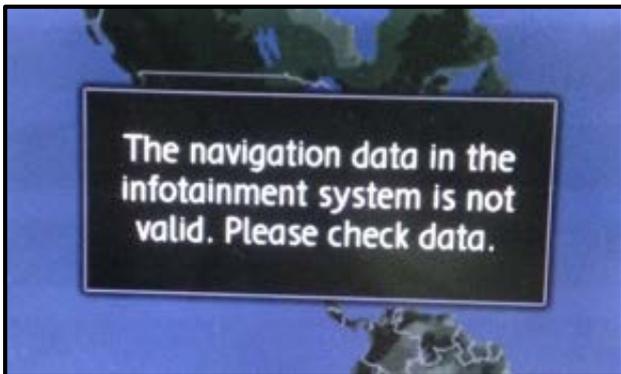
- Switch the radio ON.
- Press the “NAV” button.
- Verify the error message “The navigation data in the infotainment system is not valid. Please check data.” is displayed on the screen.

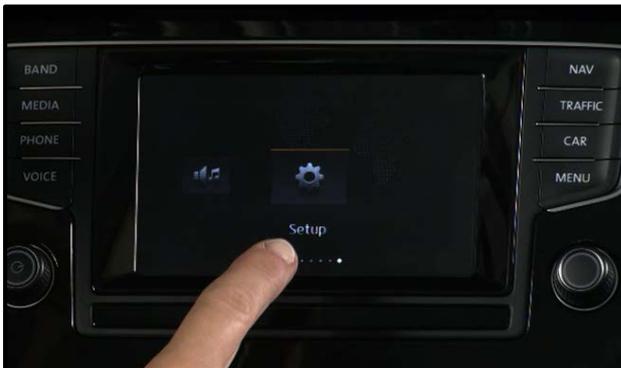
- Press the “Menu” button.
- Select “Setup” <as shown>.

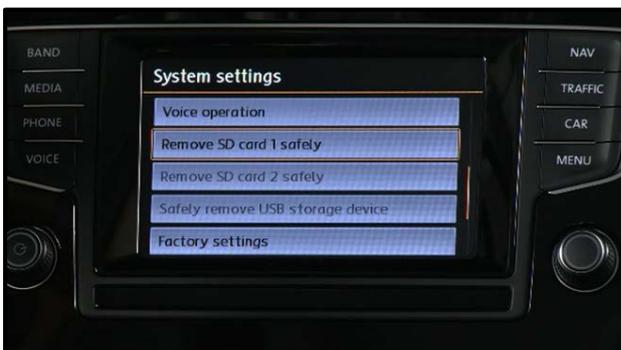
- Select the appropriate option to “Remove SD card safely”.
- Install the replacement SD card, P/N: 5G0919866H.
- Close the glove compartment.

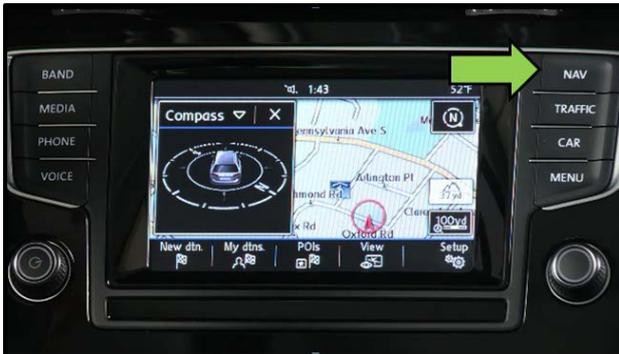
- Press the “Nav” button.
- Verify the map is displayed correctly and no error message is present.
