# Service Action

## Code: 19L2

<b>Subject</b>	<b>Coolant Pump</b>
<b>Release Date</b>	August 06, 2015
<b>Revision Summary</b>	<b>Additional parts and steps added to the work procedure.</b>
<b>Affected Vehicles</b>	<b>U.S.A. : 2010-2013 Audi A3</b> <b>CANADA: 2012-2013 Audi A3</b>  <i>Check Campaigns/Actions screen in Elsa on the day of repair to verify that a VIN qualifies for repair under this action. Elsa is the <u>only</u> valid campaign inquiry &amp; verification source.</i> <ul style="list-style-type: none"><li>✓ Campaign status must show "open."</li><li>✓ If Elsa shows other open action(s), inform your customer so that the work can also be completed at the same time the vehicle is in the workshop for this campaign.</li></ul>
<b>Problem Description</b>	The coolant pump may develop a small leak over time.
<b>Corrective Action</b>	Inspect and, if necessary, replace the coolant pump.
<b>Parts Information</b>	Parts will be allocated prior to owner notification. If allocated parts have been used and your dealership is at the weekly Upper Order Limit, submit requests for additional parts via email to <a href="mailto:upperorderlimits@vw.com">upperorderlimits@vw.com</a> .

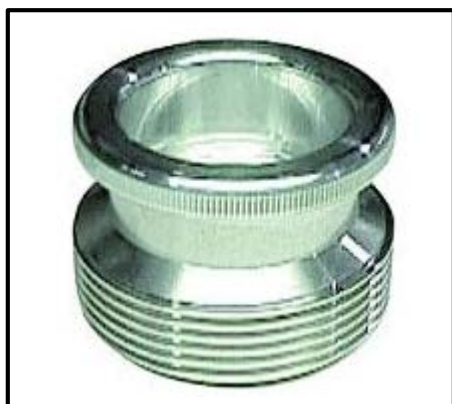
- Cooling System Tester - Adapter-VAG1274/8

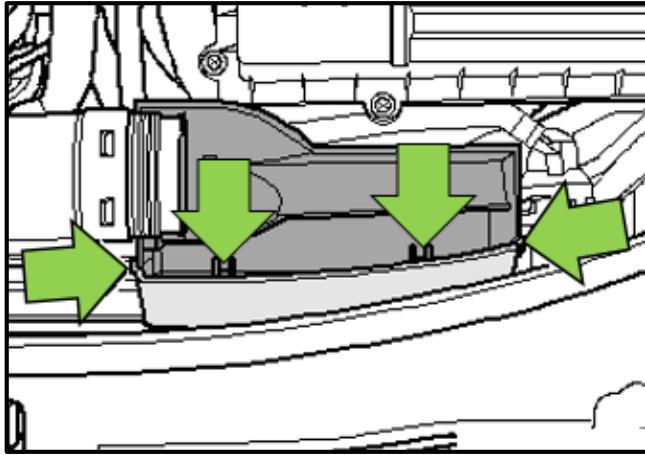
- Disengage the wire retainers <arrows> to unfasten the lower air duct.
- Remove the lower air guide and lower air guide hose.

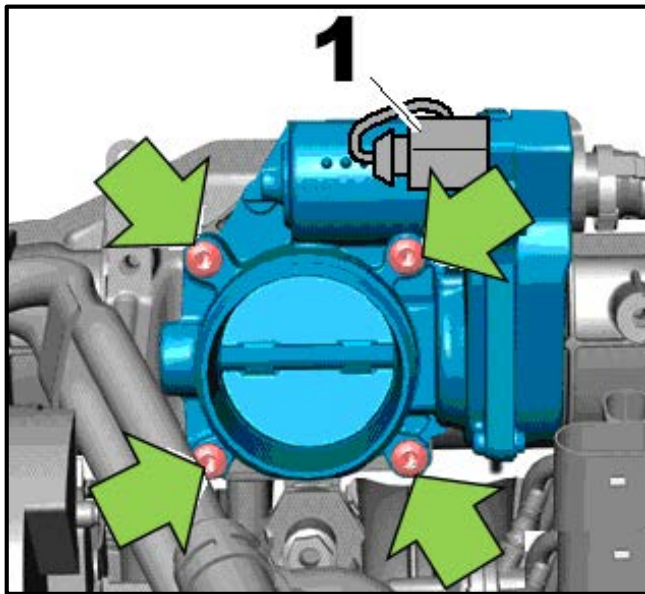
- Disconnect the connector <1> at the Throttle Valve Control Motor (J338).
- Remove the J338 mounting bolts <arrows> and remove the J338.

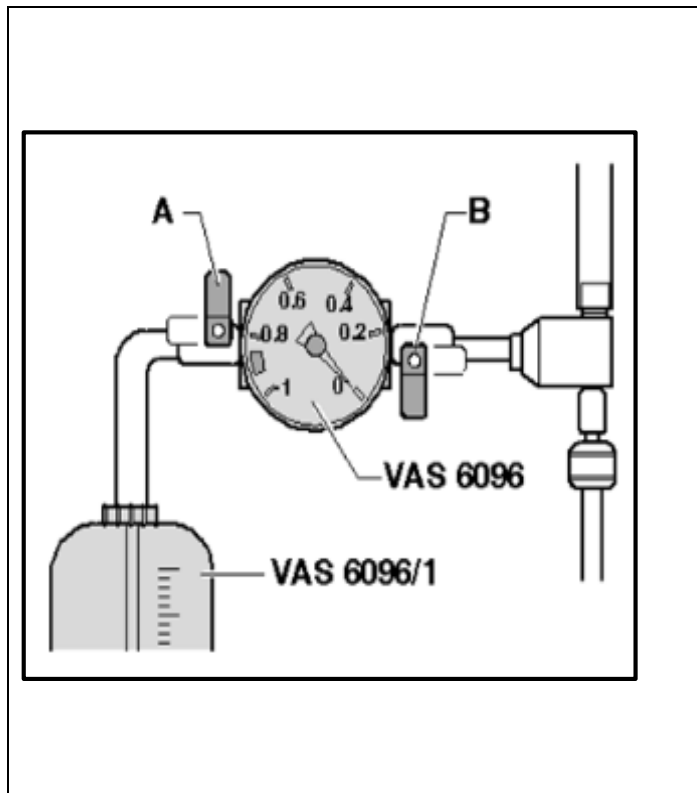
- Open the valve <B>.
- Allow the VAS 1274/8 to pull the cooling system into a vacuum until the needle reaches the green section on the dial (about .9 bar).

- Reconnect the hose between the Coolant System Charge Kit – VAS 6090 and the VAS 1274/8.
- Open the valve <A> briefly and allow the hose from the VAS 6096 to fill with coolant.

- Close the valve <A> as soon as it fills with coolant.
- Re-open the valve <B> and allow air to flow for at least 2 minutes.
- The needle must remain in the green section of the dial.

- Close the valve <B>.
- Open the valve <A>.
- Allow the cooling system to fill until the needle on the VAS6096 has reached “0” and coolant flow into the reservoir has stopped.
