Technical Service Bulletin

87 Air conditioning does not cool and / or compressor is noisy

87 15 66 2038023/5 July 29, 2015. Supersedes Technical Service Bulletin Group 87 number 15-65 dated July 2, 2015 for reasons listed below.

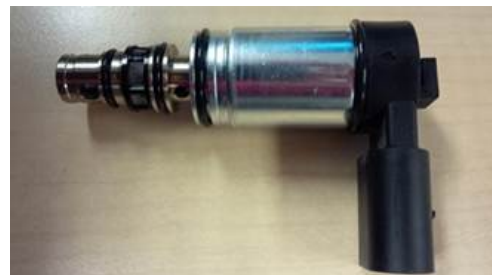
Figure 1. N280 Refrigerant Regulating Valve.

The condition may be caused by a faulty N280 valve (Figure 1). The internal components of the valve can be obstructed and incapable of full function. This loss of refrigerant regulation from N280 can cause noise from the A/C compressor and/or affect the HVAC cooling.

An improved N280 valve for the Sanden A/C compressor is now available as a replacement part (5Q0 260 839 A), and replacement of the entire A/C compressor is not necessary in every case.

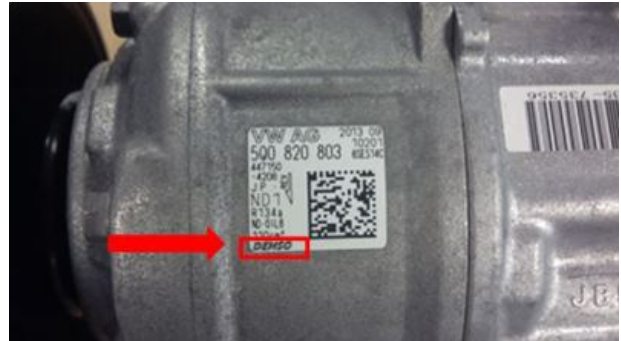
Figure 2. Denso compressor identification tag.

Denso A/C compressors are currently being installed in production, but installation of Sanden A/C compressors will resume in the future (Figure 2 and Figure 3).

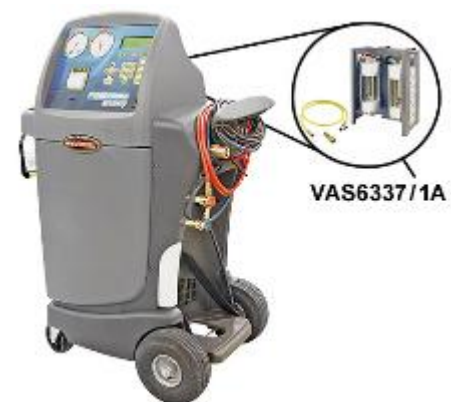
Figure 4. Robinair A/C Service Unit.

1. Connect both the refrigerant service station (Figure 4) and the diagnostic tester to the vehicle.

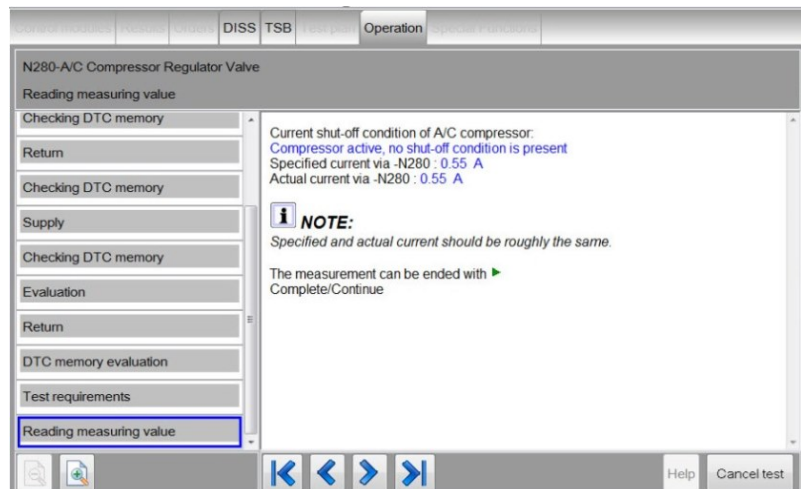
Figure 5. Checking N280 signal value Measuring Value Block.

1. With the engine at idle, switch the climate control unit to full cold and full fan.
2. Using the diagnostic tester, go to Guided Functions.
3. Monitor the measuring value for the air conditioner compressor regulating valve N280 signal (Figure 5).

The actual and specified values will be plausible and will show a normal regulating range of current for cooling request (0.400 A – 0.680 A).

However, there will be equalized pressure readings on the high and low sides of the circuit (no pressure generation from the compressor).

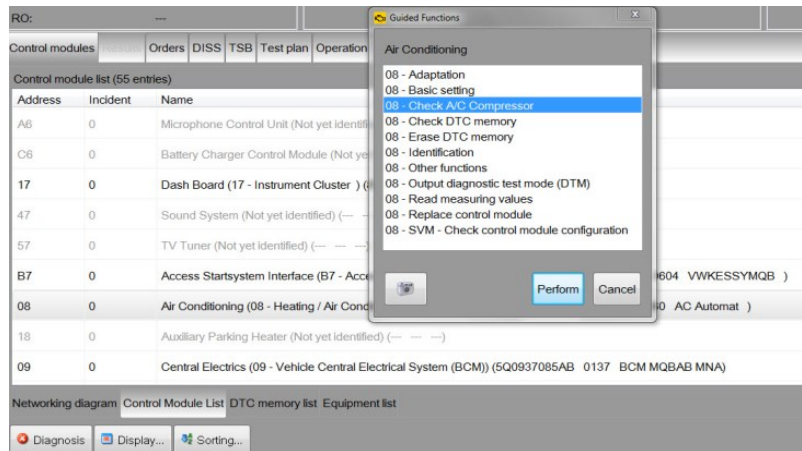
Figure 6. Selecting test plan for “Check A/C Compressor”.

- Continuing in Guided Functions, select the test plan for “Check A/C Compressor” (Figure 6).

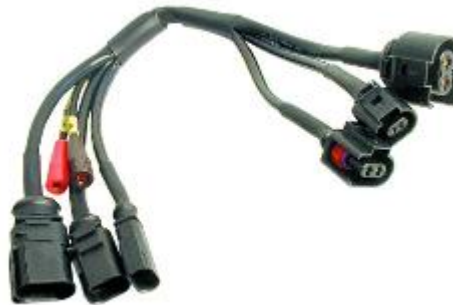
Figure 7. VAS 5256 breakout harness.

- Shut off the engine. Connect the breakout harness VAS 5256 (Figure 7) between the N280 valve and its connector.

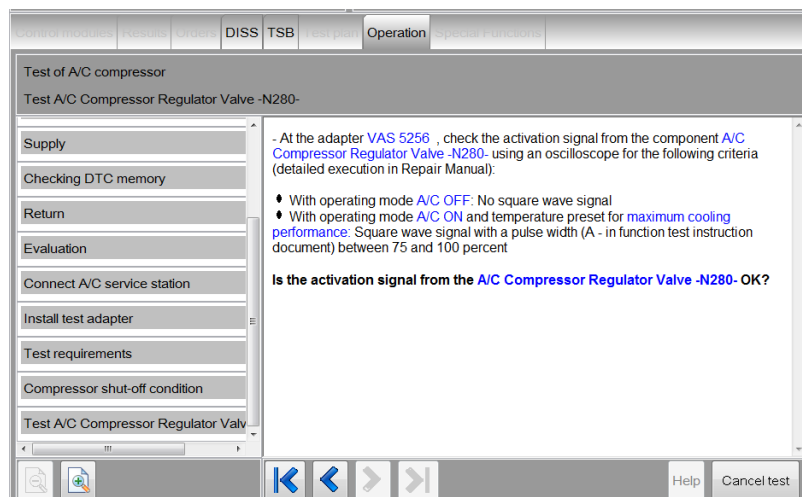
Figure 8. Checking the N280 signal wave form.

- Next, the signal wave form will be checked (Figure 8). The square wave signal should be between 75% and 100%.

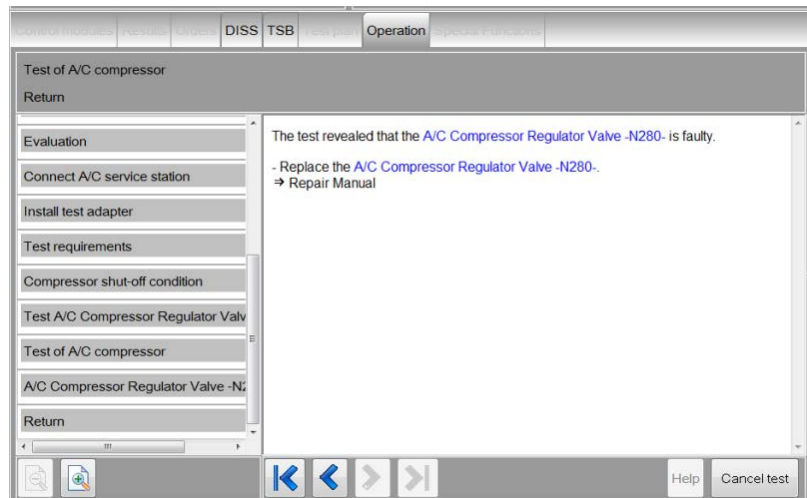
Figure 9. Checking for N280 valve contamination.

- If the wave form signal is good, the mechanical integrity of the N280 valve will be inspected next (Figure 9).

- Recover the refrigerant from the system. Remove the N280 valve using the procedure in the Elsa Repair Manual.

Warning: With the refrigerant circuit charged the N280 valve is under pressure. Be certain that the refrigerant circuit is completely discharged before removing the N280 valve.

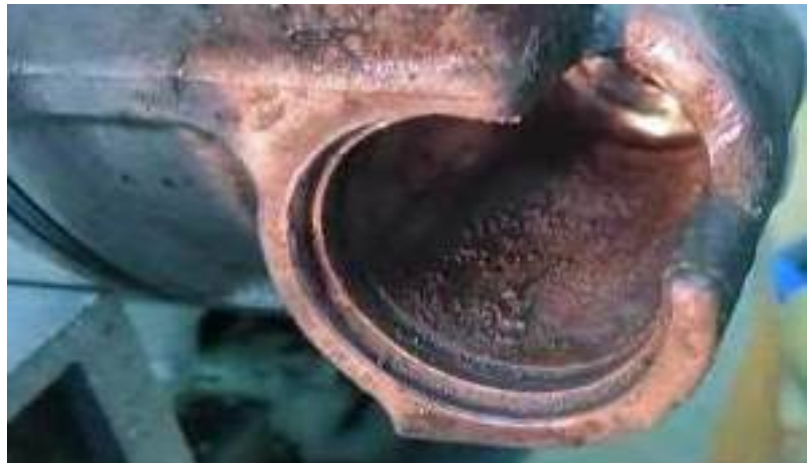
- Assess the condition of the N280 valve bore and the valve filter screen (Figure 10). If severe contamination is found in either area, the entire A/C compressor must be replaced.

Figure 10. Corrosion in the N280 valve bore.

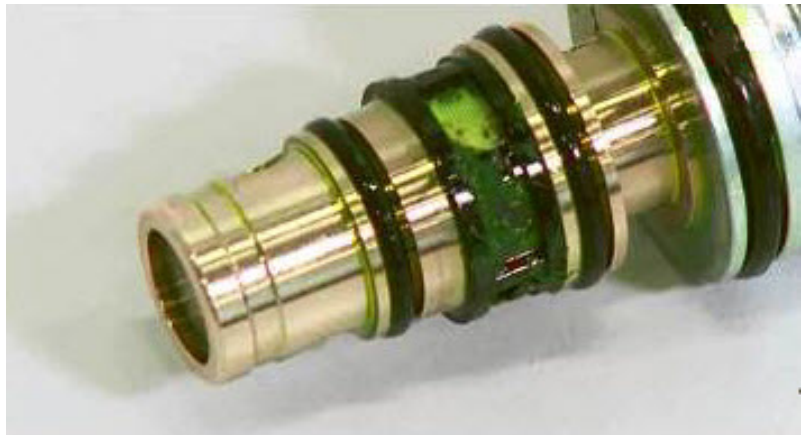
Figure 11: Severe contamination at the N280 valve filter screen.

10. Should severe contamination be found at the valve filter screen (Figure 11) and A/C compressor replacement becomes necessary, ensure that the refrigerant circuit is flushed in the course of repair.

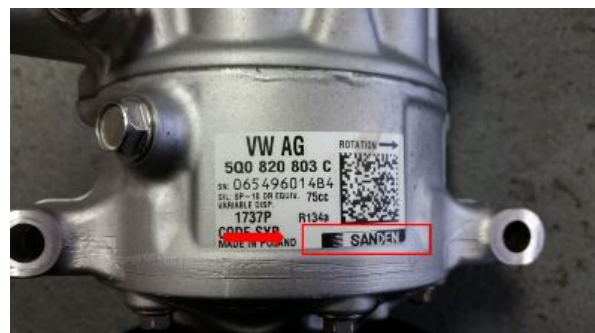
Figure 13: Sanden compressor identification tag.

1. As mentioned in the *Technical Background*, the originally-installed compressor on the MY 2015 A3 is manufactured by Sanden (Figure 13). The replacement compressor is manufactured by Denso (Figure 14).

When replacing the original Sanden compressor with a Denso compressor, be aware that while the refrigerant volume is the same regardless of the compressor installed, the PAG oil type and volume is not. Sanden and Denso compressors have specific PAG oils that must be used.

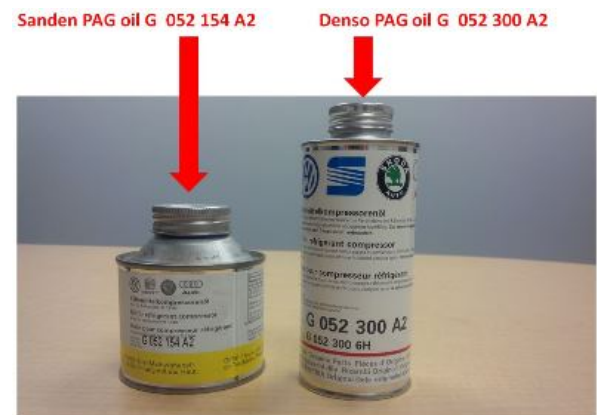
Figure 15: Compressor manufacturer specific PAG oils.

3. The replacement compressor will come with the specified type of PAG oil for the compressor (Figure 15). The amount of PAG oil supplied with the replacement compressor may not be the exact amount required to replenish the refrigerant circuit. Drain and measure the PAG oil in the replacement compressor to determine the required amount. If the amount needs to be added, do so using the correct type of PAG oil specified in ETKA. Refer to Elsa for the correct oil capacity for the compressor being installed.

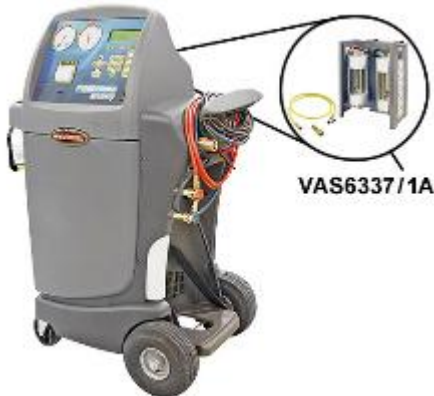
| Part Number | Part Description | Quantity |
|---|--|---|
| ROB134APF | <p>Robinair A/C Service Unit</p> | 1 |

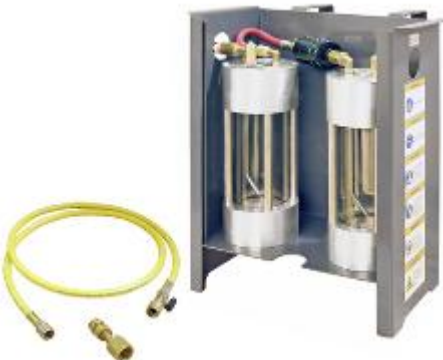
| Part Number | Part Description | Quantity |
|---|--|---|
| VAS 6337/1A | <p>Air Conditioning Flush Tool</p> | 1 |

2. The original PAG oil that will be in the refrigerant circuit must be flushed out completely with the air conditioning service station with flushing equipment, as specified in the Elsa Repair Manual.

- The flushing procedure can be found in the Elsa Repair Manual at: *Heating, Ventilation & Air Conditioning>>Refrigerant R134a Servicing>>87 Air Conditioning>>Refrigerant Circuit>>Refrigerant Circuit, Cleaning (Flushing), with Refrigerant R134a*. The procedure is also described in TSB 2018162.
