Technical Service Bulletin

87 Air conditioning does not cool and / or compressor is noisy

87 15 65 2038023/4 July 2, 2015. Supersedes Technical Service Bulletin Group 87 number 15-61 dated April 23, 2015 for reasons listed below.

Model(s)	Year	VIN Range	Vehicle-Specific Equipment
A3, A3 Cabriolet	2015	000001 - 106816	Not Applicable

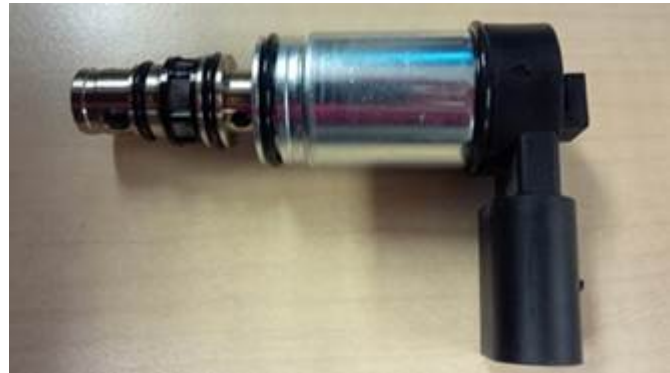
The condition may be caused by a faulty N280 valve (Figure 1). The internal components of the valve can be obstructed and incapable of full function. This loss of refrigerant regulation from N280 can cause noise from the A/C compressor and/or affect the HVAC cooling.

Figure 1. N280 Refrigerant Regulating Valve.

An improved N280 valve for the Sanden A/C compressor is now available as a replacement part (5Q0 260 839 A), and replacement of the entire A/C compressor is not necessary in every case.

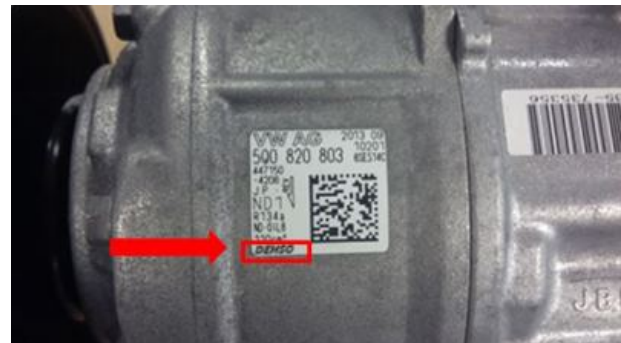
Denso A/C compressors are currently being installed in production, but installation of Sanden A/C compressors will resume in the future (Figure 2 and Figure 3).

Figure 2. Denso compressor identification tag.

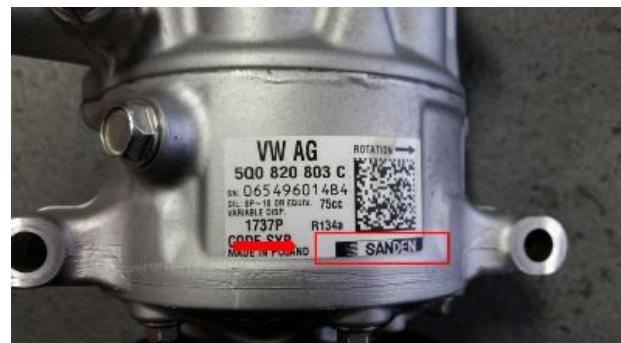
Figure 3. Sanden compressor identification tag.

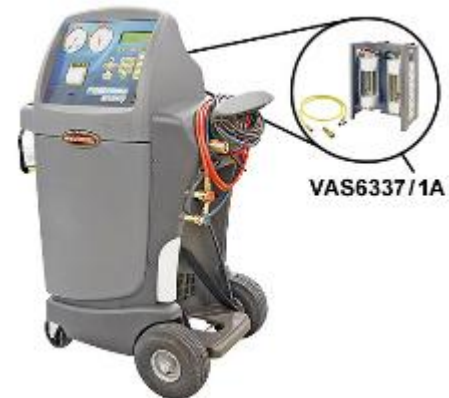
1. Connect both the refrigerant service station (Figure 4) and the diagnostic tester to the vehicle.

Figure 4. Robinair A/C Service Unit.

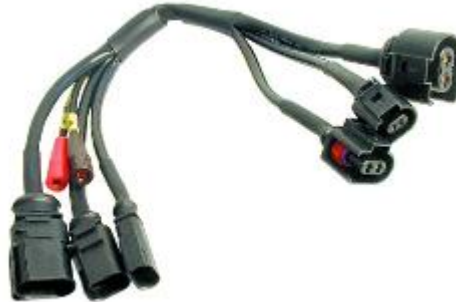
5. Shut off the engine. Connect the breakout harness VAS 5256 (Figure 7) between the N280 valve and its connector.

Figure 7. VAS 5256 breakout harness.

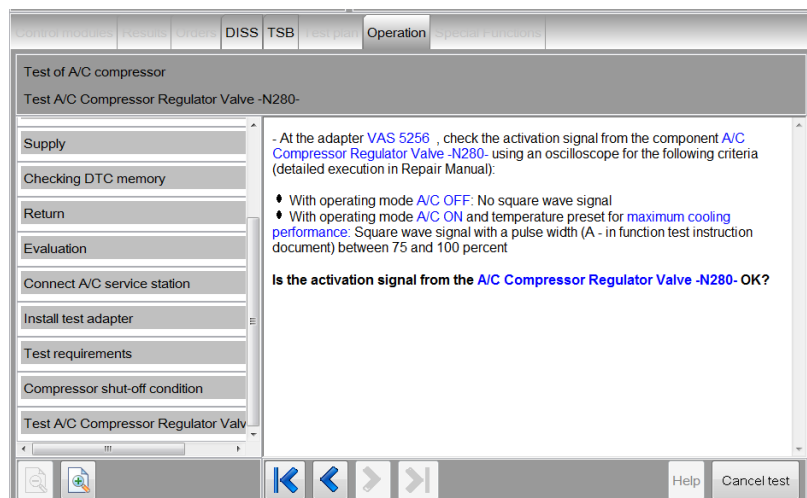
6. Next, the signal wave form will be checked (Figure 8). The square wave signal should be between 75% and 100%.

Figure 8. Checking the N280 signal wave form.

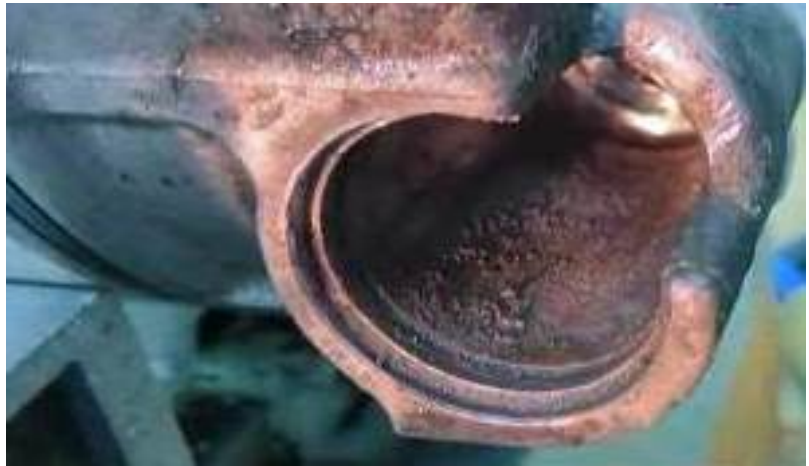
9. Assess the condition of the N280 valve bore and the valve filter screen (Figure 10). If severe contamination is found in either area, the entire A/C compressor must be replaced.

Figure 10. Corrosion in the N280 valve bore.

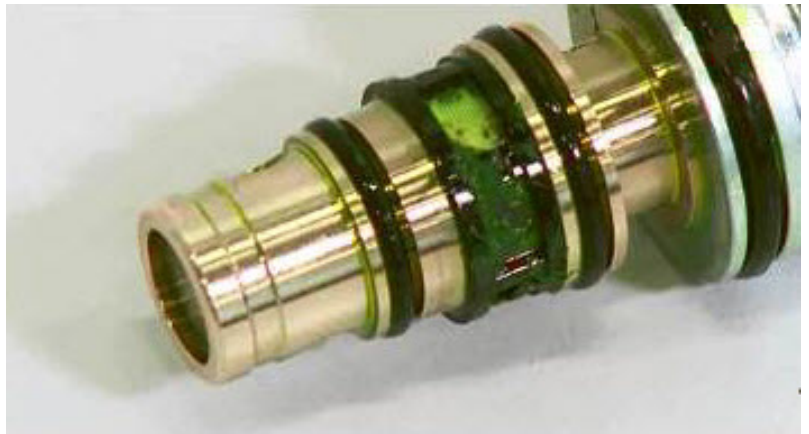
Figure 11: Severe contamination at the N280 valve filter screen.

10. Should severe contamination be found at the valve filter screen (Figure 11) and A/C compressor replacement becomes necessary, ensure that the refrigerant circuit is flushed in the course of repair.

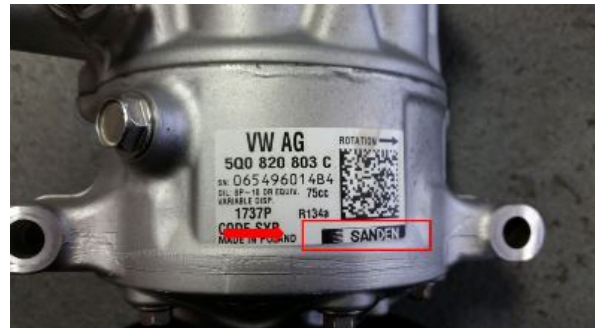
1. As mentioned in the *Technical Background*, the originally-installed compressor on the MY 2015 A3 is manufactured by Sanden (Figure 13). The replacement compressor is manufactured by Denso (Figure 14).

Figure 13: Sanden compressor identification tag.

When replacing the original Sanden compressor with a Denso compressor, be aware that while the refrigerant volume is the same regardless of the compressor installed, the PAG oil type and volume is not. Sanden and Denso compressors have specific PAG oils that must be used.

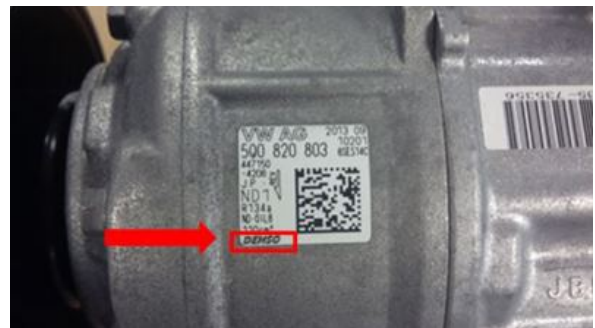
Figure 14: Denso compressor identification tag.

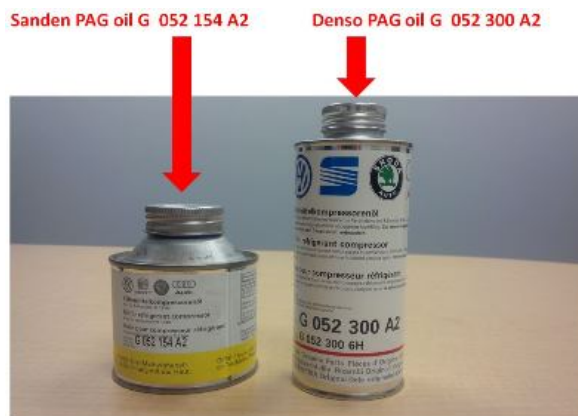
3. The replacement compressor will come with the specified type of PAG oil for the compressor (Figure 15). The amount of PAG oil supplied with the replacement compressor may not be the exact amount required to replenish the refrigerant circuit. Drain and measure the PAG oil in the replacement compressor to determine the required amount. If the amount needs to be adjusted, do so using the correct type of PAG oil specified in ETKA. Refer to Elsa for the correct oil capacity for the compressor being installed.

Figure 15: Compressor manufacturer specific PAG oils.
