**No.: 15 TS- 12**  
May 15, 2015

SUBJECT: **DD Platform Cylinder Block Oil Gallery Cup Plug Replacement**

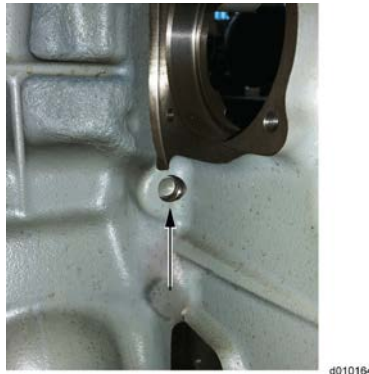
There is an oil gallery cup plug at the left rear of the cylinder block that may leak engine oil and require repair. The cup plug is located below the high pressure fuel pump mounting area. See illustration below.

There is a new procedure for replacing oil gallery cup plugs in the cylinder block. The procedure can be found in the Cylinder Block section of the *EPA07/10/GHG14 Engine Manual (DDC-SVC-MAN-0081)*. This is the only approved repair method for this particular cup plug. The part number for the cup plug located below the high pressure fuel pump is N000000004872.

**Drilling and tapping the cylinder block for a threaded plug can cause serious engine damage and may result in engine failure. The threaded plug repair method should stop being used immediately!**

Before making a repair to the oil gallery cup plug, ensure this is actually the source of the engine oil leak. There are many potential leak paths for engine oil at the rear of the engine. These include the rocker cover, camshaft housing, cylinder head, high pressure fuel pump, air compressor, flywheel housing and oil pan.
