FL685AB

NHTSA #15V-432 (School Bus)

Subject: TBB Emergency Door Handles

Models Affected: Specific Thomas Built Buses Vista, TL-960, Saf-T-Liner Conventional, ER, MVP-EF, EFX, MVP-ER, FS65, C2, and HDX Buses manufactured February 5, 2001, through May 29, 2012.

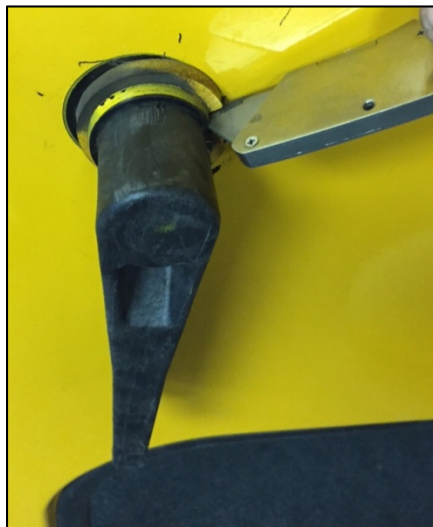
Figure 1, Cutting Washers

1. Chock the wheels, set the parking brake, make sure the shifter is in Park or Neutral. Disconnect the battery and the ignition switch is off.
2. Remove the washers between the external door handle and the door facing. Use a razor knife to slice through the large washer and then the smaller diameter plastic washer. Slide something under the washers to keep from damaging the paint on the door. See **Figure 1**.

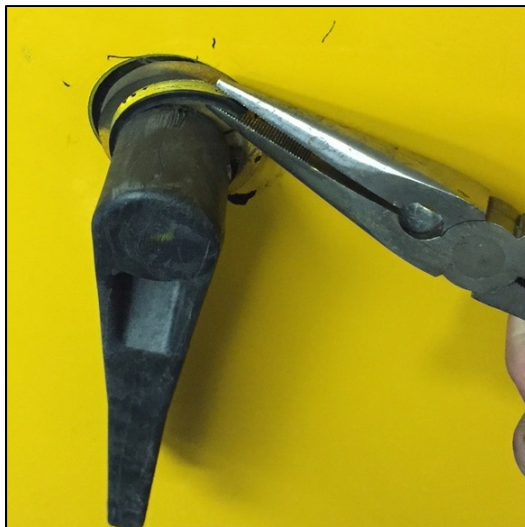
Figure 2, Removing Washers

3. Pull the washers off with needle nose pliers and discard the washers. See **Figure 2**.

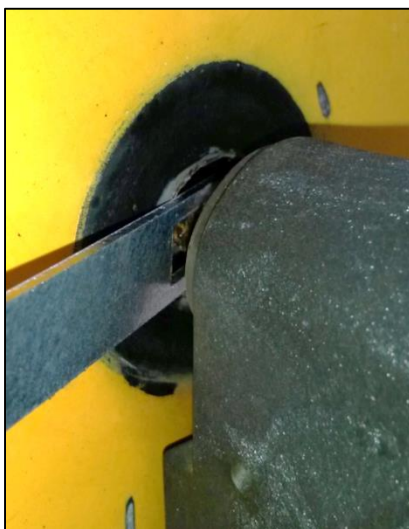
Figure 3, Using the Go/No Go Gauge

4. Once the washers are removed, use the go/no go gauge (TBB 204666 from kit TBB 204971) to verify the stem material is of sufficient thickness for operation. Try to slide the gauge over the smallest thickness of the stem on each of the four sides. See **Figure 3**. If the gauge is able to slide completely on at any point of the stem, go to “Replacement of Interior and Exterior Door Handles.” See **Figure 3** for use of the gauge.

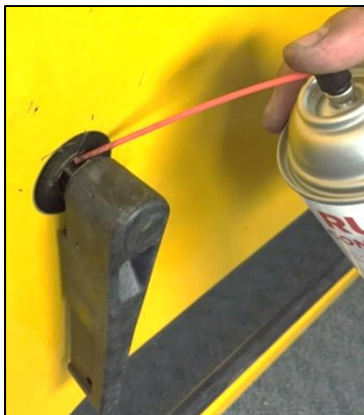
Figure 4, Applying Protectant

5. After verifying the gauge will not slide over the stem, apply a liberal amount of protectant over the entire stem (inside and outside the door cavity). Use an approved corrosion protectant such as WD-40 purchased locally. If any of the protectant liquid gets on the paint or exterior handle, remove it as quickly as possible with an alcohol based wipe. See **Figure 4**.

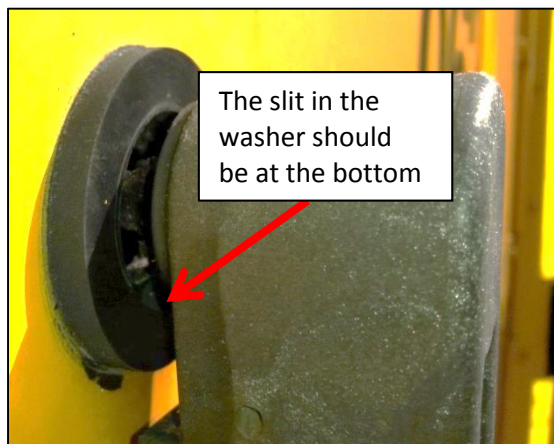
Figure 5, Position of Slit in Washer

6. After spraying the stem, install a new external washer (TBB 204677 from kit TBB 204971).
7. Make sure the painted surface around the stem opening is clean and dry. Remove the paper backing from the washer and place the adhesive side on the door around the external handle. Make sure the washer slit is installed on the bottom side of the opening. There will be an opening between the exterior washer and the door handle. See **Figure 5**.

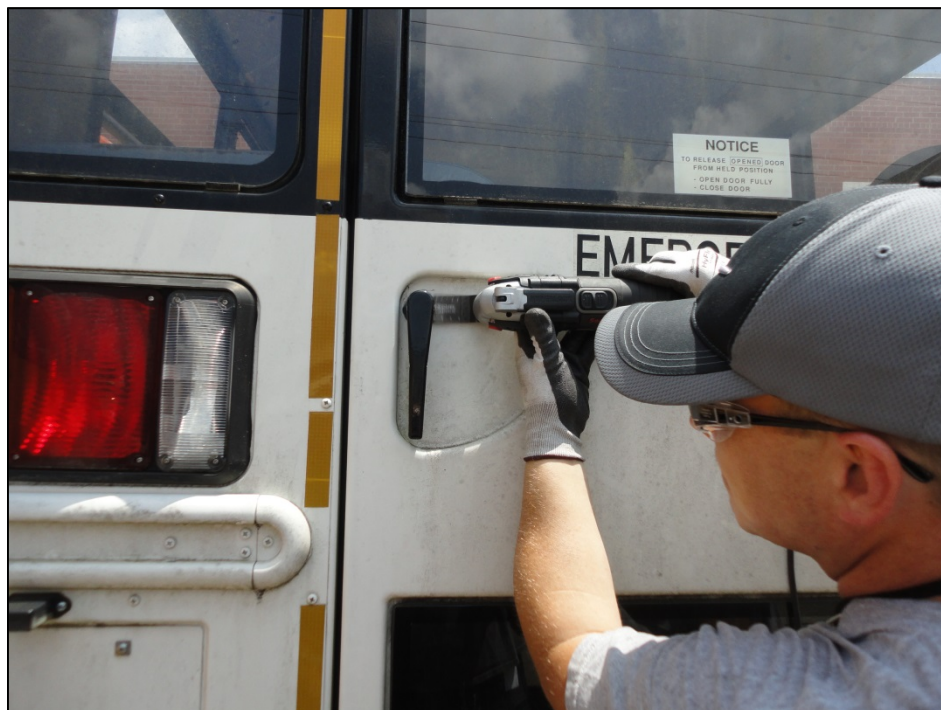
Figure 6, Cutting Off the Stem and Exterior Door Handle

1. Close and lock the door to keep it steady while performing next step.
2. Cut the stem and exterior door handle off. This can be performed with an oscillating tool or similar. See **Figure 6**.

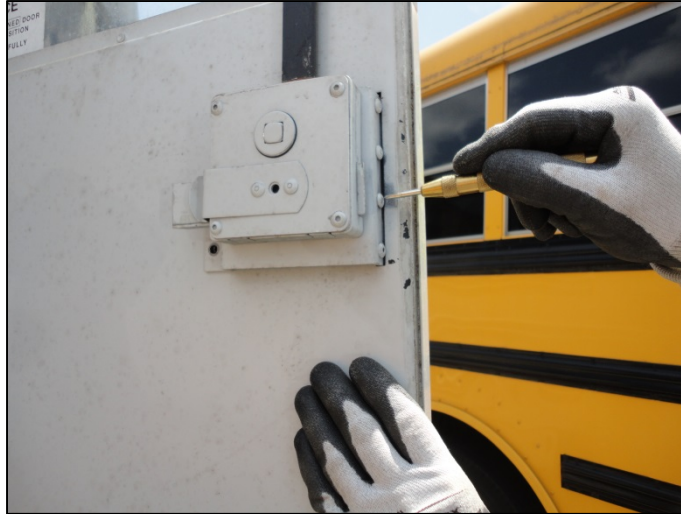
Figure 7, C2 mounting

C2 rear emergency doors will have four (4) rivets used for mounting the mechanism to the door bracket. Included in kit TBB 204987 are four (4) #12 screws to be used as replacement fasteners for the rivets. See **Figure 7**.

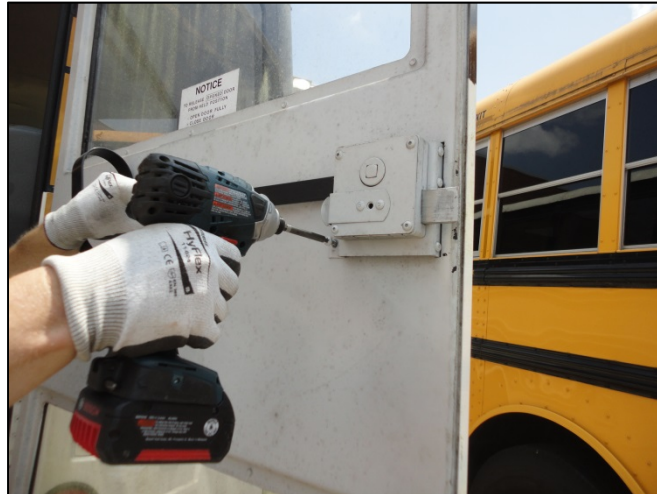
Figure 8, Legacy Mounting

Legacy products will have screws used for mounting the mechanism to the door. Remove and retain these screws for replacement. See **Figure 8**.

5. Remove the two screws on the left side of the locking mechanism and retain them for replacement. See **Figure 8**

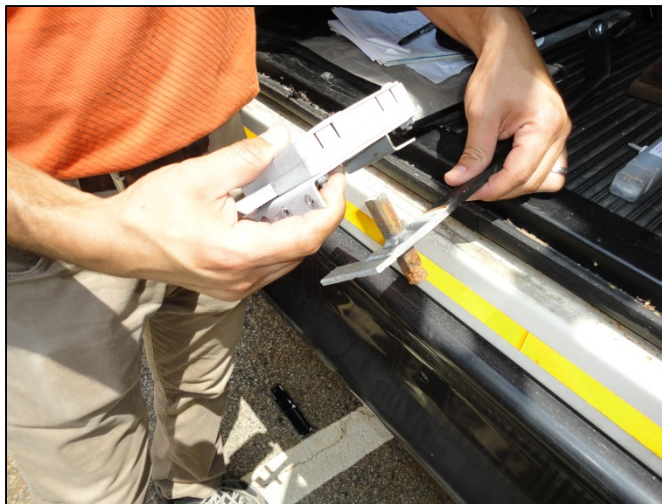
Figure 9, Removing the Locking Mechanism

6. Pull the locking mechanism and handle off the door. Lay the locking mechanism on the side the handle is not on and pull the handle shaft out of the locking mechanism. See **Figure 9**.

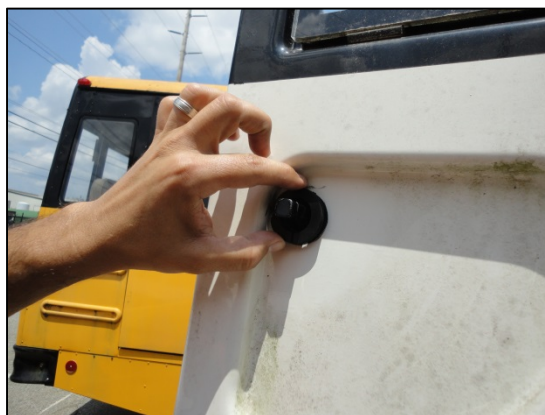
Figure 10, Installing the New Washer

7. Install the new handle with the locking mechanism and new washers from the kit (TBB 204987), using #12 screws in all fastener locations (Two (2) that were already used for mounting and four (4) used to replace the rivets).
8. Wipe the surface clean around the new stem where it exits the door.
9. Remove the paper covering the adhesive off back of the new washer and install it around stem. Make sure the washer slit is installed on the bottom side of opening. See **Figure 10**.

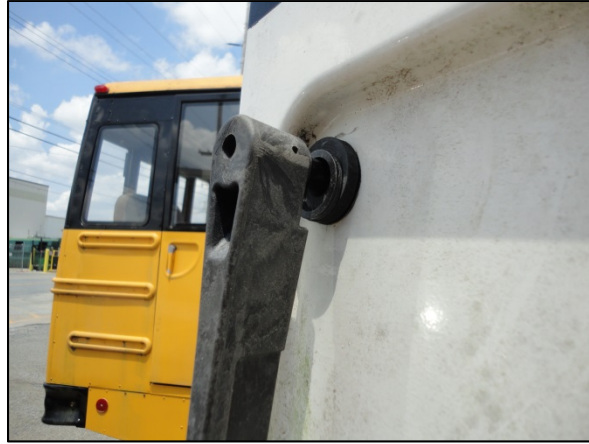
Figure 11, Position of Newly Installed Exterior Handle

10. Close the emergency door using the interior door handle. Make sure the interior handle is in the closed position. The closed position is when the interior handle is pushed all the way down to a horizontal position.
11. The exterior door handle must be installed in a vertical orientation. See **Figure 11**.

12. Using a rubber mallet, hammer the exterior handle (kit TBB 204988) onto the stem. The exterior handle must properly fit on the door stem for installation of the locking pin.
13. Insert the locking pin (TBB151501 from kit TBB 204987) into the side of the exterior handle.
14. Check door operation.
15. Unchock wheels.
