## STEER LEVER BOLT INSPECTION

Prevost vehicles

On the vehicles affected by this bulletin, the bolts of the steer lever might not be per specifications. Inspect per procedure below and replace as needed.

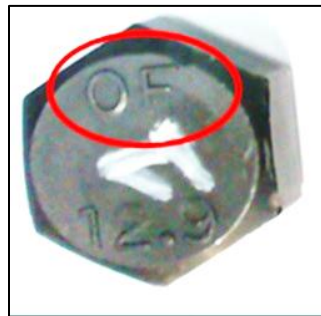
Figure 1

- 1) Verify the bolt head for the marking "OF". If present on one of the bolts, replace BOTH bolts

- 3) Replace one bolt at a time
  - Short Bolt M20 X 60 G12.9 PN 611305 QTY 2/VEH
  - Long Bolt M20 X 80 G12.9 PN 611307 QTY 2/VEH
- 4) Run a **M20 X 2.5 size tap** in the threaded section of the axle. You have to go from the back side and not the bracket side
- 5) Clean the bolt thread as well as the support thread using degreaser. Dry with compressed air.
- 6) Apply 271 Loctite or Permatex 27100 on bolt and threaded hole
- 7) Torque to **547 FT LBS**, Qty: 2 per side
- 8) Apply undercoating on Bolt heads
- 9) Reinstall sway bar links. Torque to **165 lbf-ft.**
- 10) Reinstall shocks. Torque to **110 lbf-ft.**
- 11) If no **"OF"** marking on the bolts, the vehicle is Conform.

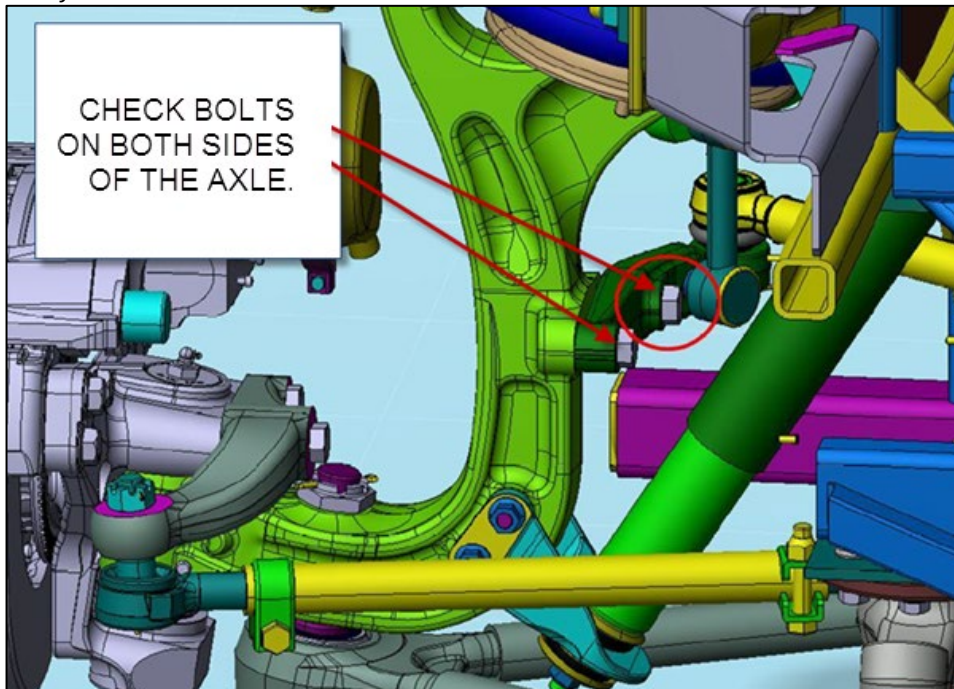
Figure 2

On the front independent suspension, inspect the bolts highlighted in fig. 2.  
Note that you may have to remove the shocks and the sway bar links to perform the replacement.  
Support the body on both sides before removing any components.

- 2) Verify **both sides** of vehicle
