## HUBODOMETER SUPPORT MODIFICATION

Prevost vehicles

On the vehicles affected by this bulletin, modify the hubodometer support to allow the wheel to be taken out without removing the support.

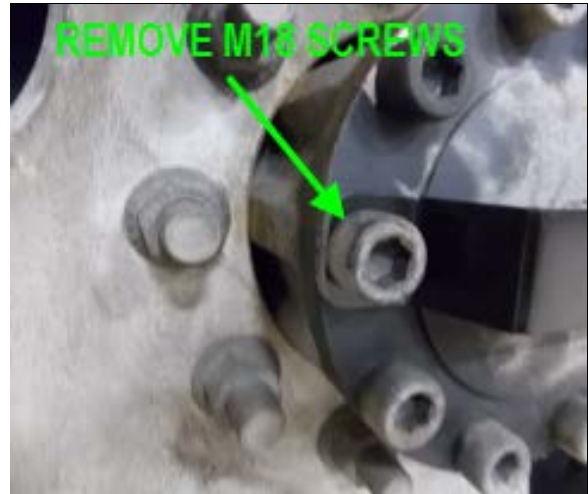
Figure 1

- 1) Using a 14mm Hexagonal socket bit, remove the hubodometer and support from the vehicle axle (two M18 Hexagonal Socket Head Screws as seen in Figure 1).

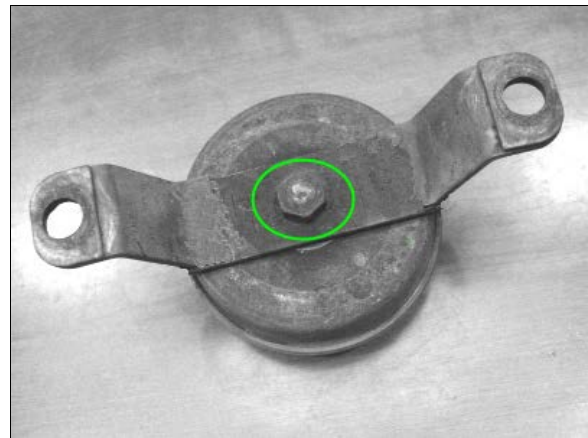
Figure 2

- 2) Remove the hubodometer from the support (hexagonal nut at the back of the unit in Figure 2).

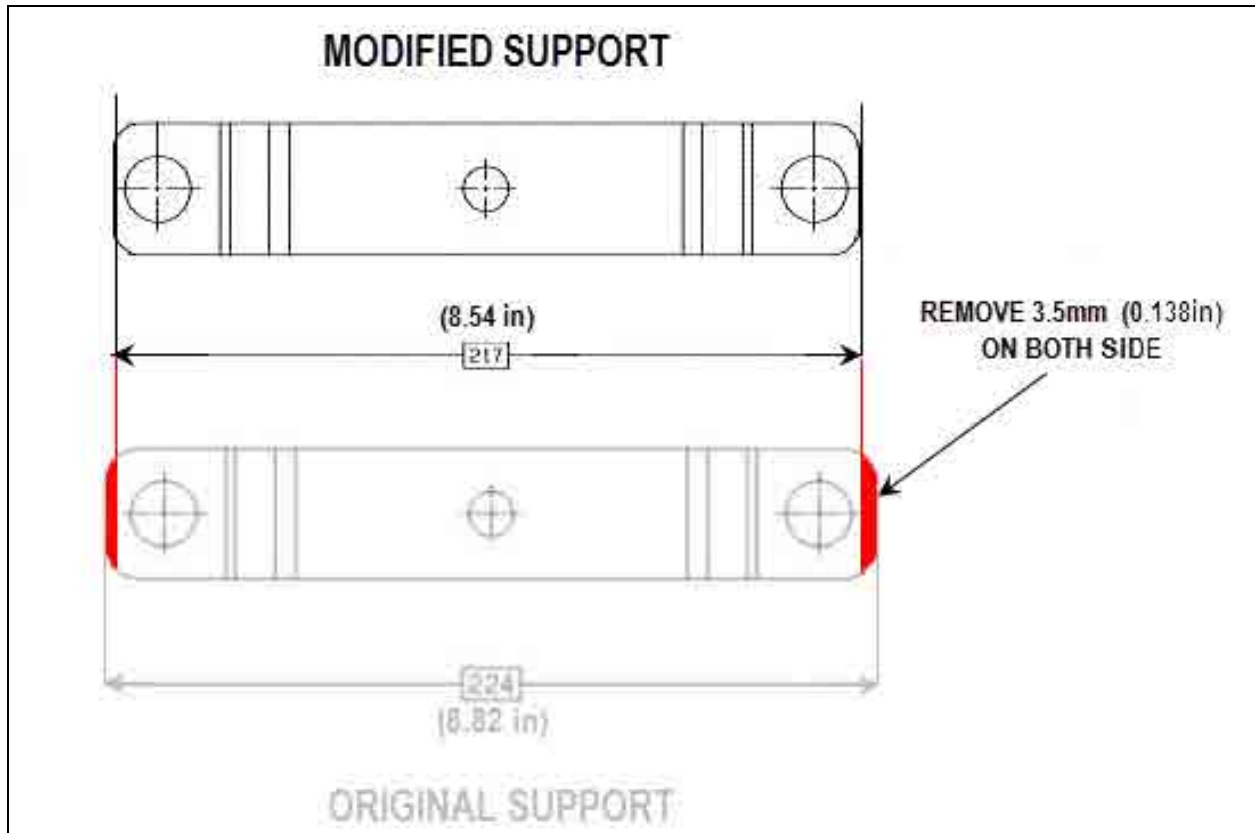
Figure 3

- 3) Using a bench grinder, remove 3.5mm from both ends of the hubodometer support. Refer to the illustrations below as a template and for the final measurement of the modified support (Figure 3).

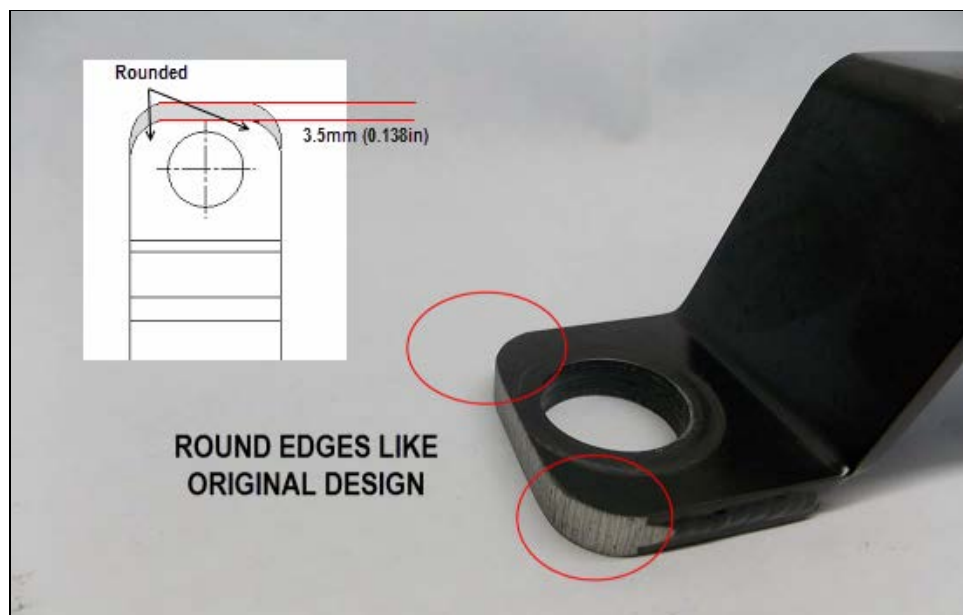
Figure 4

- 4) Grind the edges to keep the as much as possible the original “rounded” shape as seen in the illustrations below (Figure 4).

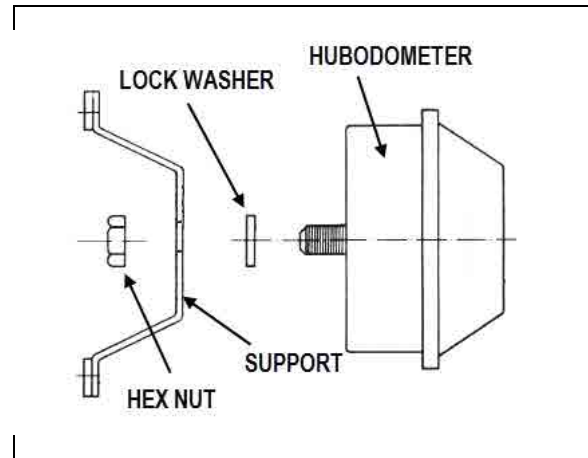
Figure 5

- 6) Let the paint dries and reinstall the hubodometer on the support. Make sure the lock washer is located between the hubodometer body and the support and tighten the hex nut to 15ft-lbs. Do not clamp hubodometer in a vise (Figure 5).

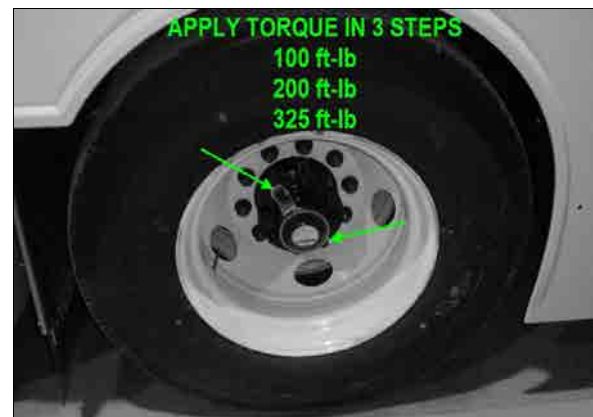
Figure 6

- 7) Reinstall the hubodometer/support assembly to the vehicle axle (Figure 6). Apply torque alternately to the two M18 hex cap screws in three steps of 100, 200 and 325 ft-lbs
