## COOLANT ELBOW ON TRANSMISSION OIL COOLER

Prevost vehicles

On the vehicles affected by this bulletin, inspect the coolant hose flexible elbow and piping arrangement on the transmission cooler.

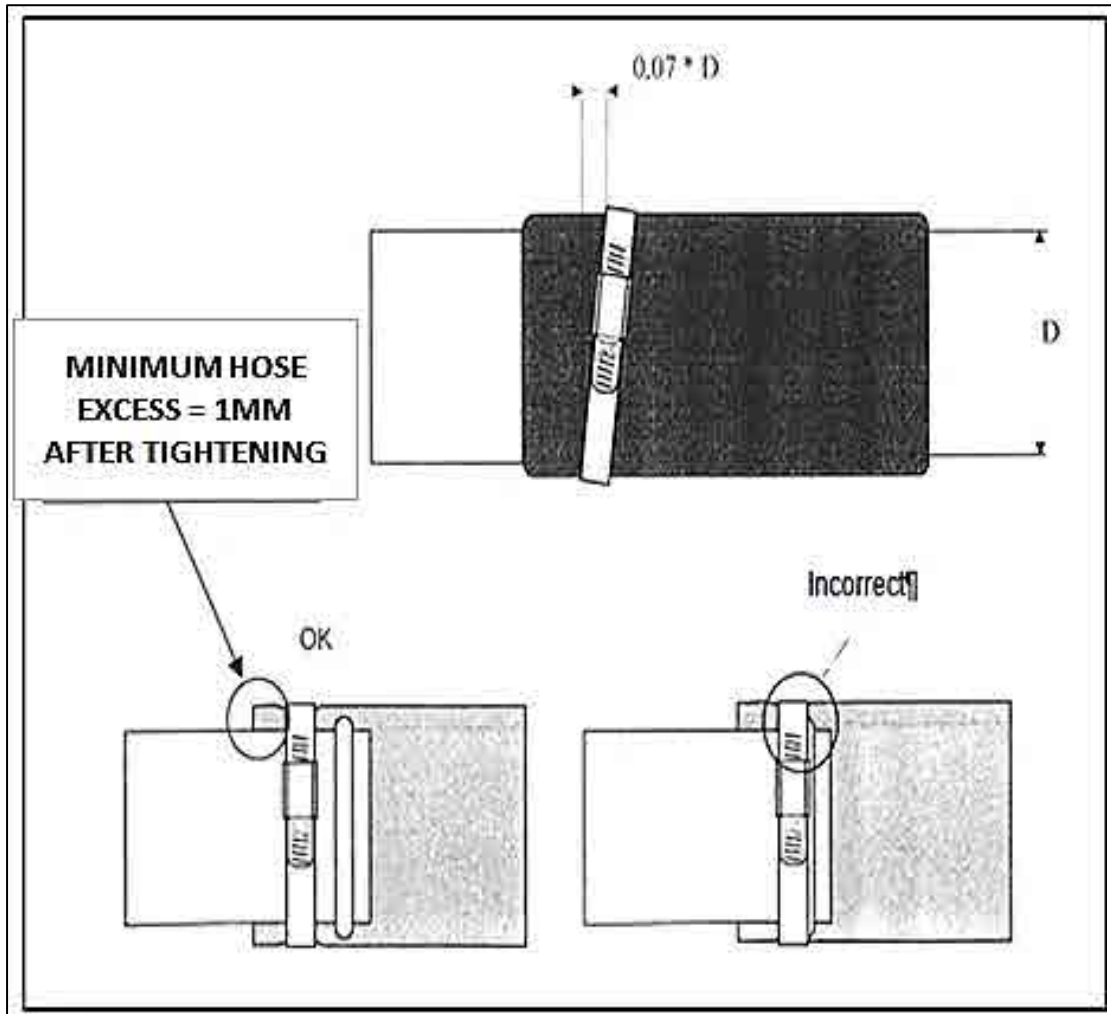
**Figure 1**

Follow installation guidelines below. (Fig. 1) Clamp must not bear on the pipe "bump", make sure it clears the bump before tightening. Respect dimensions described below.

- 1) After the vehicle has cooled down, Remove and re-install the cooling system cap to release the pressure from the system.
- 2) Lift the vehicle.
- 3) Loosen both clamps holding the transmission heat exchanger flexible hose
- 4) Loosen the p clamp (retaining pipe) on frame.
- 5) Verify that the flexible hose is not under tension or twisted etc.; it must be well routed and positioned.
- 6) Tighten the p clamp (retaining pipe) on frame.

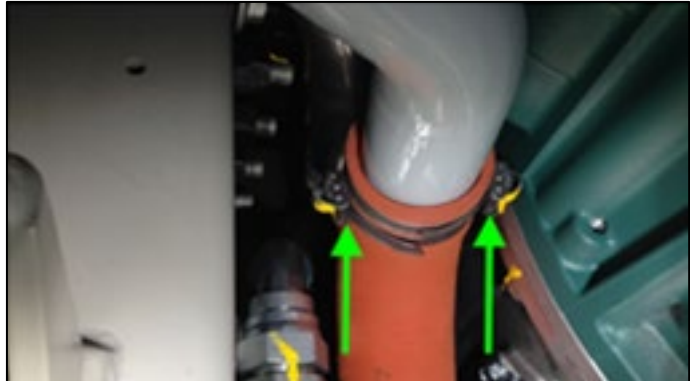
Figure 2

- 7) On the pipe side, re-install the clamps (qty 2) on the elbow between the bumps and torque to: **30 lb-in.** Apply torque seal.

Production procedure provided as a reference. (Fig. 2)

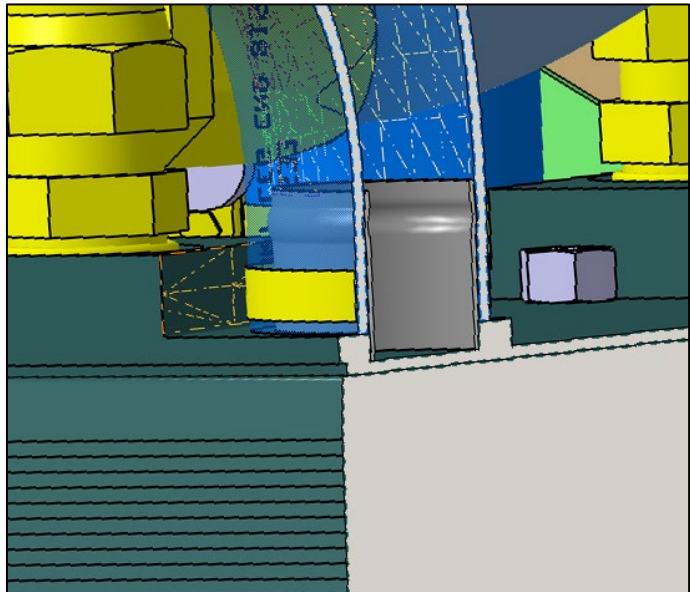
Figure 3

- 8) Re-install the clamp on the cooler side (qty 1)
- 9) Space for the clamp is tight, as shown in fig 3 & 4.
- 10) Tighten to: **30 lb-in.** Apply torque seal.
- 11) Verify that the new installation of the flexible hose is not under tension or twisted etc.; it must be well routed and positioned.

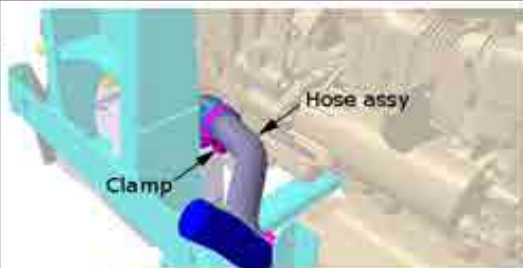
| Installing the lower hose | | | | |
| 10 | Hose Assembly | | PO3900 | |
| 11 | Clamp | | 992088 qty 2 | |
| 12 | Clamp | | 012551 qty 1 | |

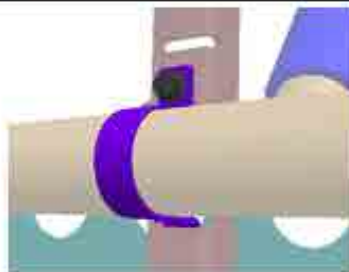
| Installing the lower hose | | | | |
|---|---|---|---|---|
| 13 | Belleville washer | | 500321 qty 1 | |
| 14 | Bolt | | 5001780 qty 1 | |
| | | <b>Note:</b> Tighten the bolt and make sure the flexible hose is align properly and seating straight on the exchanger. As per L0002KE. | | |

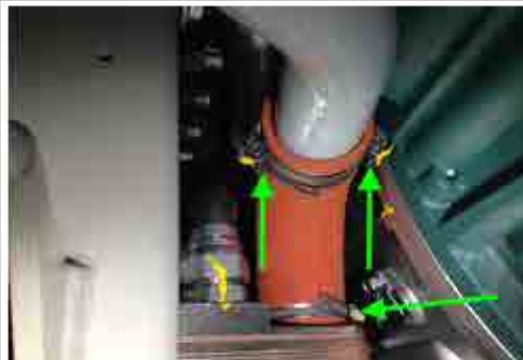
Figure 5

| Installing the lower hose | | | | |
|---|---|---|---|---|
| 15 | Torque 3 flexible clamps (T112) | 30 lb-in<br>3x | | |
| | | <u>Atlas tool – Copco</u><br><br><b>Note:</b> Arrows shows the tool orientation to reach clamps.<br>As per L0002KE. | | |
