**MAINTENANCE
INFORMATION**

MI15-24

DATE :	MAY 2015	SECTION: 06 - Electrical
SUBJECT :	POWER CABLES INSPECTION GUIDELINES

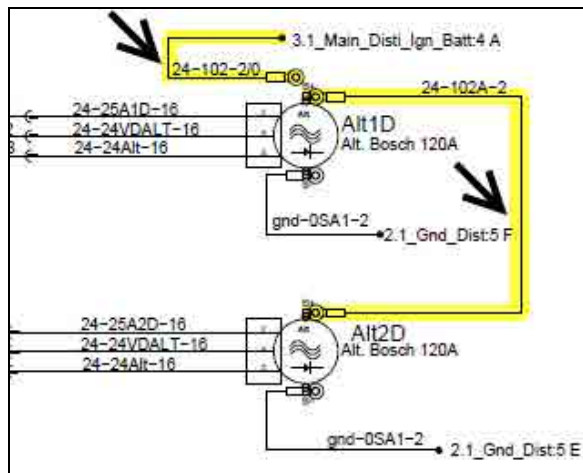
Figure 1

- There are power cables at the following locations:
 - On the **alternators positive (+) stud terminal** and from there, up to Bussman junction block in the electrical compartment (Figure 1, Figure 2, Figure 3).

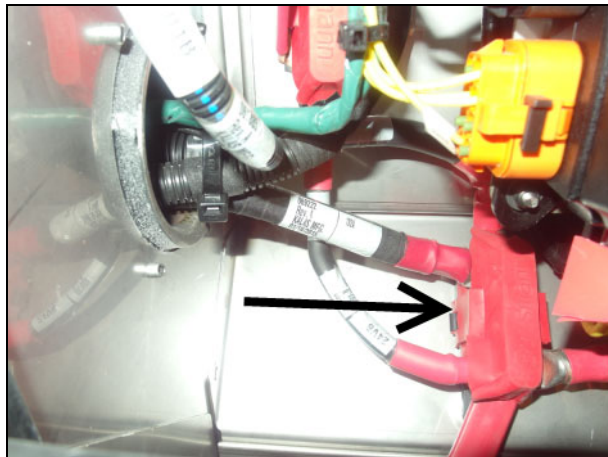
Figure 2: Bussman Junction Block - X3 Series.

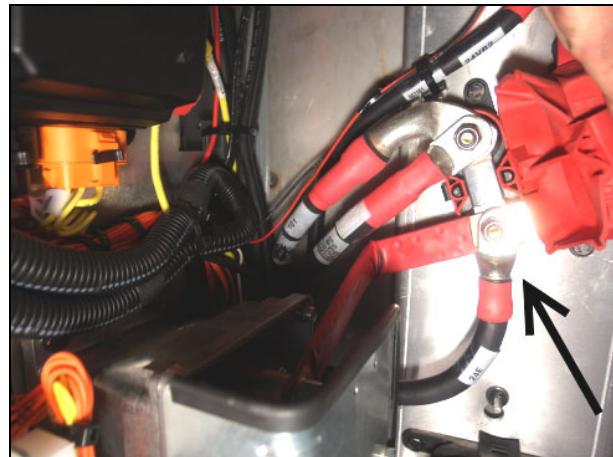
Figure 3: Bussman Junction Block - H3 Series.

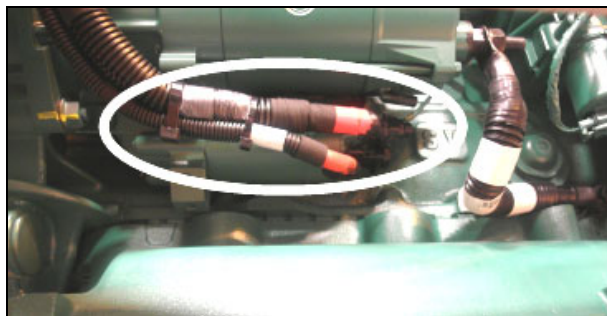
Figure 5: starter cables

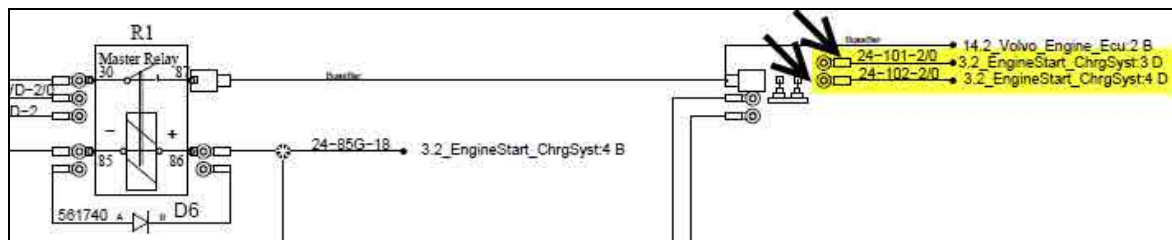
Figure 6

- In the electrical compartment, **connected to Bussman junction block** (Figure 6).

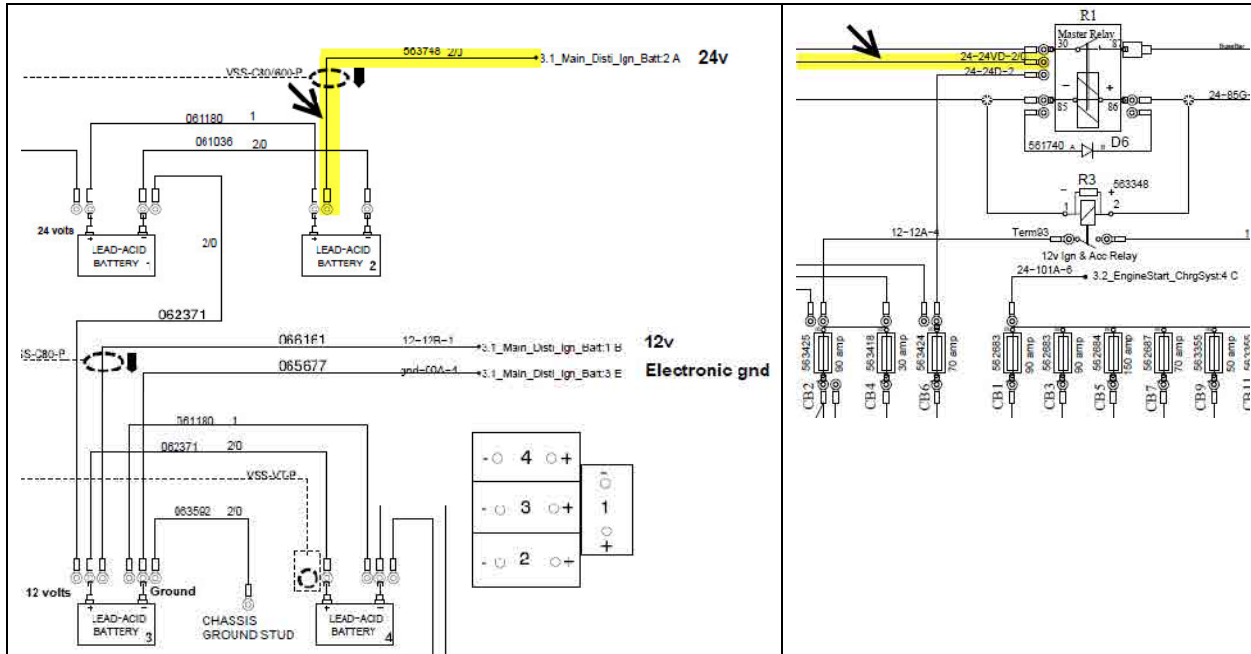
Figure 7

- In the **battery compartment** between **battery no2 and master relay R1** (Figure 7).

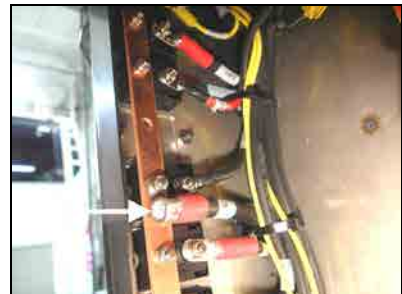
Figure 9: Power cable on main circuit breakers' bus bar.

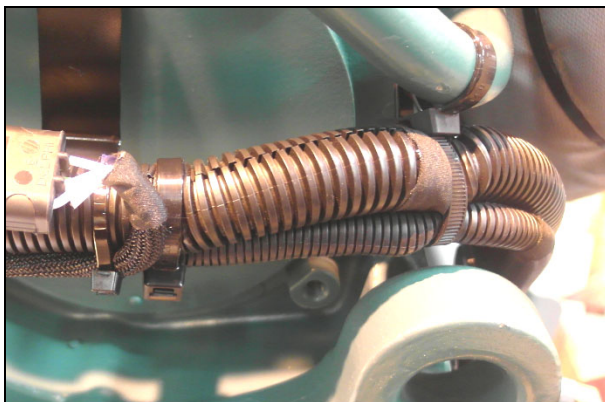
Figure 10: starter cables in a corrugated protective sheath.

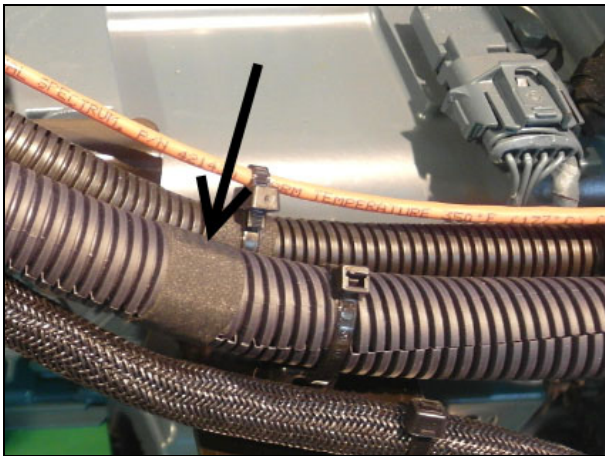
Figure 11: Two layers of fabric tape applied every 3 to 6 inches to prevent the cable from coming out of the corrugated protective sheath.

- Ensure that the power cables do not rub on bolt heads or sharp metal edges that can cut or wear the cable extruded sheath.
- For power cables passing through a corrugated protective sheath, it is recommended to apply two layers of fabric tape every 3 to 6 inches minimum to prevent the cable from coming out of the

corrugated protective sheath (Figure 11). The ends of the corrugated protective sheath should be covered with fabric tape (Figure 12).

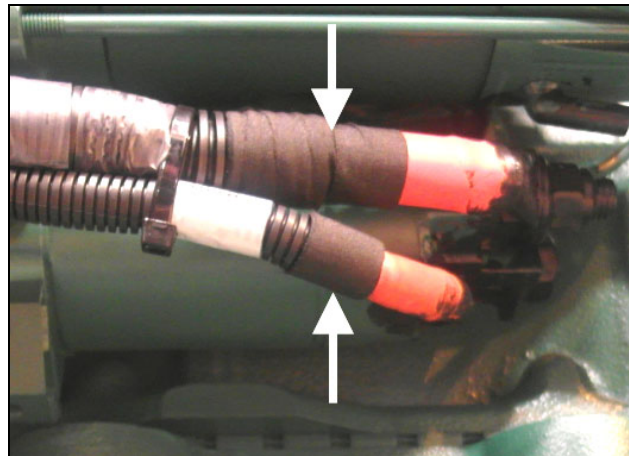
Figure 12: The ends of the corrugated protective sheath should be covered with fabric tape.

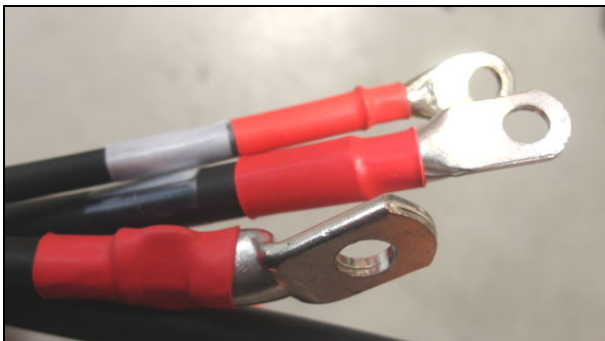
Figure 13: Cable lugs must be closed type, crimped or welded.

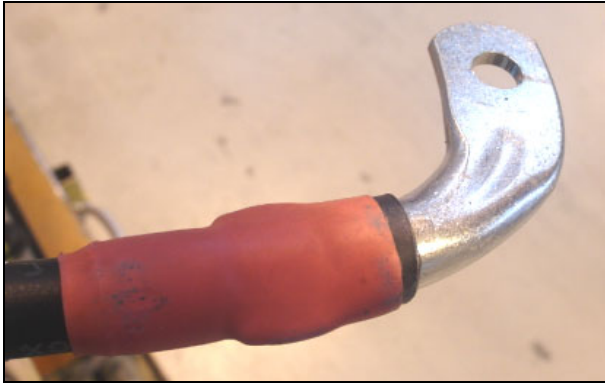
Figure 14: Power cable shouldn't be bent just next to the cable lug. Angled cable lugs are used to avoid mechanical stress.

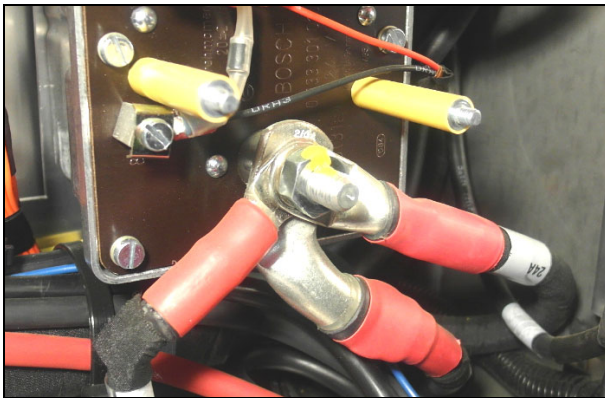
Figure 15: When several terminals are connected on a single stud terminal, the largest cable lug must be placed first, followed by the second larger and so on. Cable lugs should be distributed around the stud terminal in a way that no cable lug is distorted when tightening the nut.

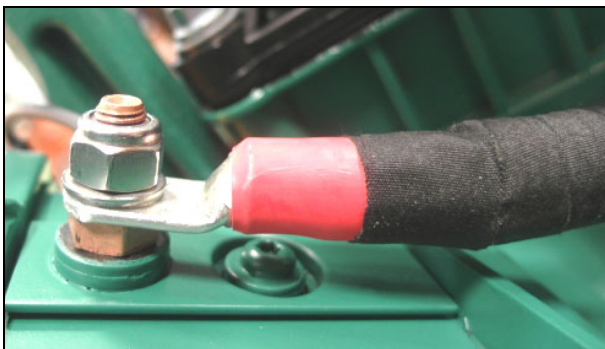
Figure 16: No exposed or broken copper strands.

- A shrink tubing (or fabric tape) should cover the copper strands.
- Ensure that the power cables and ground wire are not stretched tight.
- Ensure that the cable lugs are still properly crimped on the copper conductor, that the conductor strands are not broken so that the power cable retain its capacity and ensure unrestricted current flow.

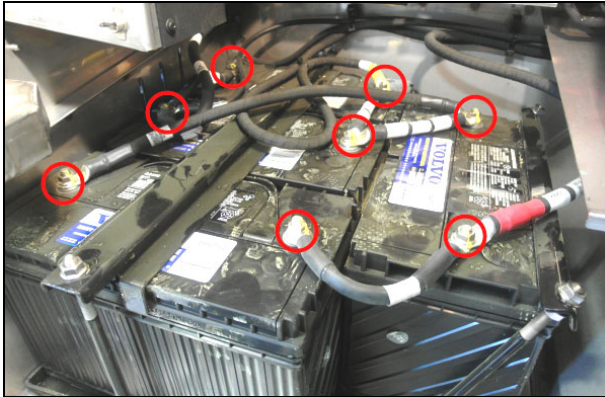
Figure 17: battery bank

- Battery interconnection cables must be checked too :
 - Ensure the cables are properly fastened to battery posts and that the cables are in good condition (consult battery manufacturer documentation for appropriate tightening torque).
 - No corroded or cut copper strands. No apparent copper strands. Protective sheath in good condition, no cuts, no rubbing against metal edges.

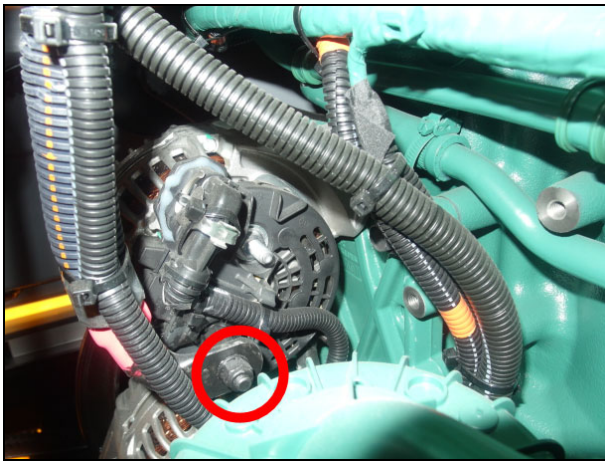
Figure 20: Make sure power cables/positive cables (+) are properly connected to alternator, that stud terminal nuts are properly tightened.

TERMINAL NUT PRESCRIBED TORQUE

Bosch HD10

- B1(+) terminal: 10 lbf-ft
- ground: 6 lbf-ft

Bosch T1

- D+: 21-28 lbf-in
- B+, B-: 88-115 lbf-in
- W: 36-48 lbf-in

Delco 50DN

- DC Output: 30-35 lbf-ft
- F1, F2, Relay: 6 lbf-ft

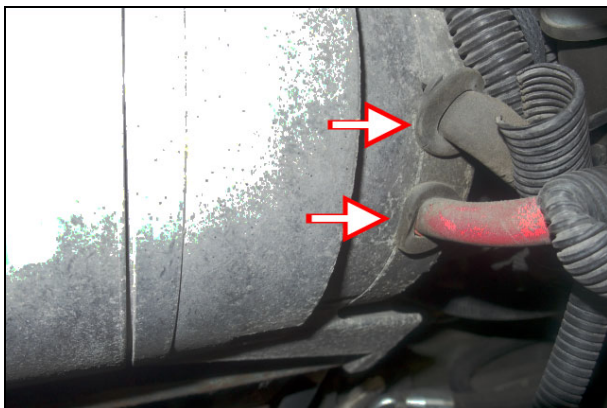
Figure 21: Bosch T1 alternator with the two required rubber grommets. Alternator cables connected to the alternator stud terminals must be protected against metal edges with rubber grommets.

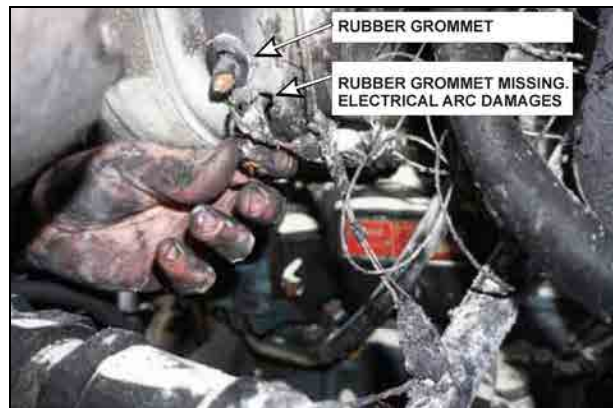
Figure 22: Fire in engine compartment caused by rubbing of power cable against metal edge of Bosch T1 alternator rear cover. Lower rubber grommet was missing when fire occurred. Evidence of electrical arc can be seen.

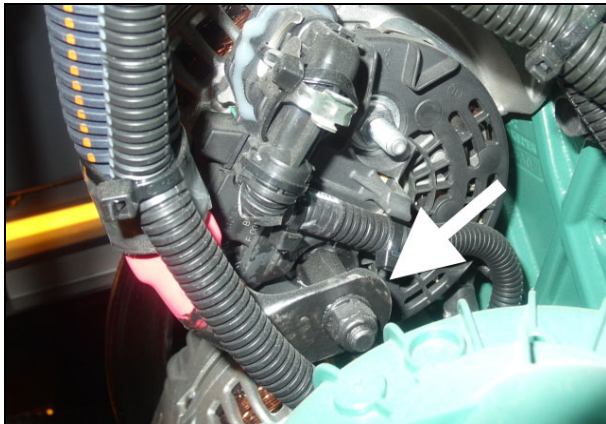
Figure 24: Upper alternator power cable lug protected with Color Guard rubber coating.

- Power cable connections on alternators, starter and ground connections exposed to water, dust, etc. should be protected against corrosion with Loctite Color Guard rubber coating (**Figure 23**) (Prevost p/n: 684013).

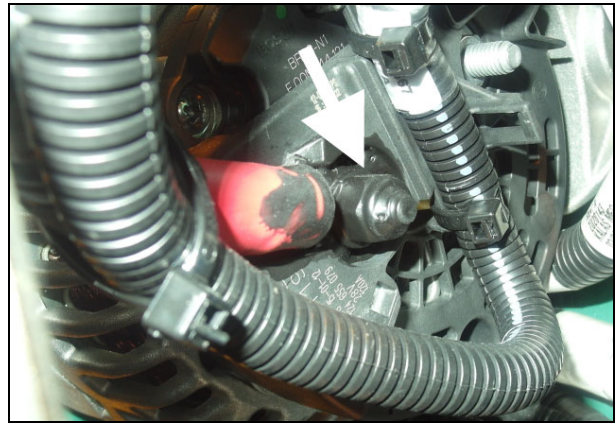
Figure 25: Lower alternator power cable lug protected with Color Guard rubber coating.

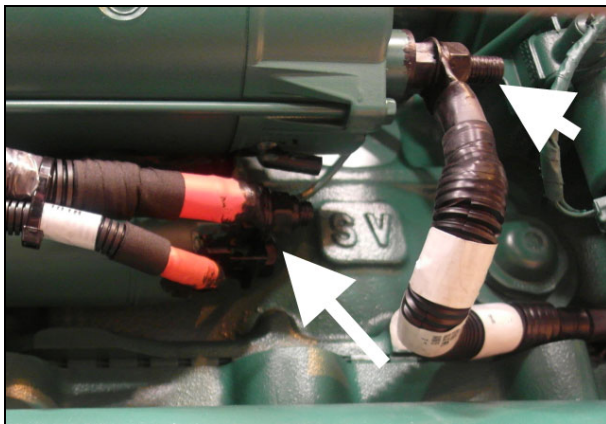
Figure 26: Starter power cable and ground cable lugs protected with Color Guard rubber coating.
