Revision B  
Sept 11, 2015

## HOT GAS BYPASS IMPROVEMENT, SMALL AC [H3 VIP] Prevost vehicles

Following **WB13-04**, update the hot gas pickup tube circuit for an improved version with a better resistance to vibrations.

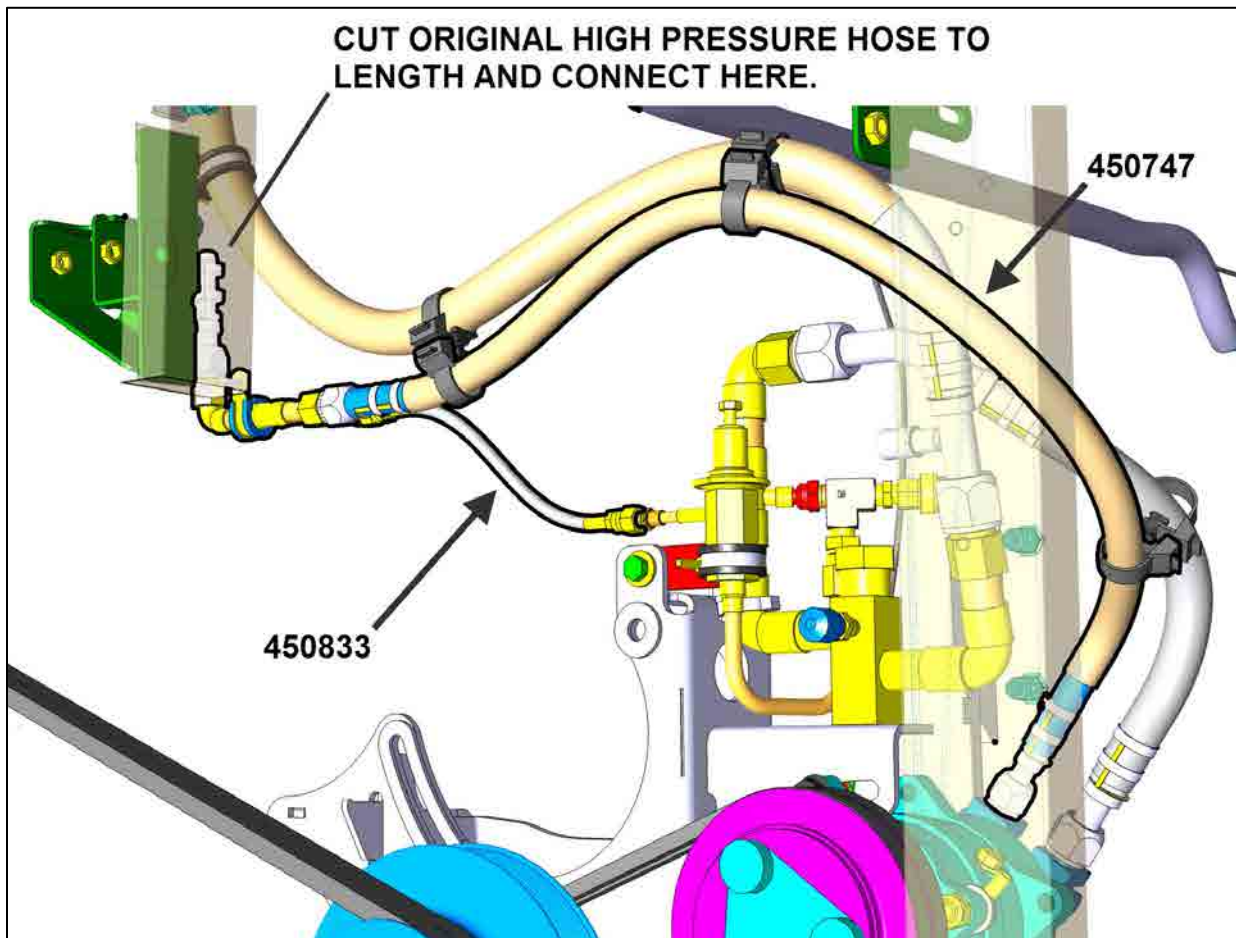
Figure 8 : Hose installation

9. Connect #8 size hose #450747 to compressor high pressure outlet. (Fig. 7 & 8).  
Connect #4 size hose #450833 to bypass valve. (Fig.7 & 8)

10. Connect hoses #450747 and #4 size hose #450833 to hot gas pickup tube (Fig. 8, 9 & 10).

12. Support hose #450747 at required locations to prevent abrasion with #504751 dual swivel cable tie base. (Fig. 8 & 11)

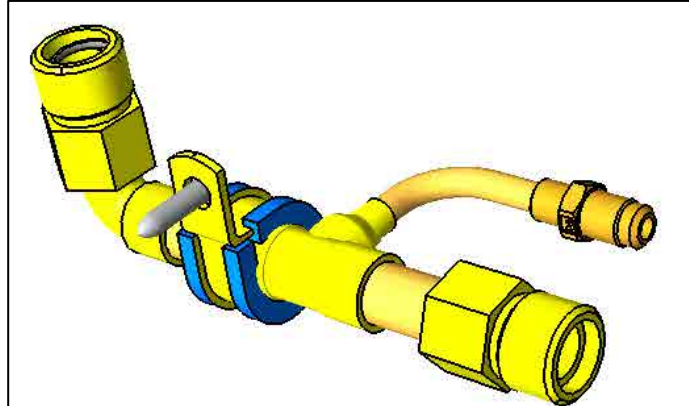
Figure 9 : Hot gas pickup tube

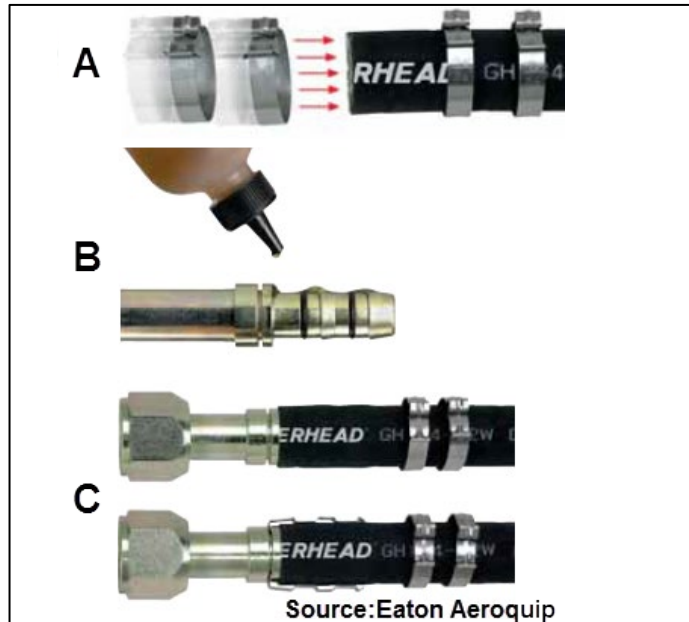
Figure 12 : Eaton E-Z Clip System™

14. (Fig. 12, **A**) Slip the two clamp rings #504761 on the hose.
15. (Fig. 12, **B**) Oil the nipple on fitting #5011319 with oil compatible with A/C systems. This must be done to ease the insertion of the nipple in the hose.
16. Insert nipple in hose up to fitting shoulder. Wipe excess oil.
17. Slip O-ring #507343 in fitting cavity.
18. (Fig. 12, **C**) Snap cage # 504765 in fitting groove over hose. The cage must be able to rotate in the groove.
19. Slip clamp rings over the cage arms and into the channels on each arm. (Fig. 13) Rotate the clamp rings to have the clasp neatly placed between cage arms, not over.
20. (Fig. 13) Close the clips with crimping pliers #504767. The pliers should be placed squarely on the camp ring connection points and remain square during the closing of the clamp.

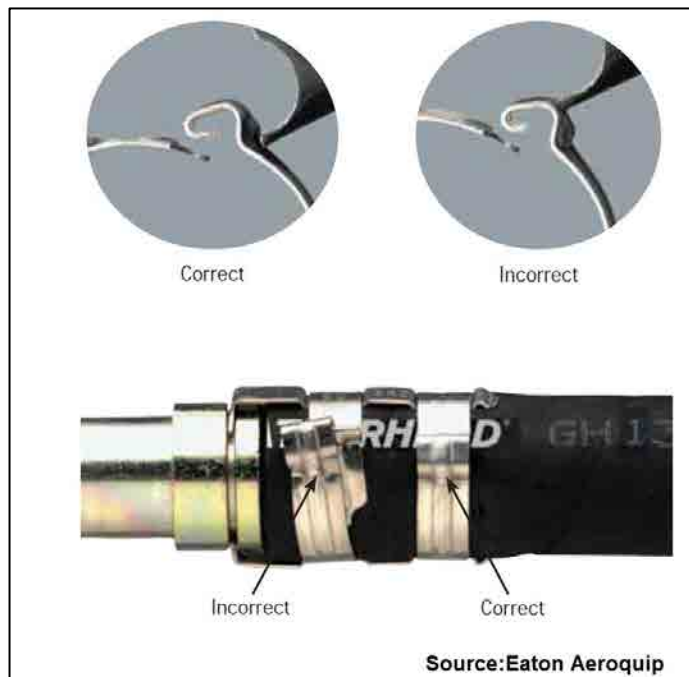
Figure 13 : Clamp ring clasp recommendations

For easiest assembly, the clasp should be closed *between the cage arms*. (Fig. 13)

If the pliers are not kept square during closing of the clip, the clasp may have an offset. Use the pliers to correct the clasp alignment. (Fig. 13)
