**MAINTENANCE  
INFORMATION**

**MI15-45**

DATE :	OCTOBER 2015	SECTION: 18 - Body
SUBJECT :	H3 Series Rear Frame Stress Crack Repair

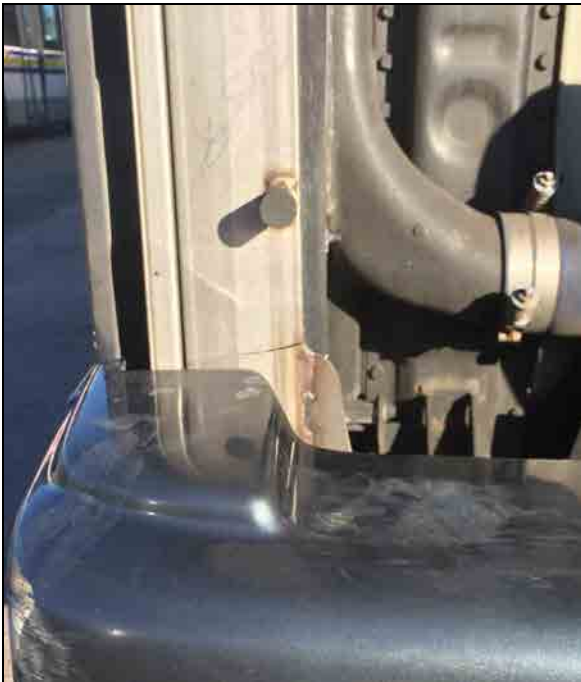
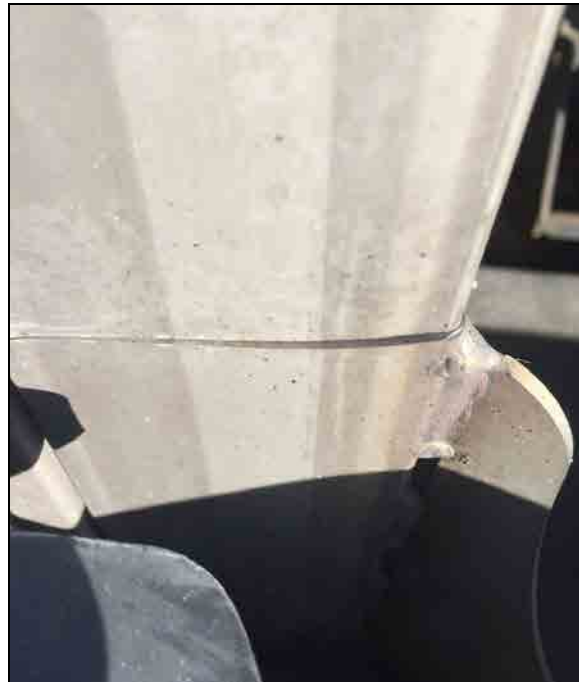
On some 2014 – 2015 H3 Series vehicles, a stress crack can develop in the left rear frame support beam as shown in the pictures below.

On these vehicles, it is possible to install and weld a frame reinforcement in the rear frame support beam to repair the affected area.

The procedure below outlines the steps required to perform this installation on a typical H3 Series vehicle using Kit MI15-45 frame reinforcement.
