BATTERY EQUALIZER INCORRECT PROGRAMMING

Prevost vehicles

On the vehicles affected by this bulletin, one of the 100 Amp Vanner Battery Equalizer may have been incorrectly programmed and must be replaced.

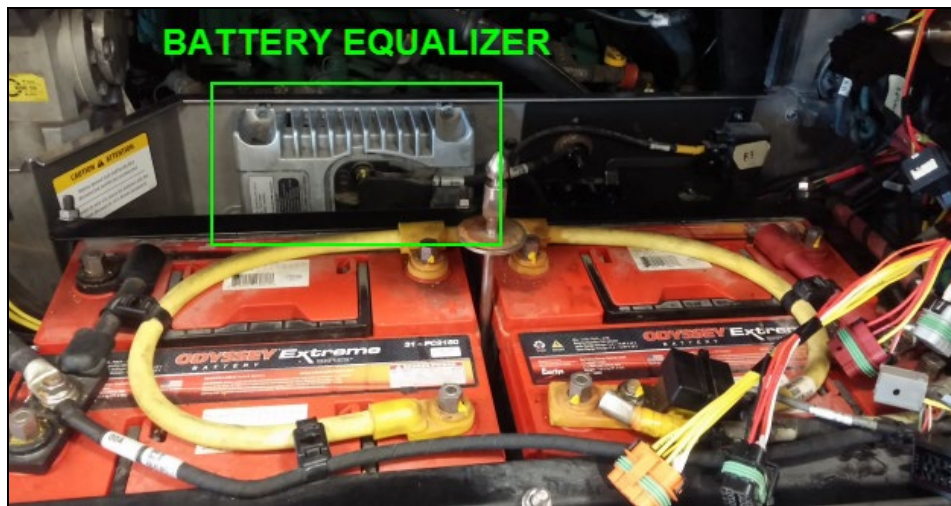
Fig.1 Battery Equalizer location

1. Access the battery equalizer located in the vehicle battery box (rear engine compartment Fig.1 and Fig.2 below).

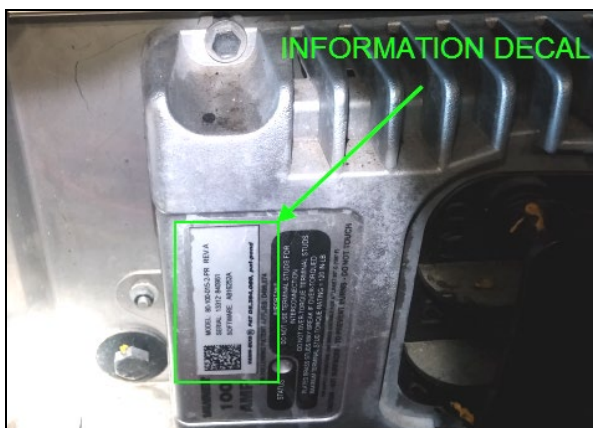
Fig.3 Information decal location

2. On the battery equalizer, validate the unit serial number located on the information decal applied on the left side of the equalizer body (Fig.3 & 4 below).

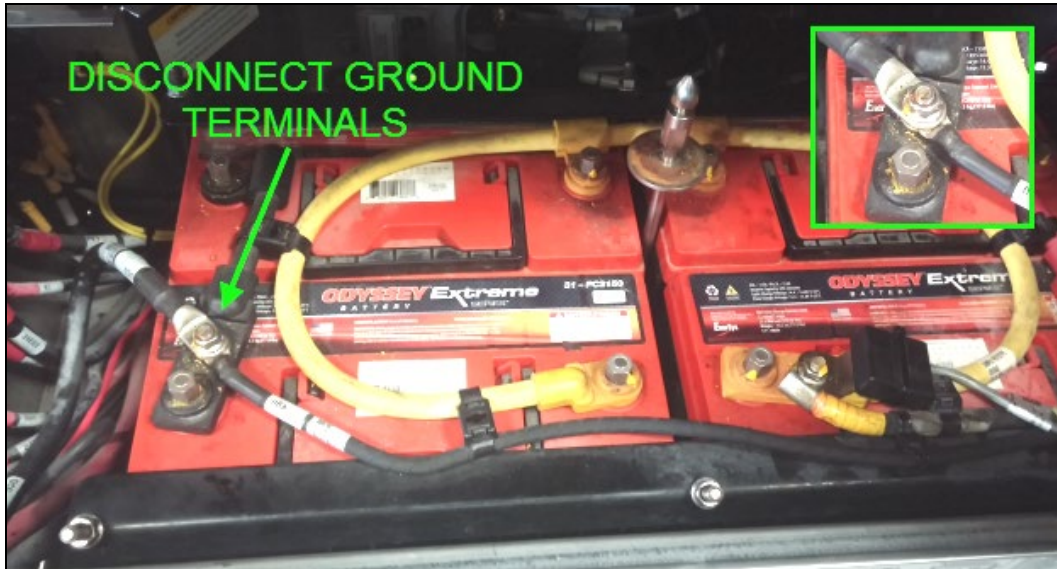
Fig.5 Battery ground terminals to be disconnected first

- On the affected vehicle, first disconnect the batteries starting with the battery ground terminals (Fig.5).

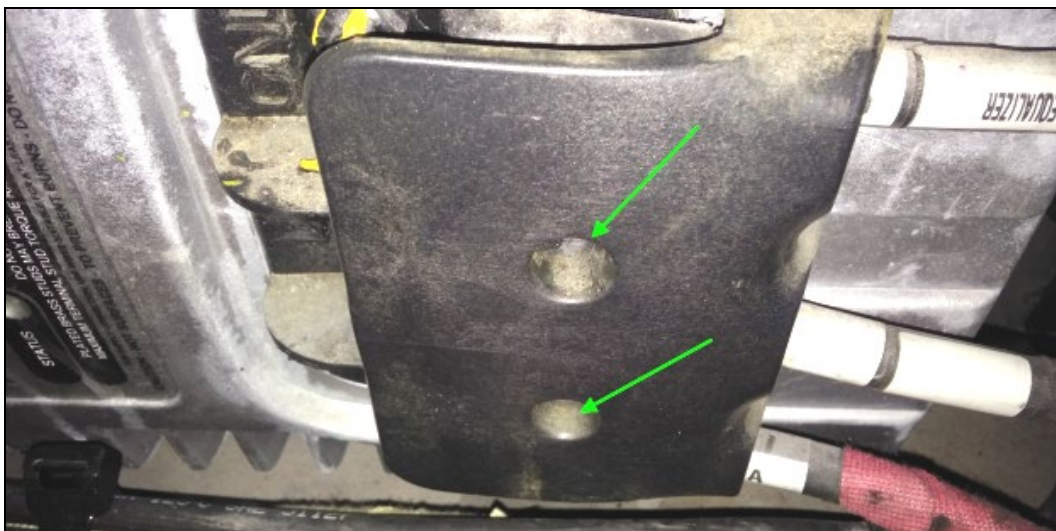
Fig.6 Equalizer wire cover screw location

- Remove the equalizer wire cover (two Phillips head screws identified by arrows in Fig.6 below).

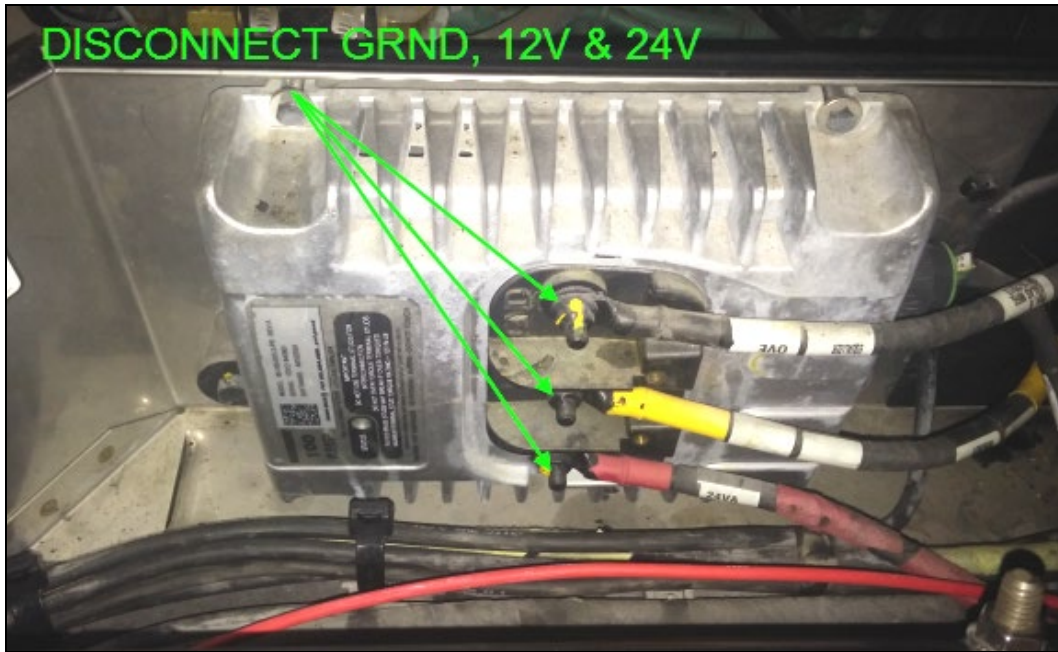
Fig.7 Equalizer power wires and terminal posts.

5. Disconnect the equalizer ground, 12 volt & 24 volt power wires (Fig.7).

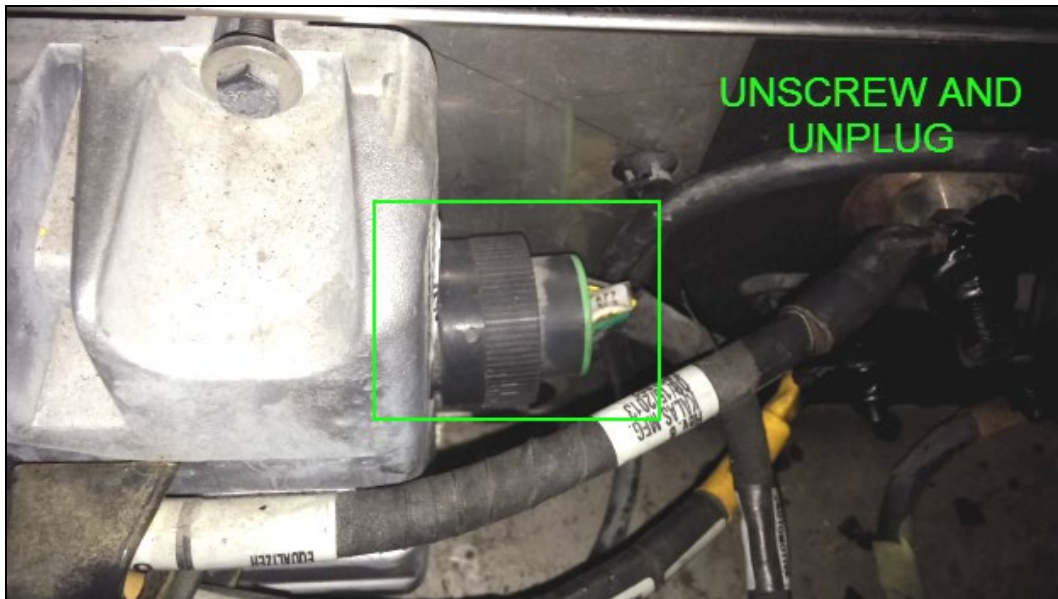
Fig.8 Equalizer side connection & harness

6. Unscrew and disconnect the equalizer side plug show in Fig.8.

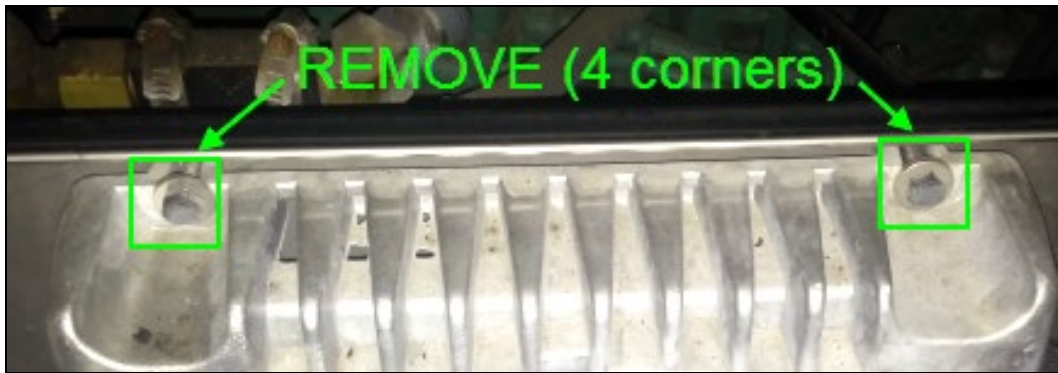
Fig.9 Equalizer top mounting hex bolts

- Remove the four hex bolts at each corner holding the equalizer to the battery box body (top bolts shown in Fig.9 below).

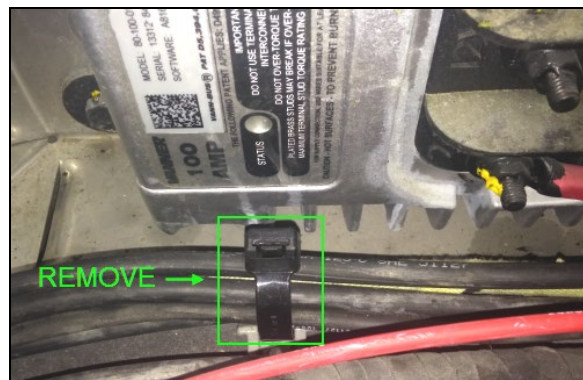
**NOTE:** It may be necessary to cut the cable ties holding the vehicle harness at the bottom of the battery box and move the harness away to access the equalizer lower hex bolts.

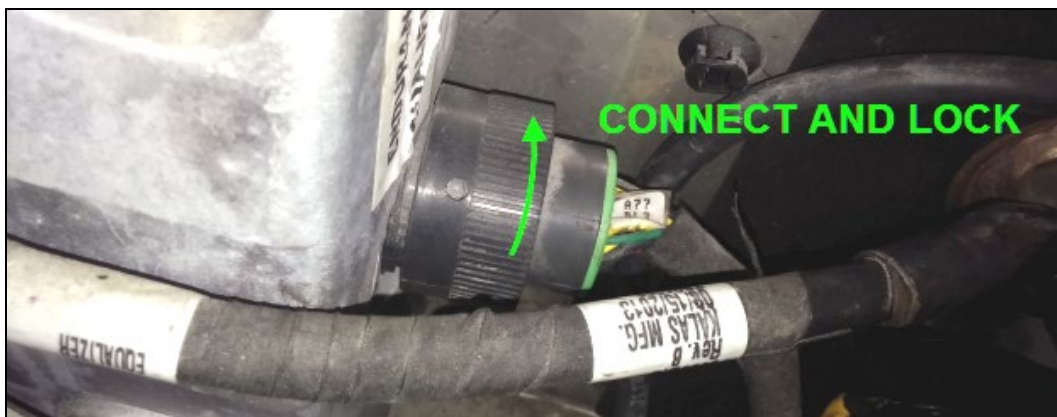
Fig.10 Reconnecting Equalizer harness

- Install the new equalizer using the four hex bolts previously removed
- Reconnect and lock (screw) in place the equalizer side plug (Fig.10).

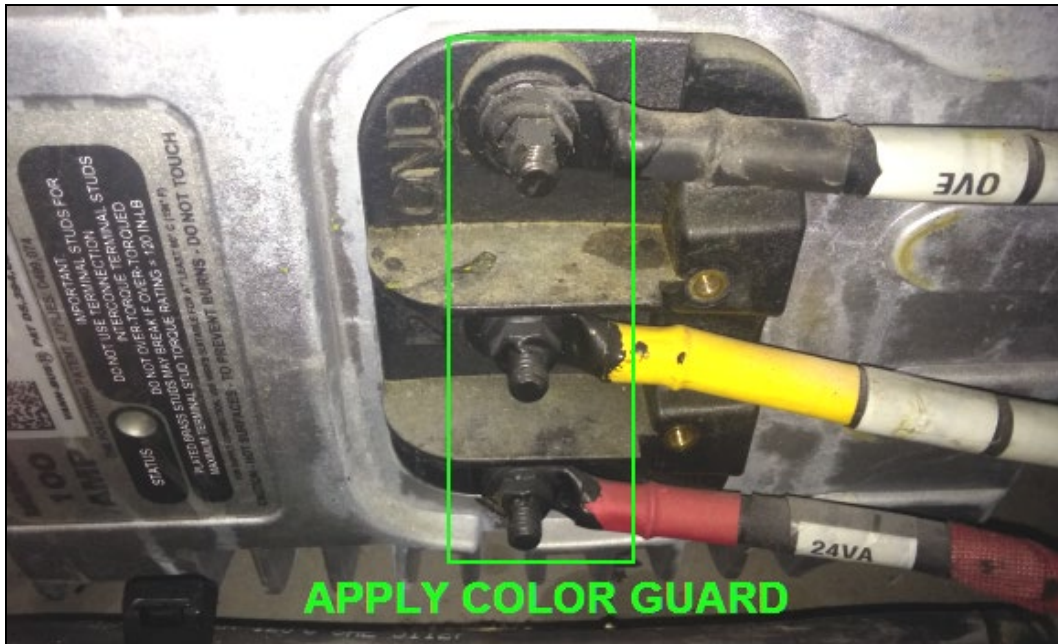
Fig.11 Reconnected power wires and Color Guard application

10. Reconnect the equalizer 12 volt, 24 volt and ground terminals (Fig.11).
11. Apply black Color Guard spray to the three terminal posts and let it dry (Fig.11).

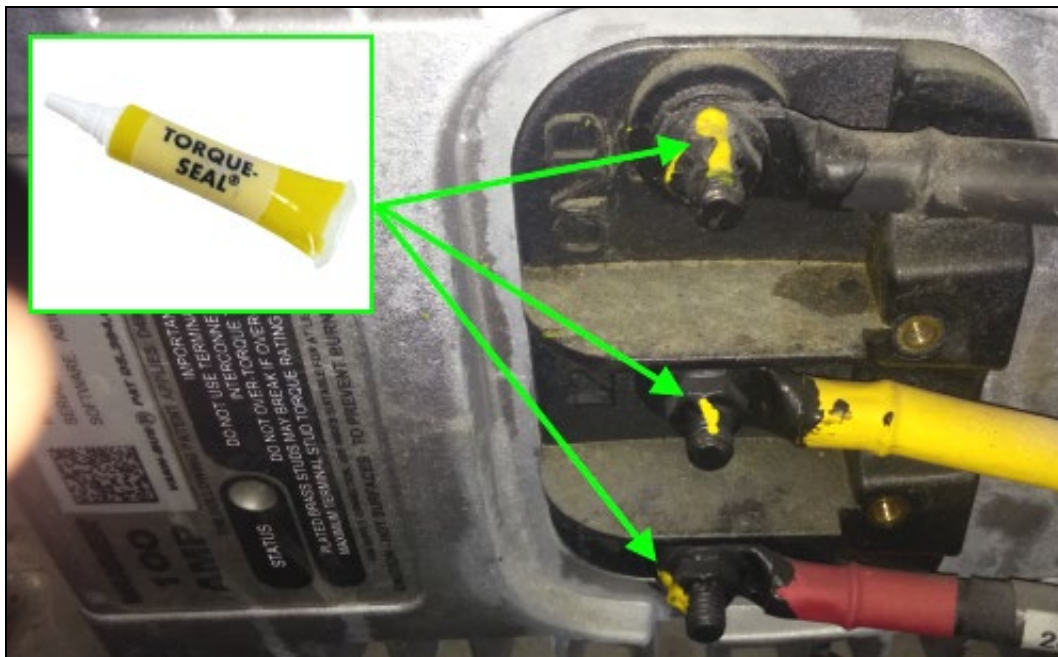
Fig.12 Torque Seal inspection lacquer application

12. Apply a small amount of yellow torque seal inspection lacquer over the dried terminal posts (Fig.12).

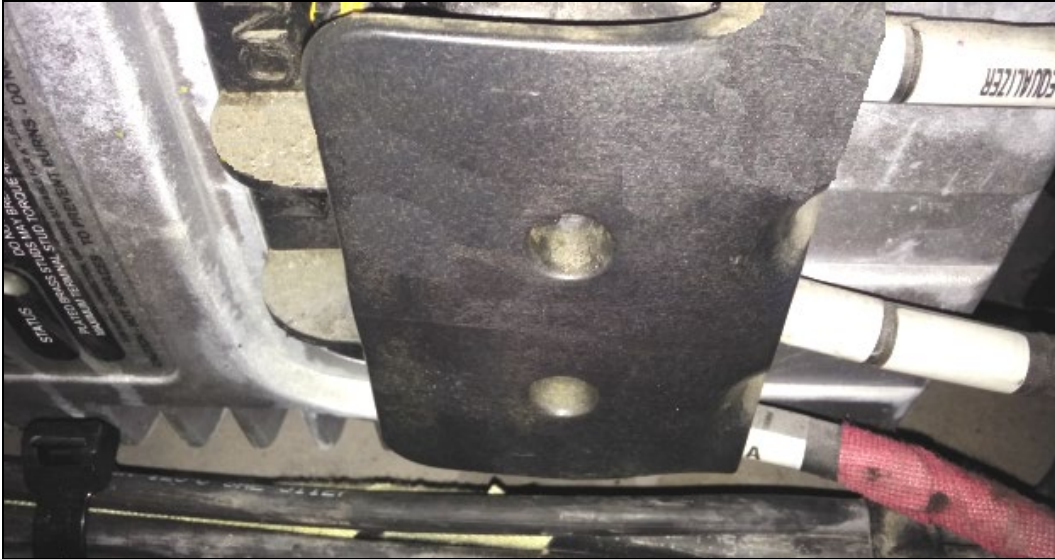
Fig.13 Reinstalled wire cover

13. Reinstall the equalizer wire cover shown in Fig.13.

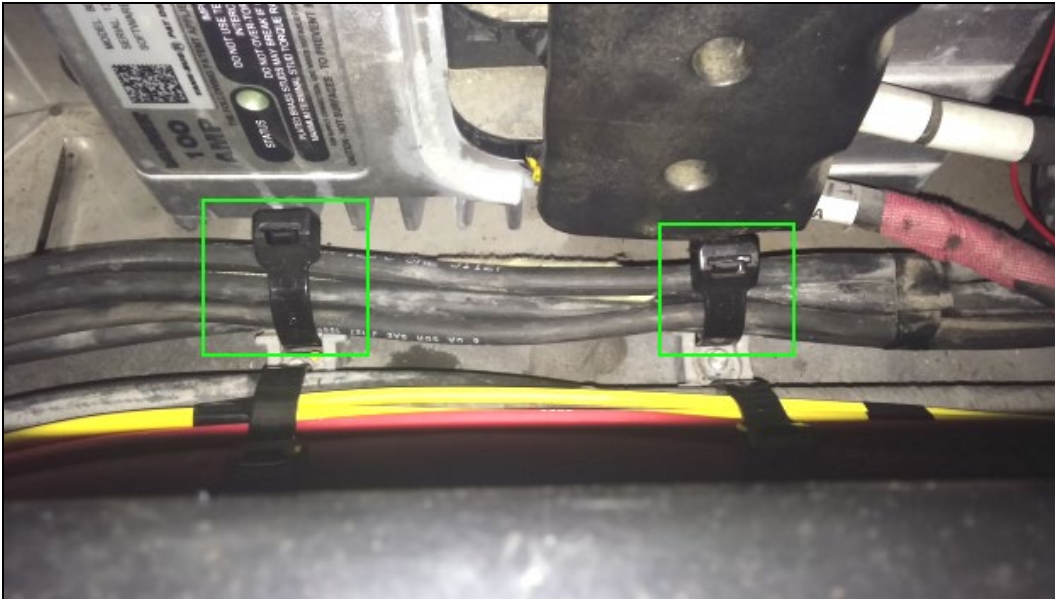
Fig.14 Installed cable ties

14. Reinstall new cable ties at the bottom of the battery box if previously removed during step 7 (Fig.14).

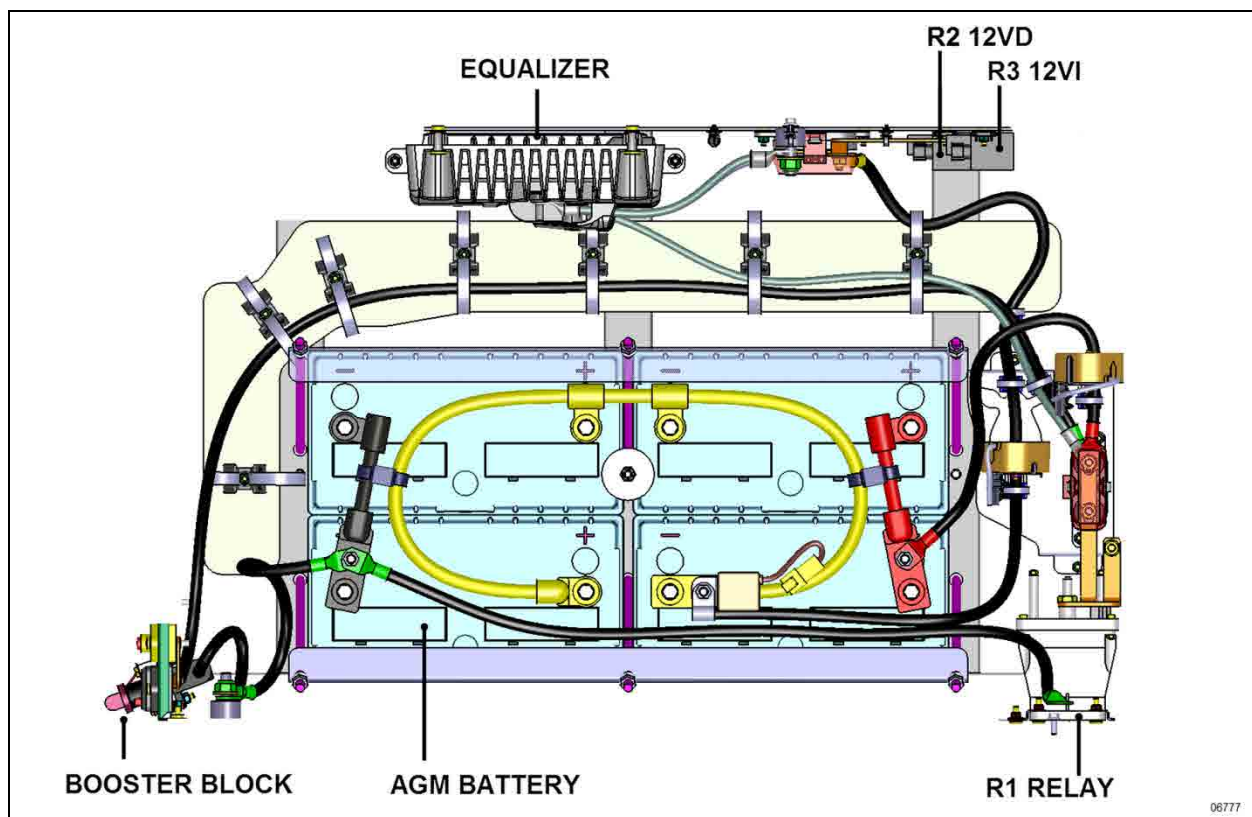
Fig.15 Battery compartment overview

15. Reconnect the batteries following Fig.15 below (apply a small amount of torque seal to the connections).

Positive terminals must be connected first and ground last to prevent sparking.
