PREVOST

**WARRANTY
BULLETIN**

WB15-50

DATE :	DECEMBER 2015	SECTION :	18 - BODY
EXPIRATION:	DECEMBER 2017		
SUBJECT :	REAR JUNCTION BOX DECAL, R34 RELAY INFO

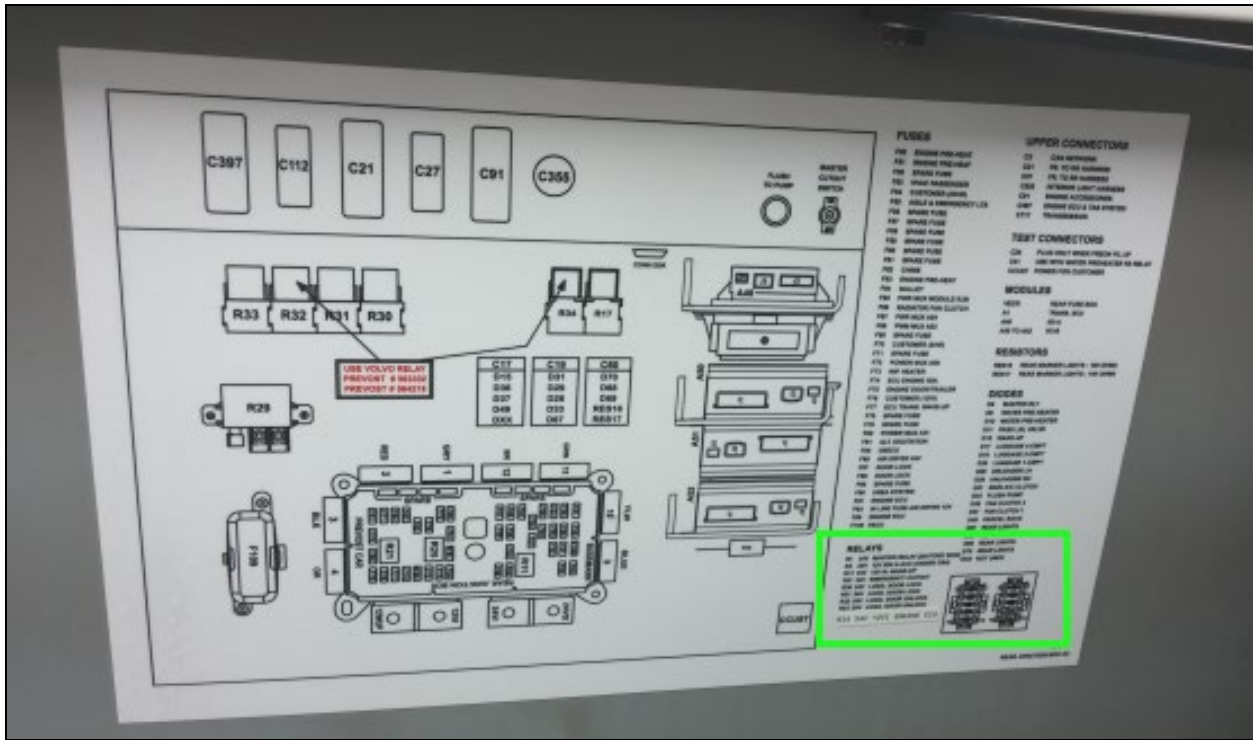
Fig2. Typical relay identification area - Rear Junction Box decal (X3 Coach Shown).

1. Open the vehicle right engine door and locate the rear junction box decal (Fig.1 & 2).

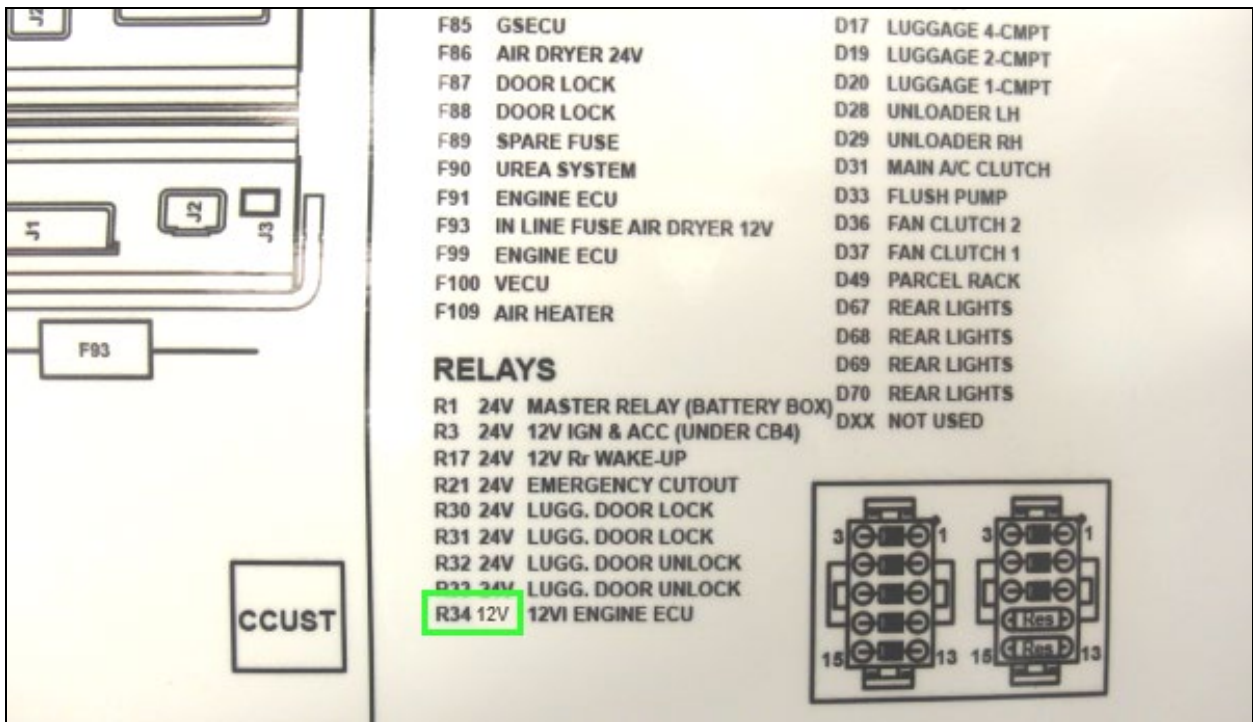
On the vehicles affected by this bulletin the rear junction box decal located in the right engine compartment is displaying incorrect information regarding the R34 relay voltage.

Specifically, the R34 relay should be identified as a 24 volt relay instead of a 12 volt relay.

2. On the decal lower right corner, validate that the R34 relay description is inaccurate (Fig.3) and identifies the relay as being a 12 volt relay (12V) instead of a 24 volt (24V).

Fig.3 R34 Relay incorrect 12V information (X3-45 Coach Shown).

Consequently, all affected vehicles must have a small decal displaying the correct information applied over the rear junction box decal R34 relay description.

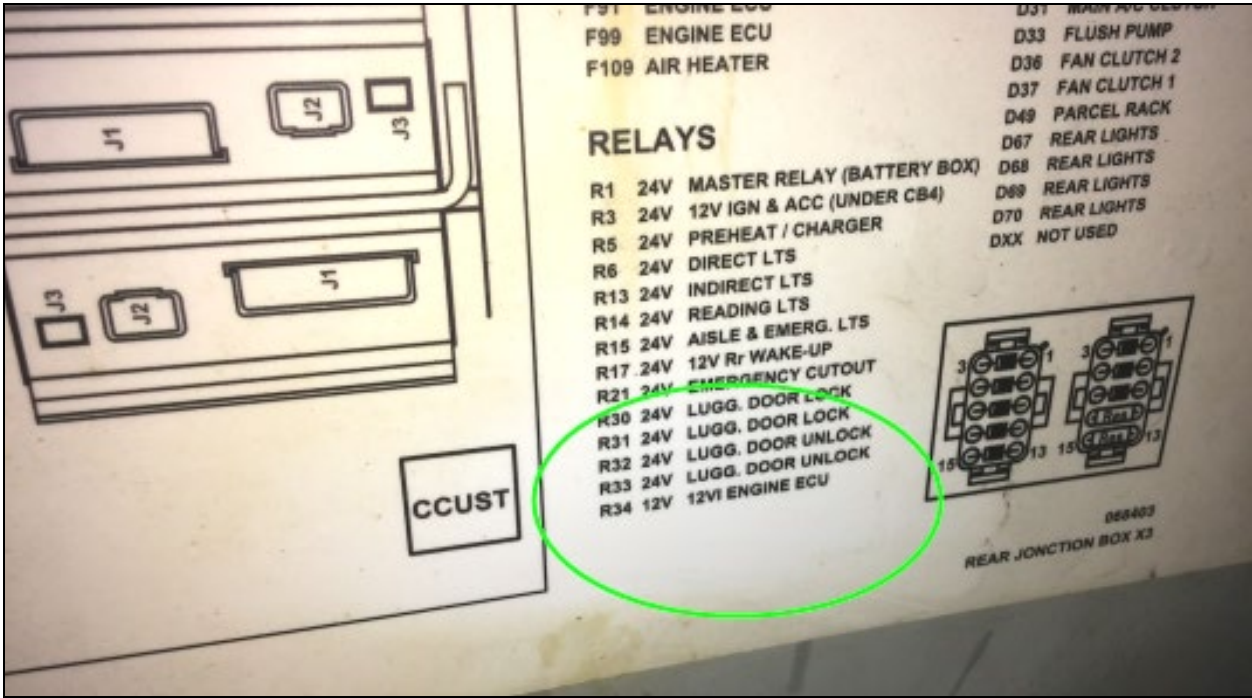
Fig.4 Cleaned area before decal application (Older X3-45 Coach Shown).

3. To ensure proper adhesion of the new decal, carefully clean the area from grease, dirt and road grime (Fig.4).

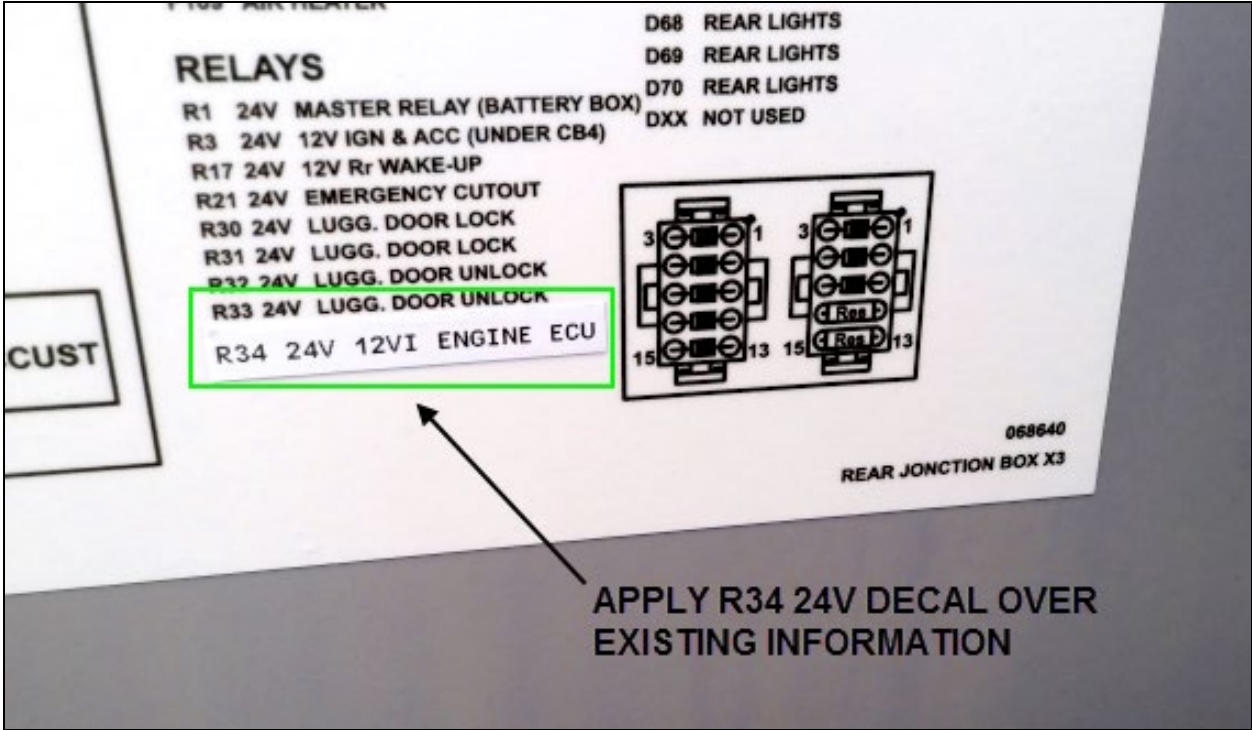
Fig.5 Decal showing correct R34 voltage (X3 Coach Shown).

4. Apply the new decal over the existing 12 volt information as shown on Fig.5 and make sure of proper adhesion (apply pressure on the entire area with a plastic card or scraper. In cold weather, apply moderate heat as necessary).
