# Front Seat Side Shield is Loose or Separating - 8/10 way Power Seat

14-16MY Highlander/HV

2014-2016	Highlander	2014-2016	Highlander HV
-----------	------------	-----------	---------------

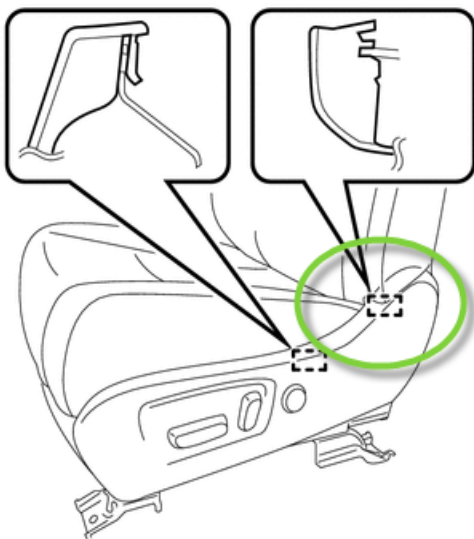
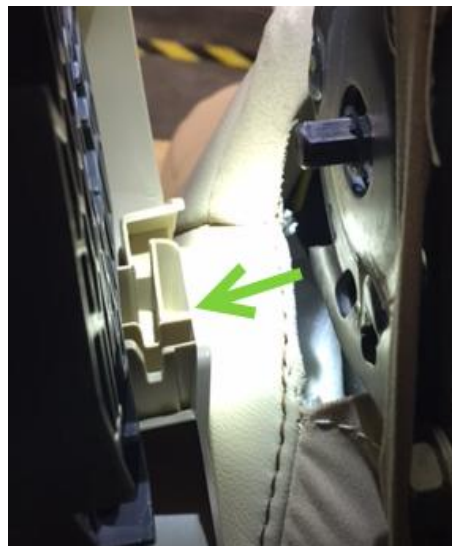
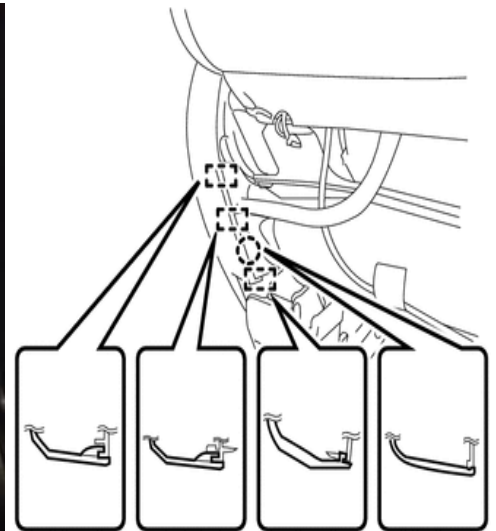
Some vehicles may exhibit a condition in which the front corner mounting point of the side shield would separate from the lower frame assembly. This condition may occur when the customer enters or exits the vehicle and significant downward pressure is placed directly on the seat cushion shield. This condition could also potentially show a significant gap at the top of the shield to the cushion, or complete separation from either the front or rear retainer/engagement points.

3. Install the lower frame side shield.
  - a. Follow Repair Manual instructions until Step 35 – G.
  - b. Skip to step 35 – J & K and install the rear lower frame side shield locating tab as shown in the Figure below. Install only the rear locating tab of Step 35 – J and all retainers on Step 35 – K. This is very difficult since the locating tab and the rear engagement points will need to be done in 1 overall step.
