Seat Cover Material Loose at Front Edge

Service Category Vehicle Interior

Section Seat

YEAR(S)	MODEL(S)	ADDITIONAL INFORMATION
2013 - 2014	Avalon, Avalon HV	
2012 - 2014	Camry, Camry HV

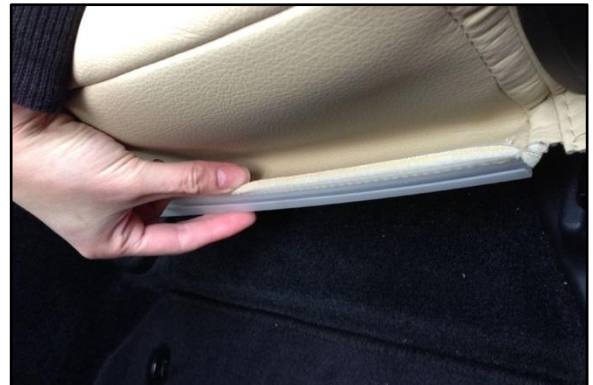
Figure 1.

1. Confirm seat bottom cover material has separated from flange.

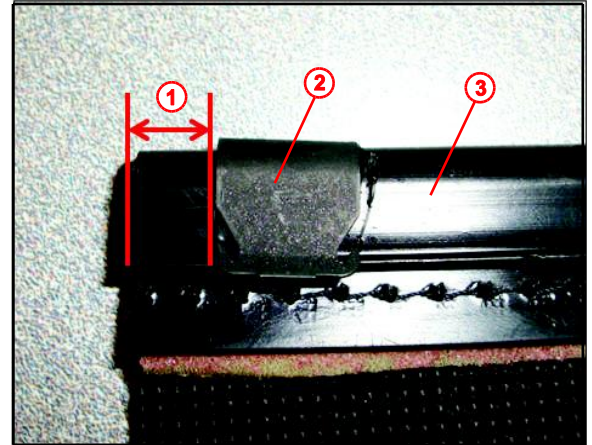
Figure 3.

1	10 mm
2	U-Clip
3	J-Hook

4. Reinstall seat bottom cover material (J-Hook with additional U-clips) to seat frame flange.

Ensure that both the J-Hook and U-Clips are fully seated on the seat flange.
