# Program Bulletin

## CUSTOMER SATISFACTION PROGRAM

**SUBJECT:** Engine Harness Chafing On EGR Stud

**MODELS:** 2015 Chevrolet Silverado HD  
2015 GMC Sierra HD  
Equipped with the Duramax Diesel 6.6L Engine (RPO LML)

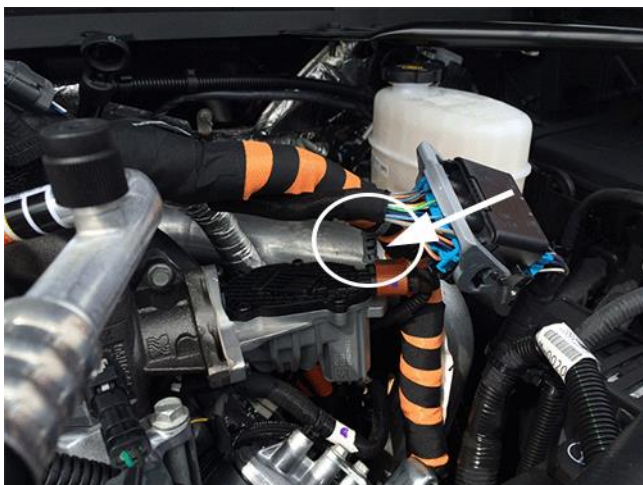
4290172

3. Disconnect the X107 (36 way) connector and reroute the male end under the main engine harness (orange flex wrap) and reconnect X107 connector.

4. Locate and install the gray standoff clip onto the EGR stud.
5. Remove fender covers and close hood.
