## Overview of noises in interior of model series 176/117

| Topic number | LI68.00-P-059550 |
| Reason for change | Update of noise sources |

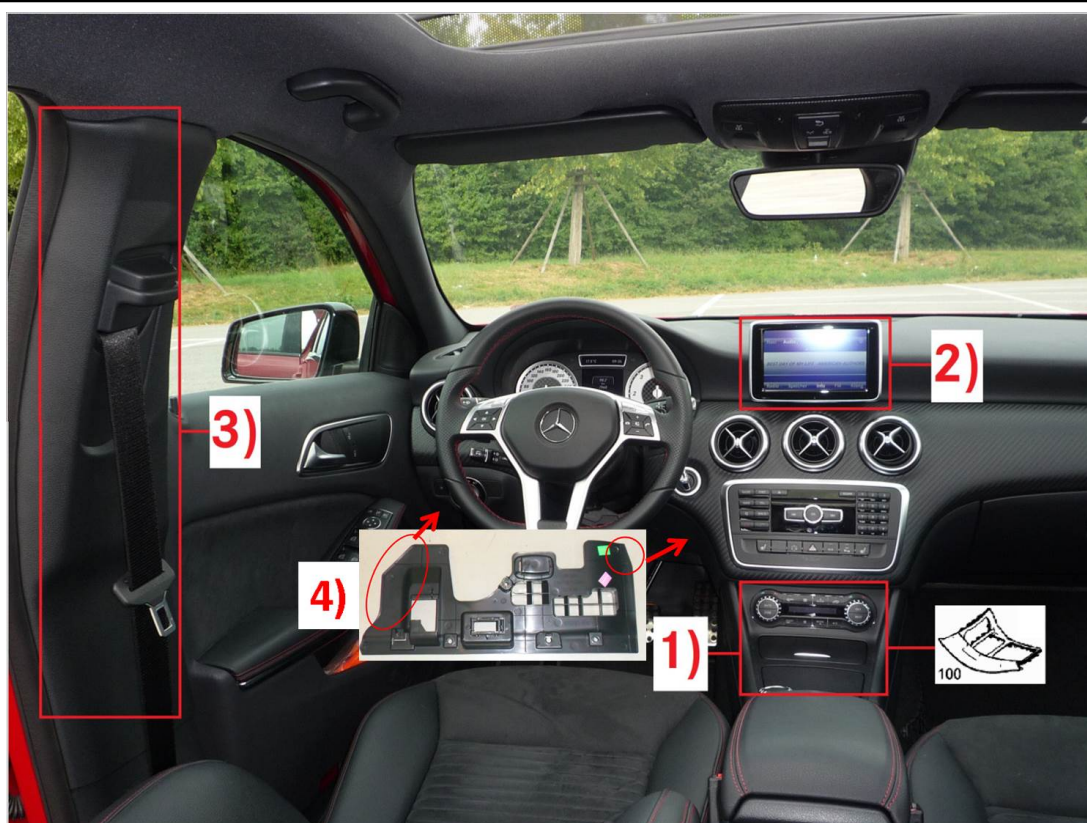
Possible noise locations.  
jpg:

\*\*\*Fault locations and designations can be found in the attachment "Fault locations"\*\*\*

Creaking noises in area of A/C operating unit

Rattling noises on rough or bumpy roads

Noises in area of B-pillar trim or belt height adjuster at front left or right

Dynamic excitation produces vibrations and noises in the instrument panel which are difficult to locate.

| Attachments | |
|---|---|
| Possible noise locations.jpg | Noise locations |

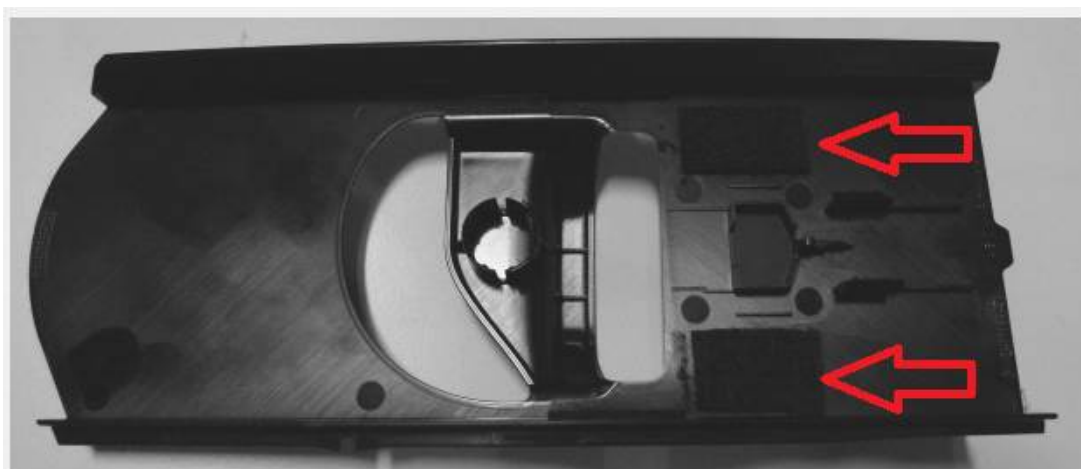
Picture1.jpg:

3b)c) The B-pillar trim makes noises

| Attachments | |
|---|---|
| Picture1.jpg | For fault location 3) B-pillar trim: Affix felt |

3c) On all vehicles produced after 30.05.2013 the belt extender can be lined with felt. To do this, detach belt extender and affix two pieces of felt (1mm thick) of dimensions 20 x 30 mm (see attachment "Bild1.jpg"). Then reinstall the belt extender (see attachment "Bild2.jpg")

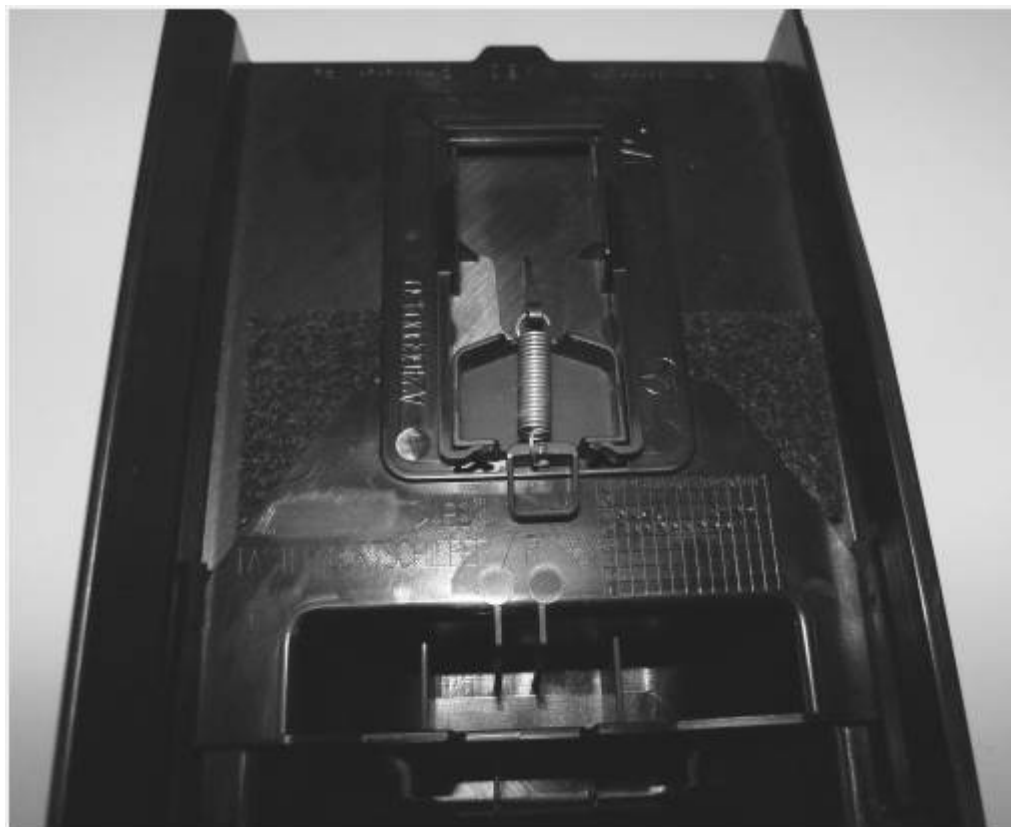
Picture2.jpg:

| Attachments | |
|---|---|
| Picture2.jpg | For fault location 3) B-pillar trim: Result |

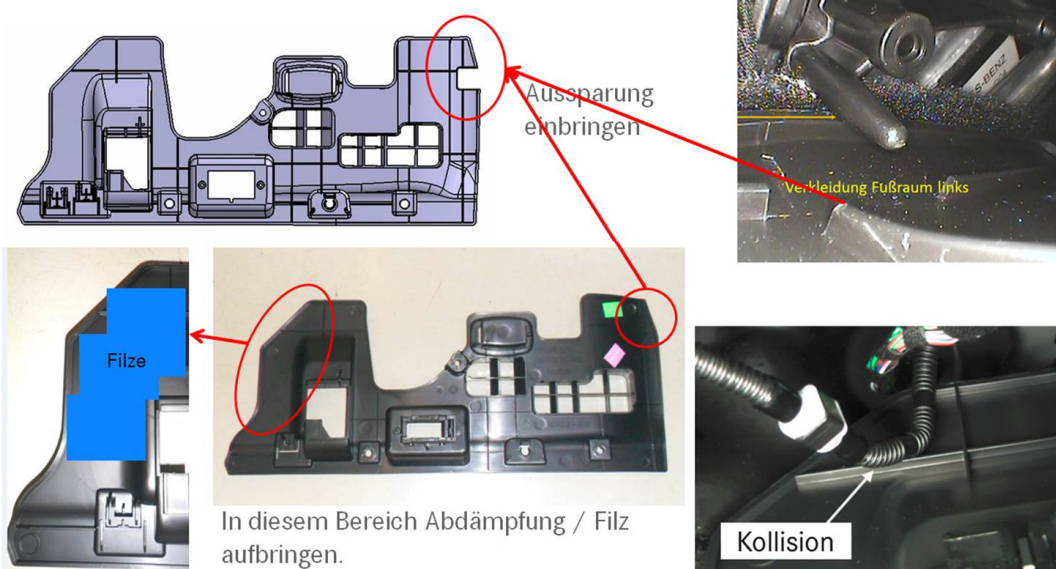
Picture3.jpg:

- The A/C housing partially touches the edge of the footwell cover on the right if the tolerances are unfavorable.

- The washer fluid hose and the coupling element partially touch the footwell cover on the left.

| Attachments | |
|---|---|
| Picture3.jpg | For fault location 4) Footwell cover |

Fußraumabdeckung:

A 156 680 27 00, A 176 680 00 06, A 176 680 05 06

- Trim the footwell cover to eliminate the interference zone.

- Felt (min. 1 mm height) should be affixed in the interference zone of the washer fluid hose.
