Odor from the air conditioning

Topic number	LI83.30-P-059119
Version	3
Design group	83.30 Air conditioning
Date	06-26-2015
Validity	166.0 up to A428283 166.8 up to A428728
Reason for change	Damage code revised. Remedy, work units modified
Reason for block

Odor from the air condition at series 166

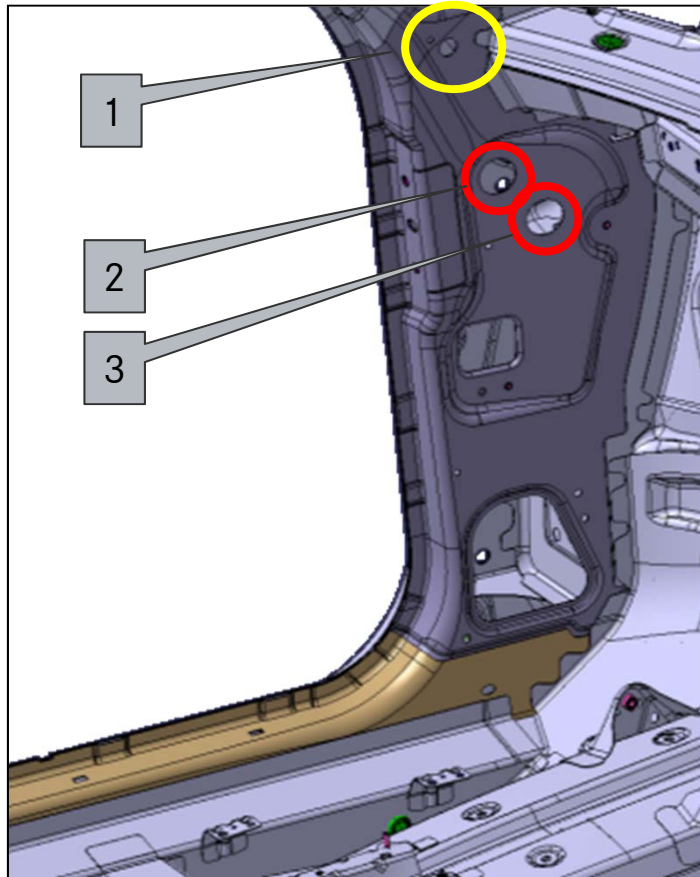
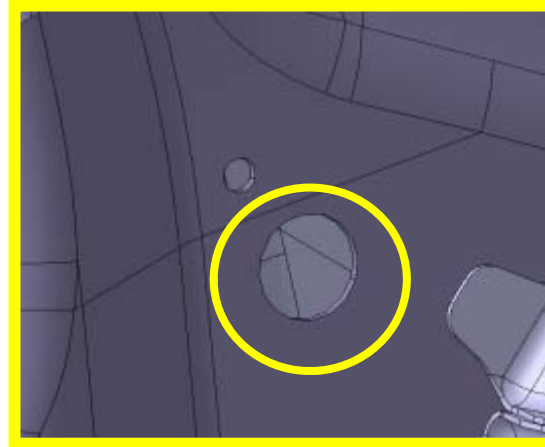
A 003 997 55 86
Ø 20 mm

Close holes (1, 2, 3) with plugs

- Remove A-pillar paneling on left and right
- Close bodysHELL hole (1) with a stop plug as per "Repair instructions TIPS.pdf"
- Install A-pillar paneling on left and right

- Install interior trim at right and left entrances
- Remove covers under instrument panel
- Remove glove box
- Close bodysHELL holes (2, 3) with stop plugs as per "Repair instructions TIPS.pdf"

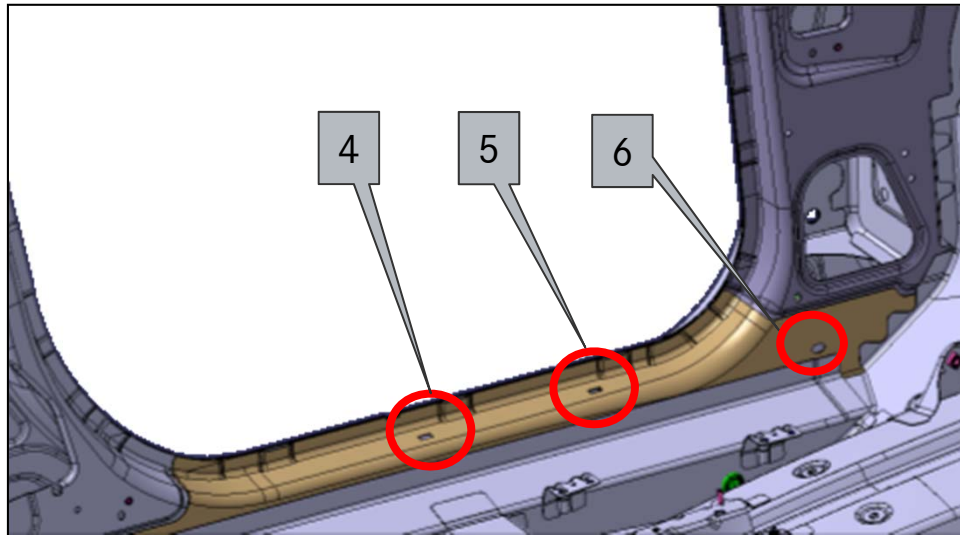
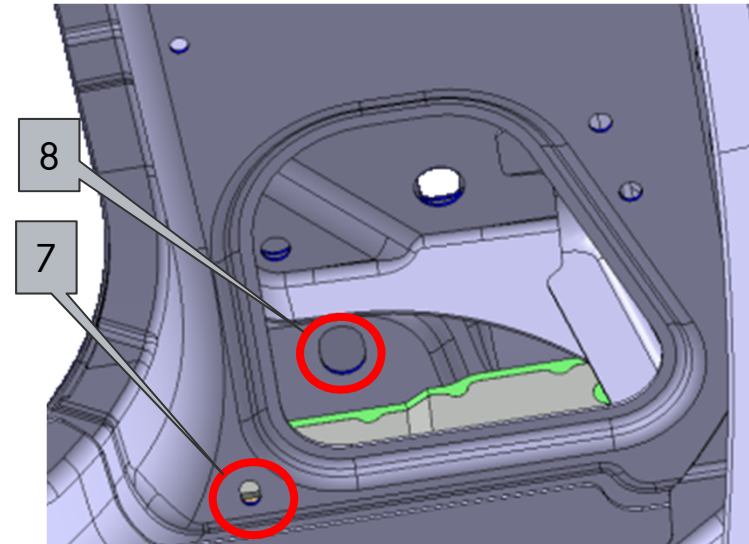
Close holes (4, 5, 6, 7, 8) with tape A 006 989 30 85

- Remove interior trim at right and left entrances
- Tape up bodysHELL holes (4, 5, 6) as per "Repair instructions TIPS.pdf" (trim adhesive tape to size as required)

- Remove radar sensors control unit
- Remove Night View Assist control unit
- Remove front SAM control unit
- Remove foam piece
- Tape up bodysHELL holes (7, 8) as per "Repair instructions TIPS.pdf" (trim adhesive tape to size as required)

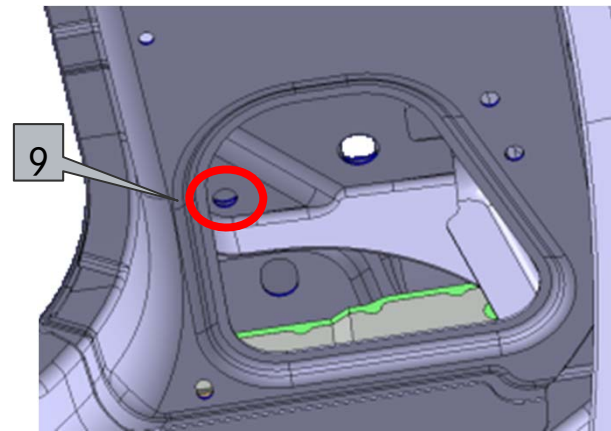
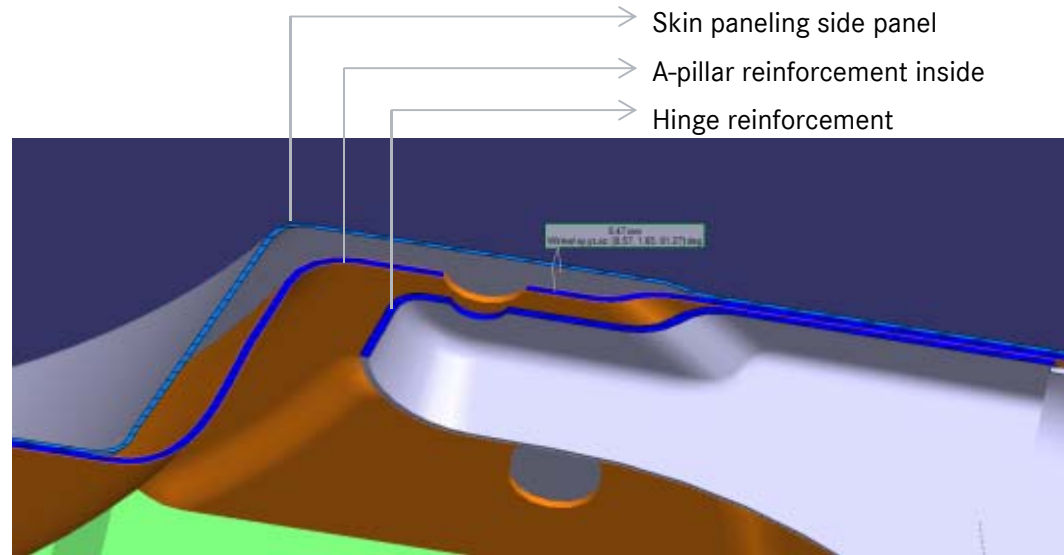
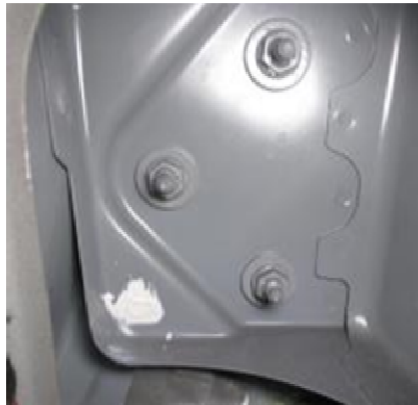
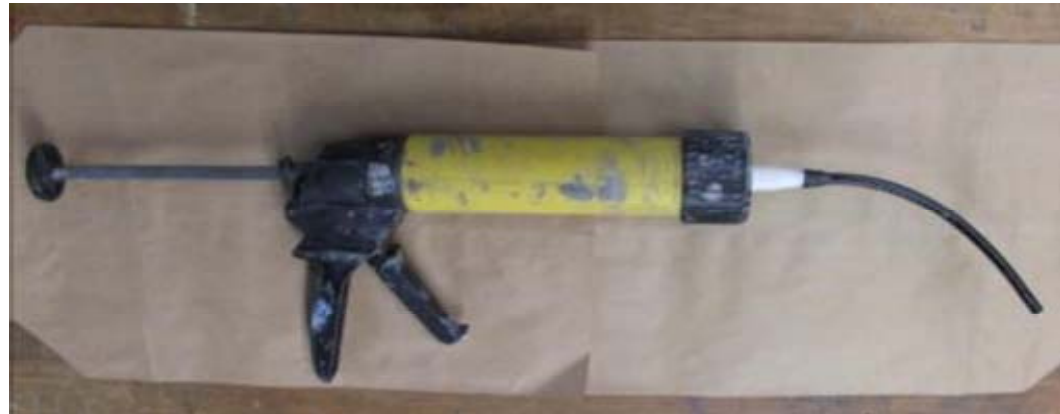
Close hole (9) with sealing A 005 989 6320

Lead hose through the hole (9) to the skin paneling side panel. Pull out the hole slowly and apply sealing material until the cavity between the panels is completely filled.

- Seal off bodysHELL holes (9, 10) with seam sealant as per "Repair instructions TIPS.pdf". To apply the seam sealant, fit the hose on the cartridge nozzle and pass it through the bodysHELL hole (9, 10).

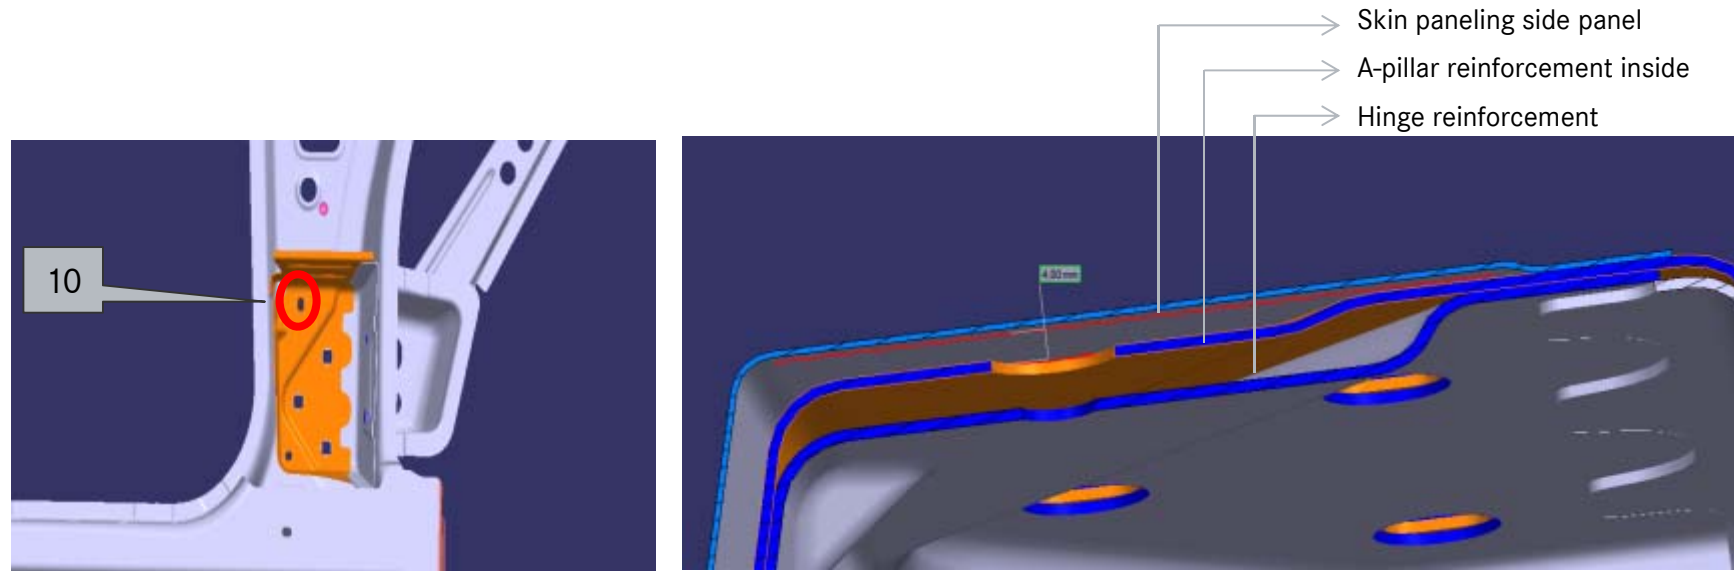
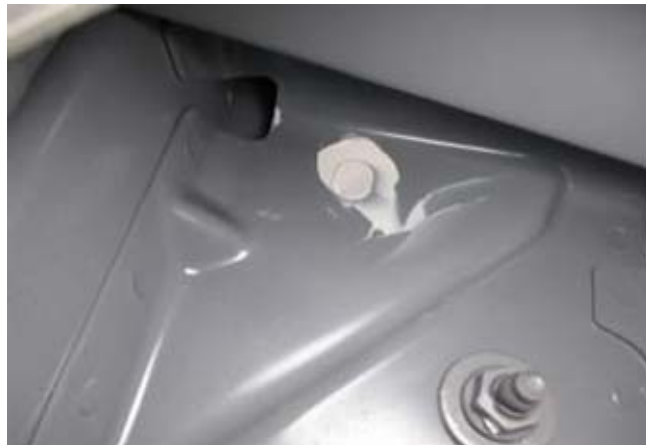
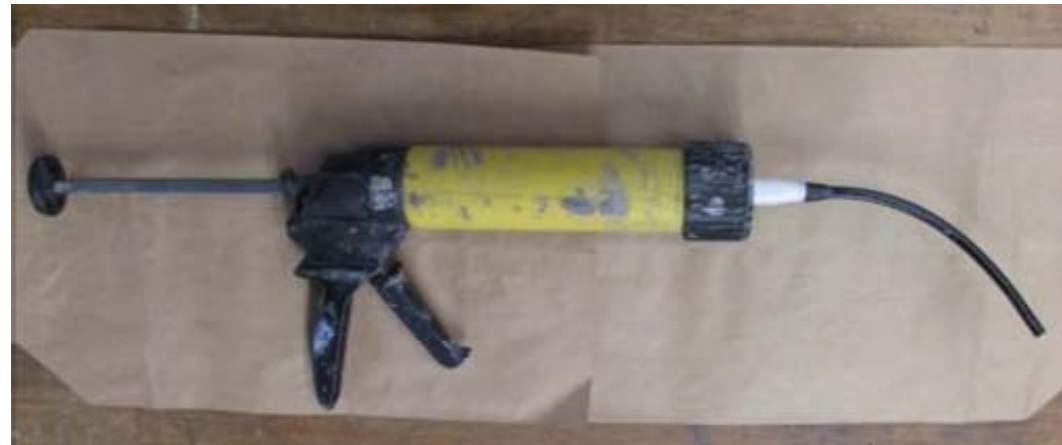
Close hole (10) with sealing A 005 989 6320

Lead hose through the hole (10) to the skin paneling side panel. Pull out the hole slowly and apply sealing material until the cavity between the panels is completely filled.
