## Creaking noise from rear backrest bearing on door side

| Topic number | LI91.12-P-061755 |
| Design group | 91.12 Rear seats |
| Validity | Model series 222 with code 223 or code 224 Individual rear seat system |

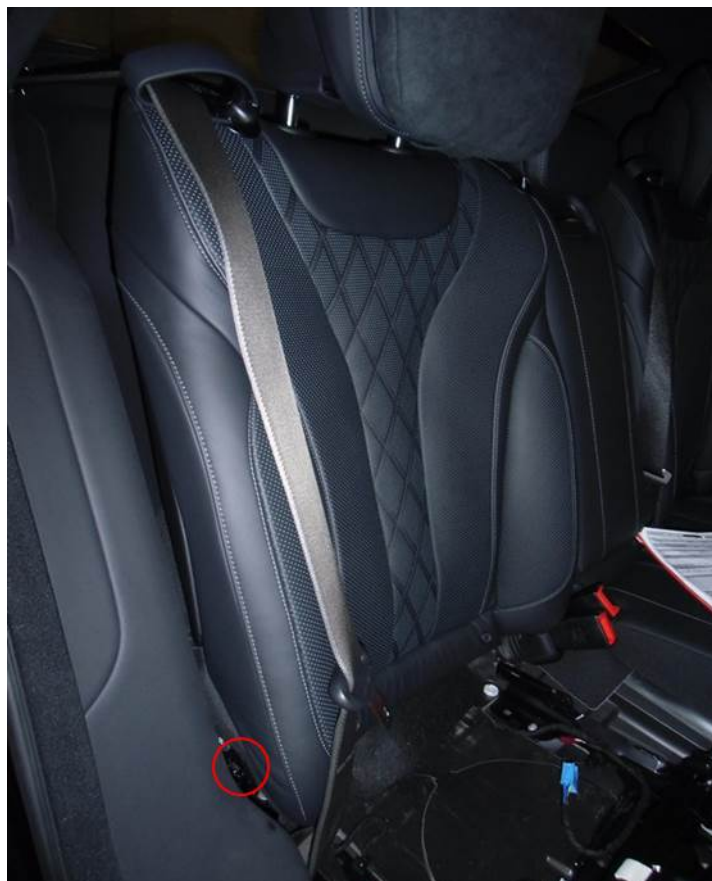
pic 1.jpg:

Creaking and squeaking noises when the rear backrest is loaded on the door side (Fig. 1)

| Attachments | |
|---|---|
| pic 1.jpg | Rear backrest bolted connection on door side |

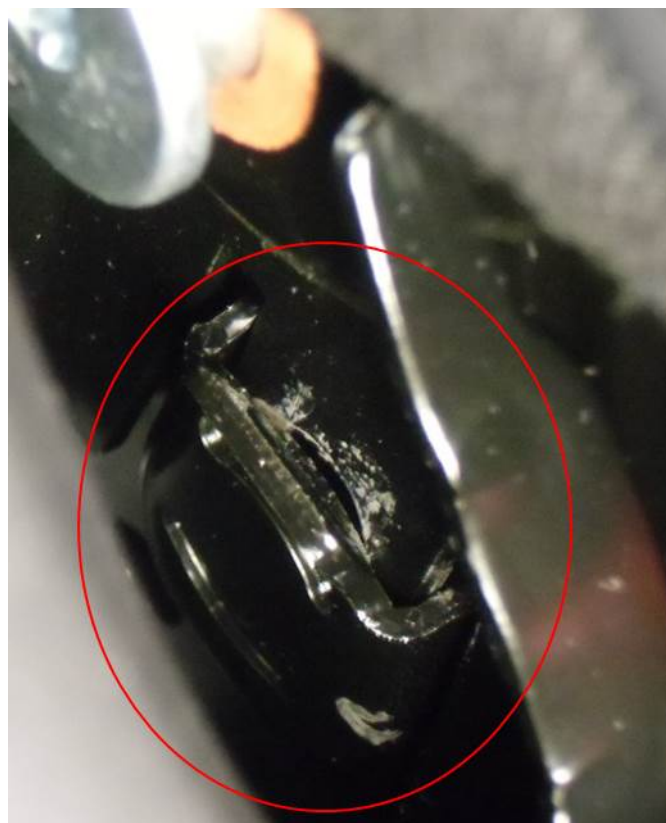
pic 2.jpg:

The lateral pressure of the upholstery between the backrest cushion sides and the wheel arch liner or the pressure of the assembly protector on the wheel arch liner causes the bearing guide of the door-side fitting does not always reach the correct position for installing the bolts.

As a result, the bearing has too much play and can cause noises. (Fig. 2)

| Attachments | |
|---|---|
| pic 2.jpg | Door-side rear backrest bearing not in lowest end position |

1. Slacken the bolted connection of the rear backrest frame with the problem.
2. When bolting down the backrest, make sure that the bearing on the door side is correctly seated and shake the backrest into the required end position before tightening the bolted connection with the torque wrench. This is shown in Fig.3, item 10 and in AR91.12-P-1620LFA under item 10.

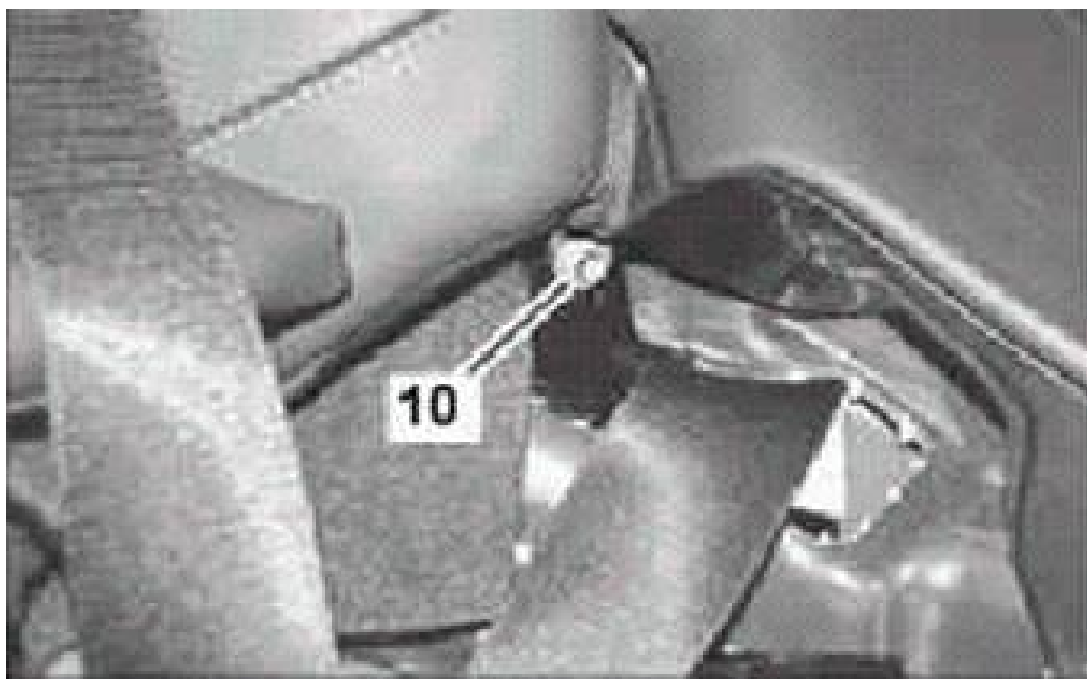
pic.3.jpg:

| Attachments | |
|---|---|
| pic.3.jpg | Bolt of door-side rear backrest bearing; item 10 |
