# Service Bulletin

**Subject:** Front Fascia Lower Air Dam Exhibits Poor Fit and/or Appears Mismatched, Wavy or Gapped to Fascia

**Models:** 2010-2016 Cadillac SRX

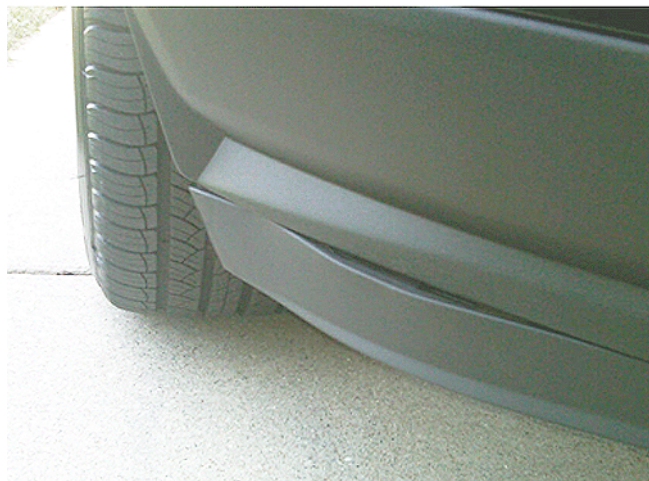
#### Passenger Side Air Dam

Some customers may comment that the front fascia lower air dam fits poorly to the fascia. The common descriptions are that the dam appears mismatched, wavy or gapped to the fascia. Some examples are shown in the graphics below.

**In order to obtain the proper fit, it is important to follow the Installation instructions included in each front lower air dam kit. No additional parts are necessary as all components are included in the kit.**
