# Service Bulletin

**Subject:** Transmitter/Fob Appearance After Integrated Blade Removed

**Models:** 2010-2015 Chevrolet Camaro

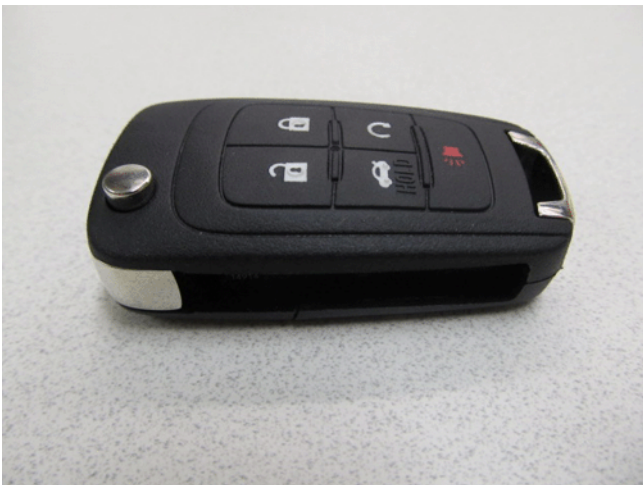
Some customers may comment on the appearance of the transmitter after the integrated blade has been removed.

2010-2014 Camaro

- This will occur after Recall #14294 has been performed.
