Service Bulletin

Subject: Information on Anti-Abrasion Tape Located on Underside of Rear Liftgate or Rear Compartment Lid

Models: 2016 Chevrolet Corvette

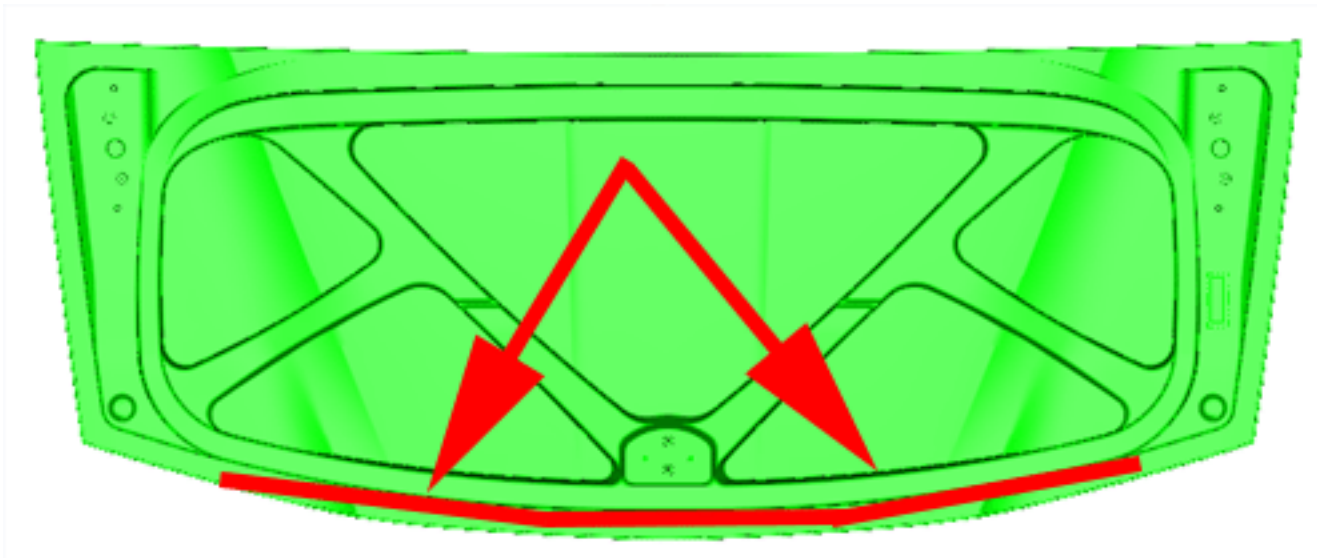
Convertible Anti-Abrasion Tape Locations

Some customers or technicians during Pre-Delivery Inspection (PDI) may notice a strip of black anti-abrasion tape attached to the underside of the rear liftgate or rear compartment lid.

The black tape attached to the underside of the liftgate/rear compartment lid is an anti-abrasion tape used to improve the power release function.

Important: DO NOT REMOVE THE ANTI-ABRASION TAPE.

If the tape is removed, the liftgate/rear compartment lid may not release high enough from the rear weatherstrip, causing difficulty opening.
